Aleksander Piwek*

Chapel at St. Joseph's Church in Gdańsk

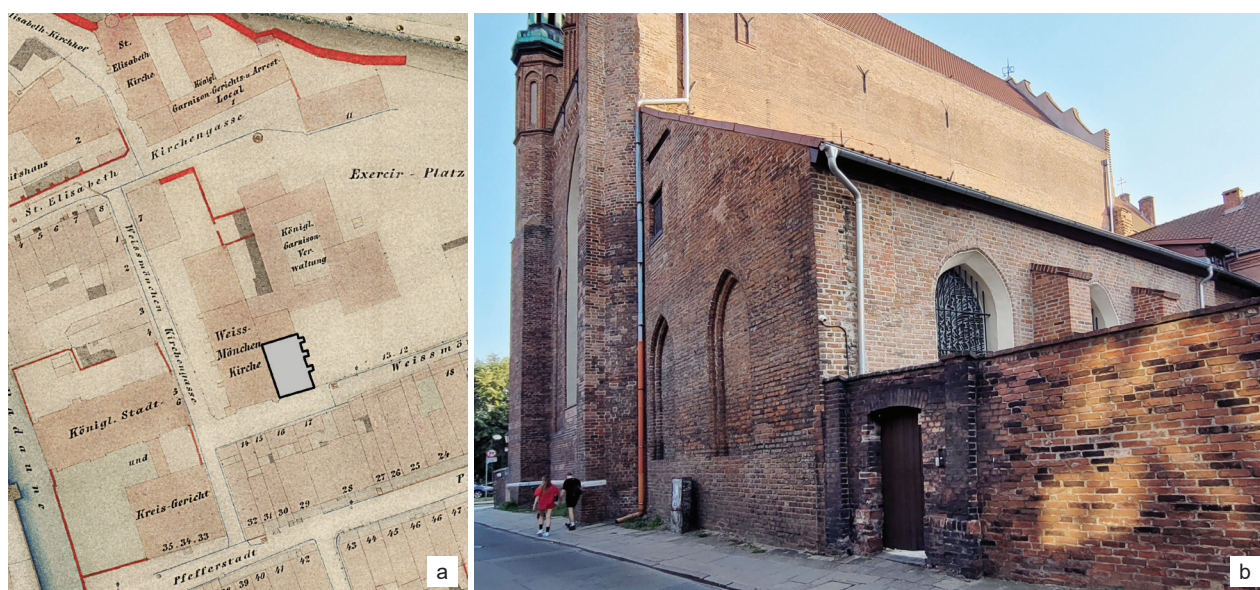
Fig. 1. Location of the chapel at St. Joseph's Church in Gdańsk:

a) fragment of a city plan (1866–1869) (source: BG PAN CIII 610), b) view from the north-eastern side (photo by A. Piwek)

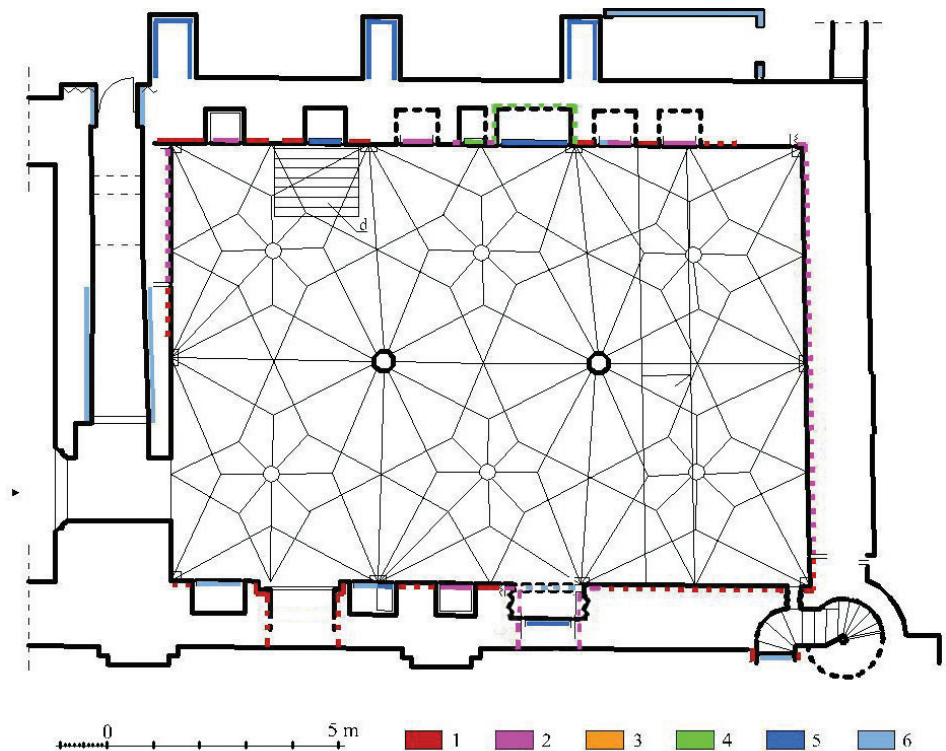
Fig. 2. Stratification of the walls of the chapel at St. Joseph's Church in Gdańsk on the ground floor (below the windows) and in the basement.

The letter "d" indicates the extent of the wooden trapdoor, different from the stone floor of the chapel.

The architectural analysis of the external surfaces of the walls brought some information about the history of the building, but much more was obtained by carrying out work in the interior of the chapel (Figs. 2, 3). The scope of the research undertaken was limited mainly to areas where the original plaster had not survived. In addition to fragmentary modern and younger painting decorations, conservators found medieval (consecration crosses) decorations on them. The original function of the described interior was therefore sacred, located within the present chapel space.

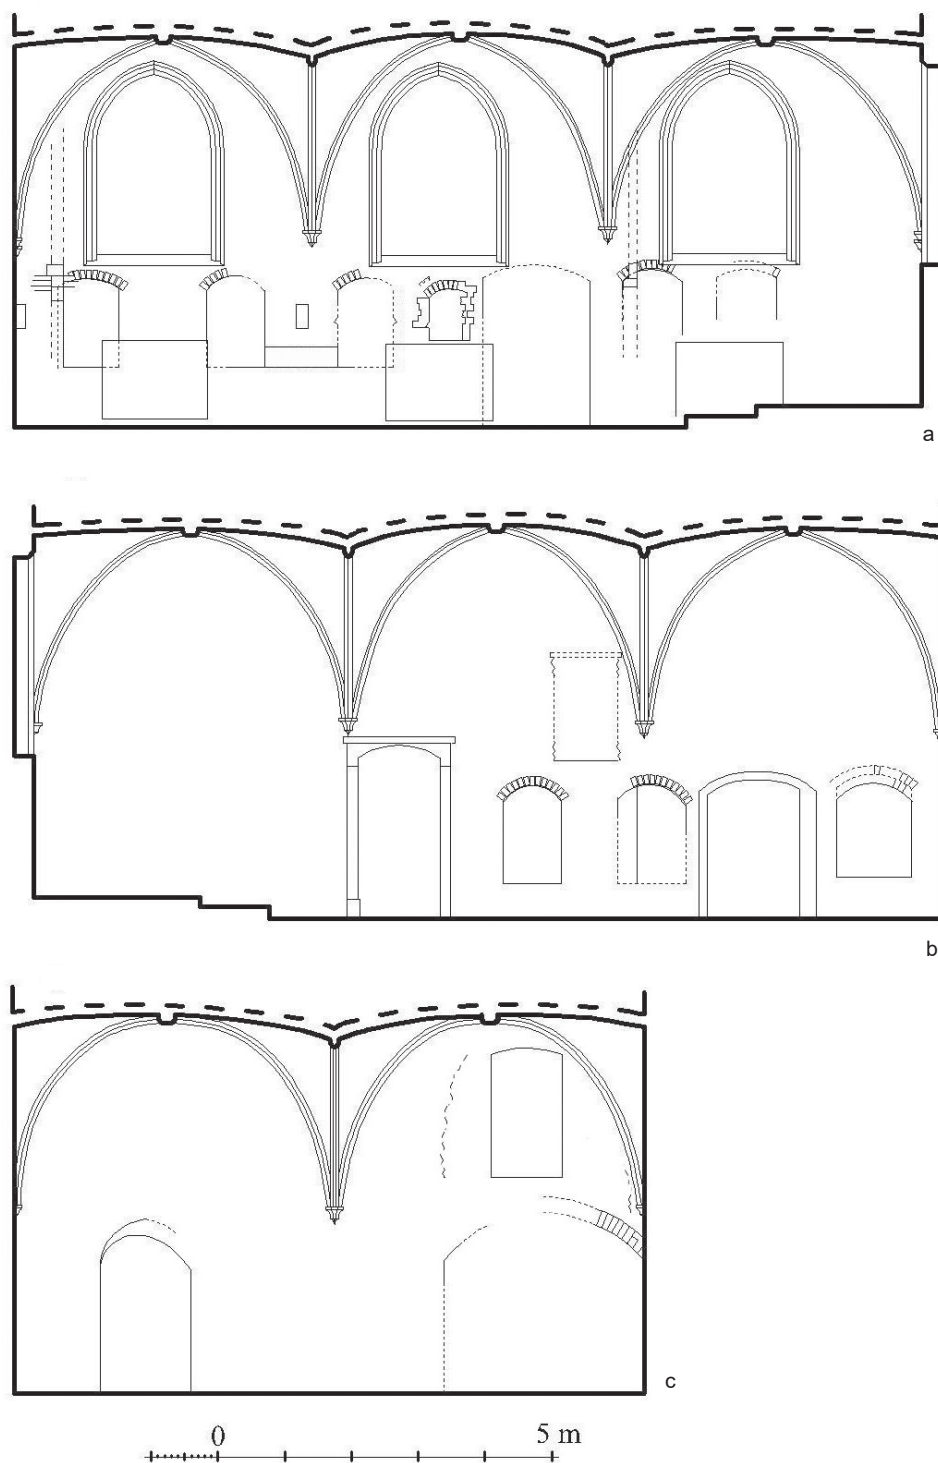
Fig. 3. View of the surface of the internal walls of the chapel at St. Joseph's Church in Gdańsk with marked traces of reconstructions: a) northern, b) southern, c) western (elaborated by A. Piwek)

An architectural analysis carried out on the inner side of the north wall revealed a considerable number of vertical grouts, connected to each other by segmental arches (Fig. 3a). The parts thus separated were found to be masonry of seven recesses. Three types were found among them. The first belonged to the first, second, fifth, sixth and seventh recesses (counting from the east wall) (Fig. 4a). They were 88–91 cm wide and 75–78 cm deep. The caps of the arches reached a height of 210–220 cm, while the edges of the base were 90 cm high (from the floor level). In recess five, the side walls (at the height of the fifth layer of bricks from its base) have a groove made up of two sloping walls. This is a remnant of a shelf. The recesses mentioned are original and date from the Middle Ages. They have been bricked up

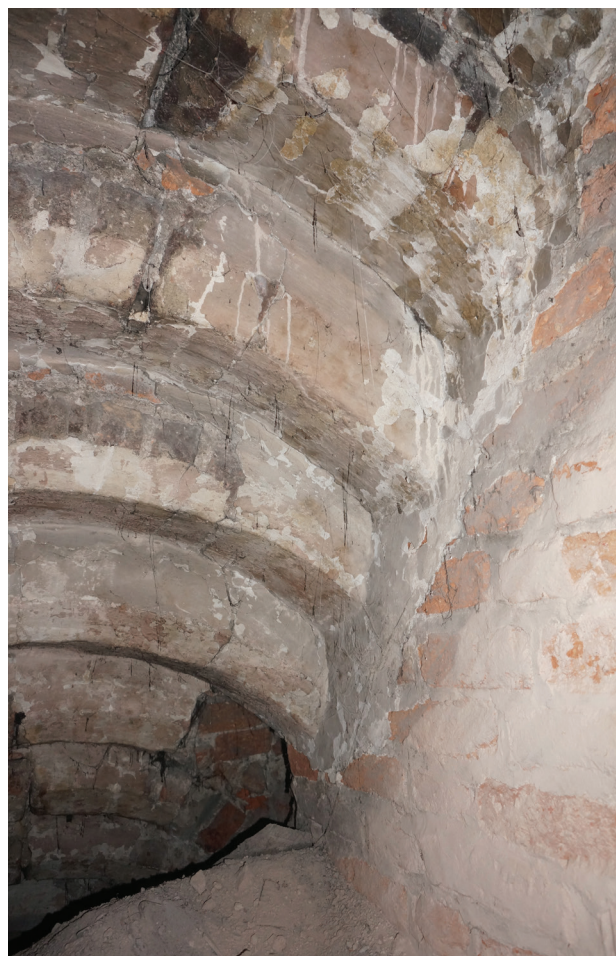
Fig. 5. A section of a partially buried descent from the level of the former matroneum to the ground floor of the chapel at St. Joseph's Church in Gdańsk (photo by A. Piwek)

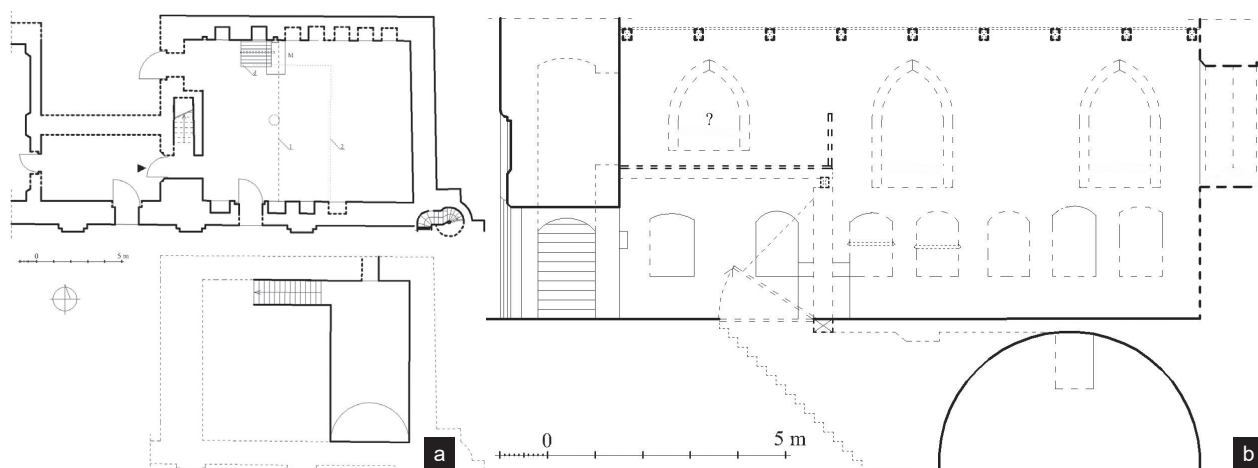
Fig. 7. Reconstruction of the chapel at St. Joseph's Church in Gdańsk and the crypt located under its eastern part from phase 1 (late 15th century):
a) plan, b) longitudinal section with view on the north wall,

1 – presumed range of the Gothic matroneum, 2 – the range of the crypt and the descent to its interior,
M – hypothetical location of the mechanism enabling the opening of the trapdoor covering the descent to the crypt, d – trapdoor
(elaborated by A. Piwek)

used as a library and storage for precious devotional objects. The north wall contained seven recesses along its entire length (Fig. 7b). The opposite wall of the small chapel probably had four recesses (the first one on the east side is presumed), but, as analysis [4, p. 5] has shown they could only have started at a length of about 3.5 m from the then east wall. The west wall was devoid of similar recesses. Instead, it contained one-flight stairs enclosed by a vaulted brick flight of segmental arches with chamfering. They led to the matroneum in the sacred interior¹². The matroneum was supported by a single pillar, the axes of which were about 4.5 m from the longitudinal walls and about 4.2 m from the west wall. Below the matroneum, in the northern part of this wall, there was a 3 m long recess surmounted by a segmental arch. The aforementioned passage to the utility courtyard was probably inside it.

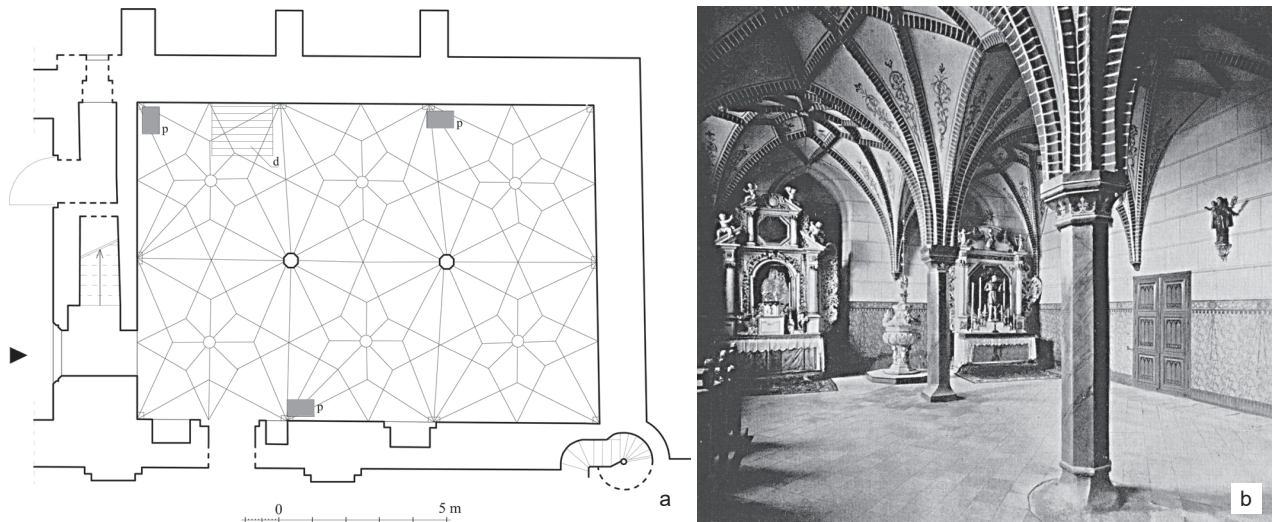
Fig. 8. The chapel at St. Joseph's Church in Gdańsk in the early 20th century:
 a) reconstruction of the plan from 1904 (p – location of furnaces) (elaborated by A. Piwek),
 b) view of the interior towards the south-east, circa 1920 (source: [14, p. 127])

deepened by 1 metre. The lowered level of the floor there made it necessary to add new steps to the old ones (leading to the ground floor level), maintaining the previous direction. On the pillars of the chapel, six vaulted areas were created, each with an extended star-shaped plan. It was probably at this time that cracks appeared in the west wall, below the north-west vault. Some of these were re-built to stabilise them. The cupboard recess in the north wall was removed. The south aisle was converted into a two-door cupboard, after a slight demoulding of the side walls and partial bricking up. The old entrance at the west wall was activated. Probably at that time, the windows were widened and glyphs were created by hacking off sections of the wall. The north wall of the chapel was reinforced (if not in 1916) with three buttresses. In 1904, furnace heating was established in the interior [13] (Fig. 8a).
