Aleksander Piwek*

Chapel at St. Joseph's Church in Gdańsk

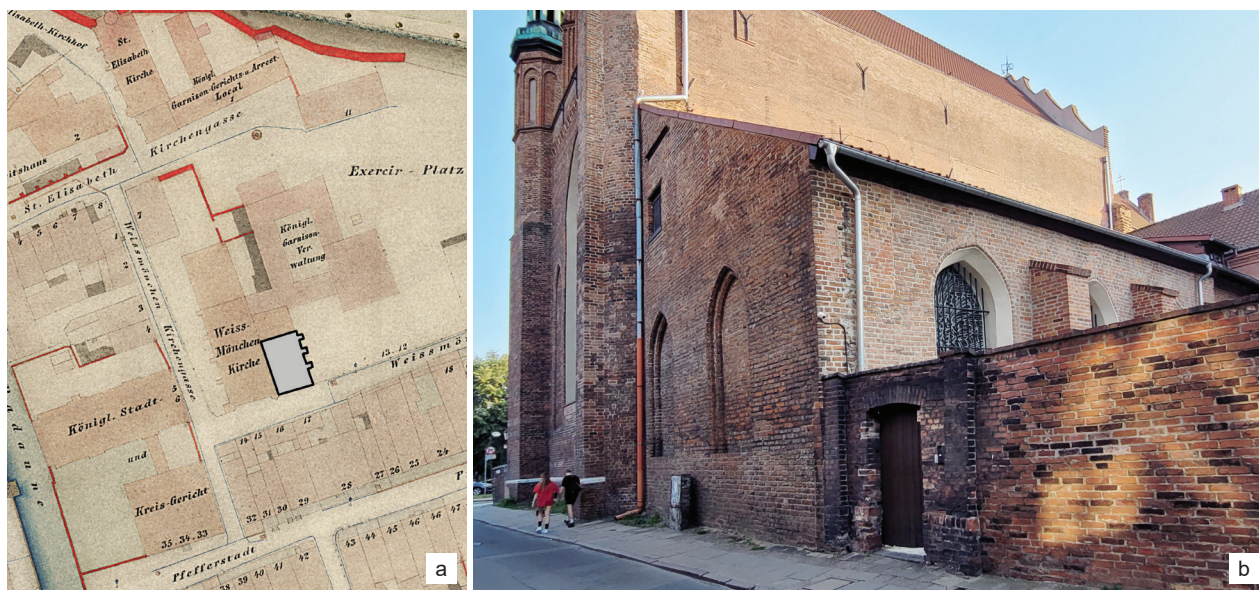
Fig. 1. Location of the chapel at St. Joseph's Church in Gdańsk:

a) fragment of a city plan (1866–1869) (source: BG PAN CIII 610), b) view from the north-eastern side (photo by A. Piwek)

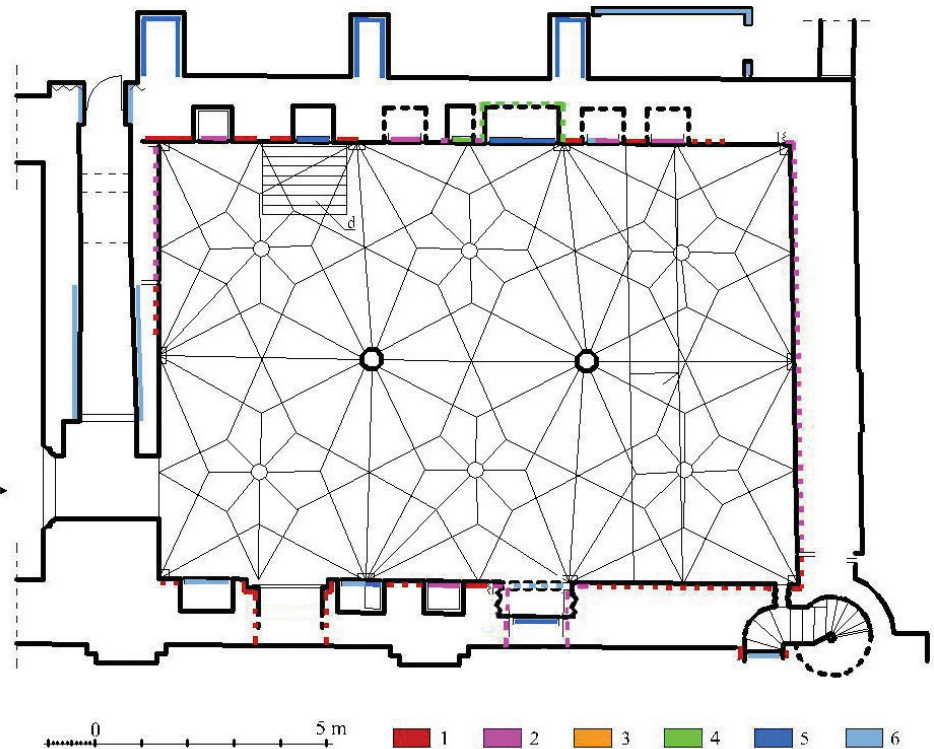
Fig. 2. Stratification of the walls of the chapel at St. Joseph's Church in Gdańsk on the ground floor (below the windows) and in the basement.

The letter "d" indicates the extent of the wooden trapdoor, different from the stone floor of the chapel.

Oznaczenia: 1 – koniec XV w.,
2 – XVII w.,
3 – XVIII w.,
4 – po 1840 r.,
5 – lata 1901–1920,
6 – 1945–2019
(oprac. A. Piwek)

The architectural analysis of the external surfaces of the walls brought some information about the history of the building, but much more was obtained by carrying out work in the interior of the chapel (Figs. 2, 3). The scope of the research undertaken was limited mainly to areas where the original plaster had not survived. In addition to fragmentary modern and younger painting decorations, conservators found medieval (consecration crosses) decorations on them. The original function of the described interior was therefore sacred, located within the present chapel space.

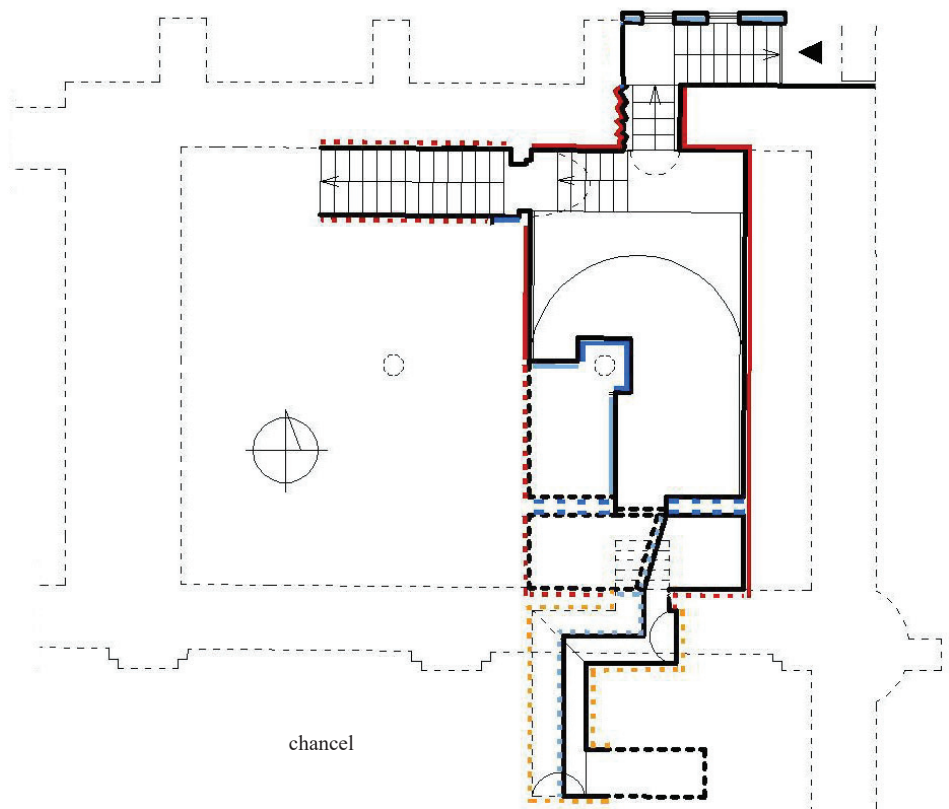
Fig. 3. View of the surface of the internal walls of the chapel at St. Joseph's Church in Gdańsk with marked traces of reconstructions: a) northern, b) southern, c) western (elaborated by A. Piwek)

An architectural analysis carried out on the inner side of the north wall revealed a considerable number of vertical grooves, connected to each other by segmental arches (Fig. 3a). The parts thus separated were found to be masonry of seven recesses. Three types were found among them. The first belonged to the first, second, fifth, sixth and seventh recesses (counting from the east wall) (Fig. 4a). They were 88–91 cm wide and 75–78 cm deep. The caps of the arches reached a height of 210–220 cm, while the edges of the base were 90 cm high (from the floor level). In recess five, the side walls (at the height of the fifth layer of bricks from its base) have a groove made up of two sloping walls. This is a remnant of a shelf. The recesses mentioned are original and date from the Middle Ages. They have been bricked up

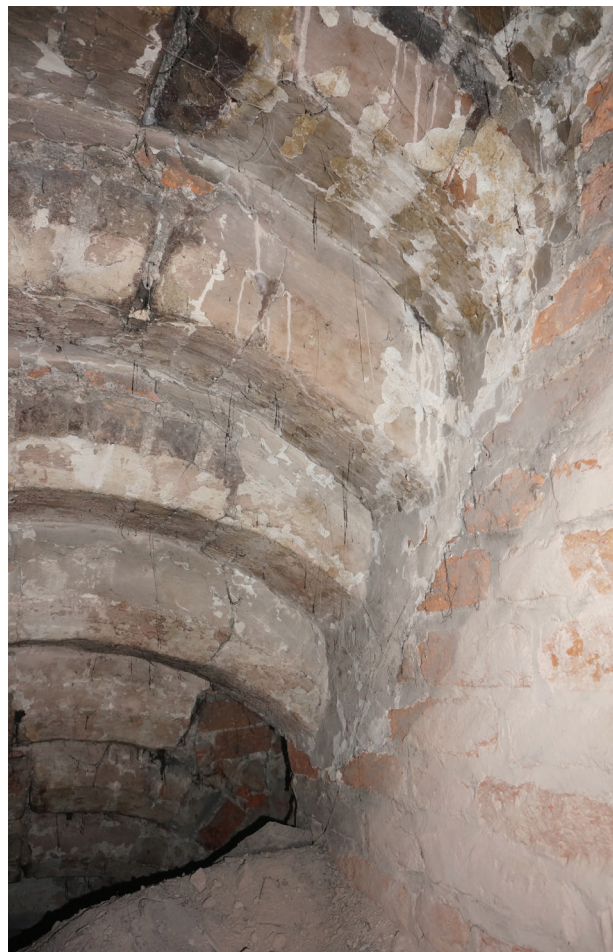
Fig. 5. A section of a partially buried descent from the level of the former matroneum to the ground floor of the chapel at St. Joseph's Church in Gdańsk (photo by A. Piwek)

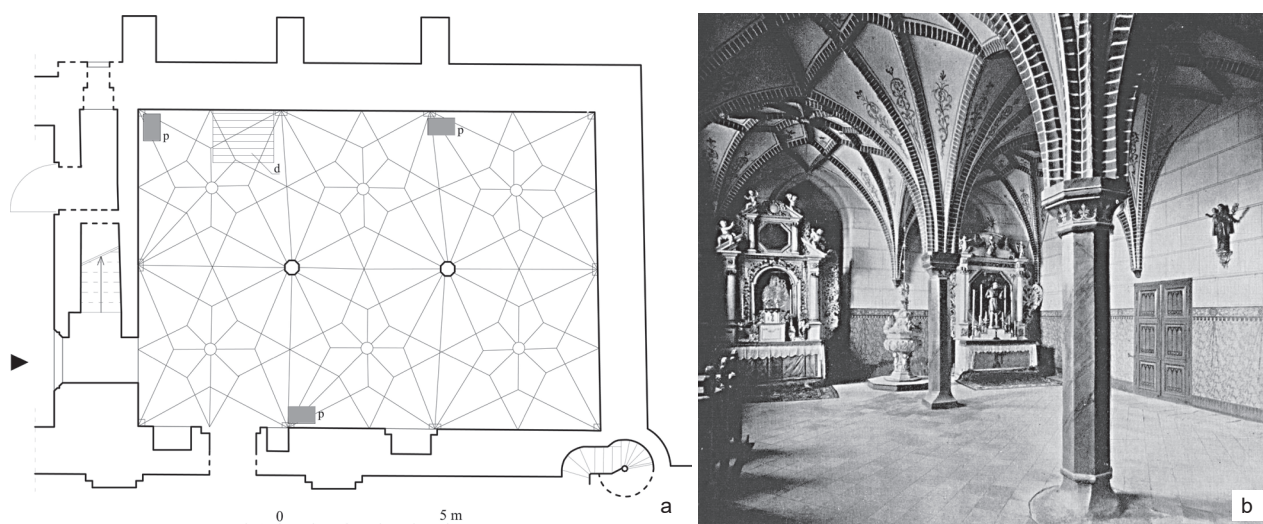
Fig. 8. The chapel at St. Joseph's Church in Gdańsk in the early 20th century:
 a) reconstruction of the plan from 1904 (p – location of furnaces) (elaborated by A. Piwek),
 b) view of the interior towards the south-east, circa 1920 (source: [14, p. 127])

deepened by 1 metre. The lowered level of the floor there made it necessary to add new steps to the old ones (leading to the ground floor level), maintaining the previous direction. On the pillars of the chapel, six vaulted areas were created, each with an extended star-shaped plan. It was probably at this time that cracks appeared in the west wall, below the north-west vault. Some of these were re-built to stabilise them. The cupboard recess in the north wall was removed. The south aisle was converted into a two-door cupboard, after a slight demoulding of the side walls and partial bricking up. The old entrance at the west wall was activated. Probably at that time, the windows were widened and glyphs were created by hacking off sections of the wall. The north wall of the chapel was reinforced (if not in 1916) with three buttresses. In 1904, furnace heating was established in the interior [13] (Fig. 8a).

During the renovations of the church in 1920, the interior of the chapel was artistically enriched (Fig. 8b). The walls were painted in two stripes imitating – in the lower one – a curtain wall, while in the upper one – stone walls. The vaults were also decorated with floral motifs (the vaulting drains, keystones and their nearest parts). The ribs were covered with a thin brick-coloured plaster with the introduction of painted white divisions to imitate the rhythm of the laid bricks. Significant furnishings included, against the east wall, two altars associated with the cults of Our Lady of the Scapular and St. Joseph dating from 1730 [14, p. 131]. Between them was a carved baptismal font from 1750 [14, p. 136]. A row of pews for the believers stood against the north wall.
