M. Landowski, K. Imielińska

Gdańsk University of Technology, Faculty of Mechanical Engineering, Narutowicza 11/12,  
80-233 Gdańsk, Poland  
mlandowski@gmail.com

## IMPACT BEHAVIOUR OF GLASS FIBRE /EPOXY COMPOSITES WITH NANO-ENHANCED RESIN AFTER WATER EXPOSURE

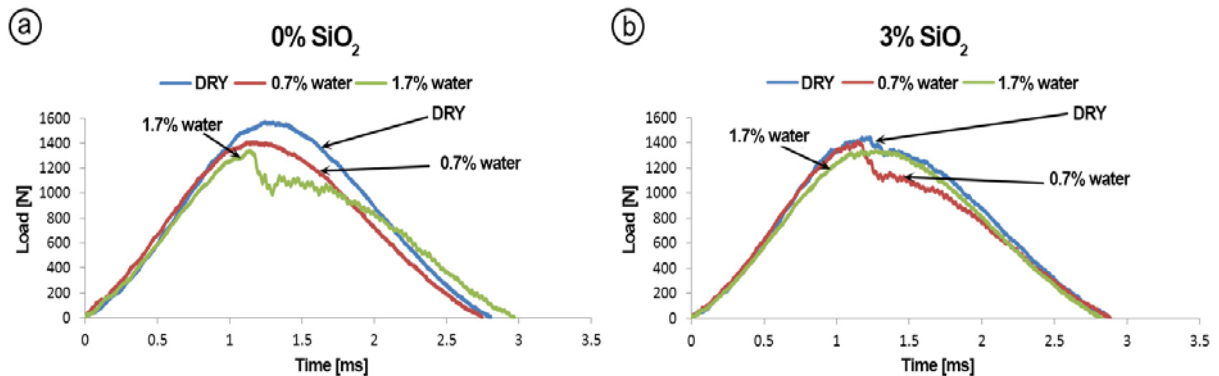
**Fig. 1.** Impact load-time characteristics for (a) unmodified, (b) 3% nanoparticle modified specimens in dry and wet conditions (with variable water contents). Impact energy 3J

Fig. 1 compares dynamic force –time impact characteristics at 3J impact energy for unmodified specimens (Fig. 1a) and specimens with 3%wt. nanoparticles (Fig. 1b) both in “dry” condition or with 0.7% and 1.7% water absorbed. Smooth curve profile for “dry” and 0.7% water (Fig. 1a) indicates that only minor impact damage resulted in these specimens whereas at higher water contents (1,7% ) more severe fibre damage resulted. Addition of 3% SiO<sub>2</sub> (Fig. 1b) changes the failure mode of “wet (1.7% water) specimens compared to the dry (3% SiO<sub>2</sub>) and to the unmodified (0% SiO<sub>2</sub>). At 3J impact energy, dry (and 0.7% water) 3% SiO<sub>2</sub> modified specimens are subjected to fibre breakage whereas in wet condition (1.7% water) smooth load-time curve is observed which is indicative of minor damage (matrix cracks) and a positive nano-particle effect. Fig 2a illustrates slightly decreased peak impact load for SiO<sub>2</sub> modified specimens. This property remains practically unchanged after water exposure (up to 2% water absorbed). However failure modes are different. Energy absorbed (Fig. 2b) decreased with increased water amount and absence of nanoparticle effect was observed.

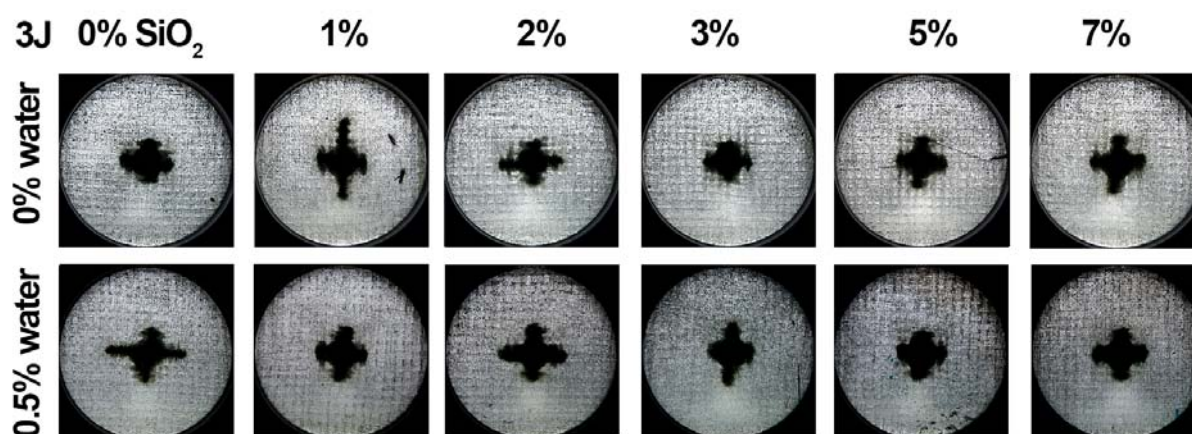
Fig. 3. Impact damage in laminates modified with 1-7% nanoparticles in dry (upper row) and wet (0,5% water absorbed)

Fig. 3 illustrates impact damage in laminates modified with 1-7% nanoparticles in dry (upper row) and wet (0.5% water absorbed). The shape of impacted zone differs slightly due to different failure modes, however impact damage area (Fig. 4) is 10-15% lower for unmodified specimens. The improvement in the behaviour of 3% SiO<sub>2</sub> modified specimens is observed in terms of impact damage area for “wet” (1-2% water absorbed) specimens.

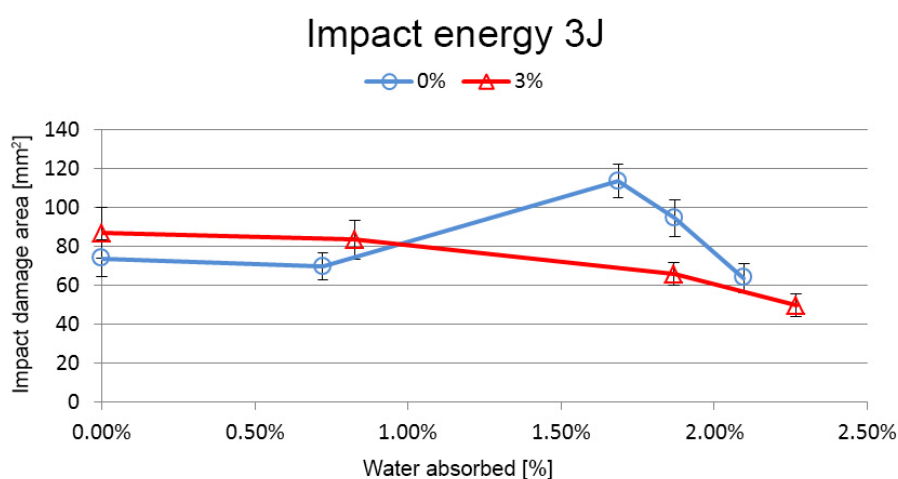
Fig. 4. Impact damage area as a function of percent water absorbed by the specimens with 0% and 3% nanoparticles. Impact energy 3J

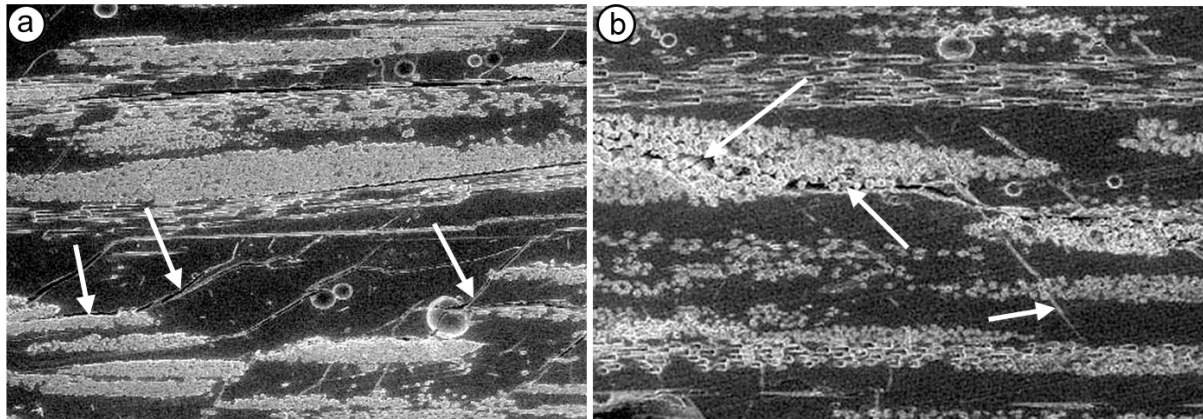
**Fig. 5.** SEM micrographs of dry (a) and wet (b) (1,7% water absorbed) specimen modified with 3% nano-SiO<sub>2</sub> after 3J impact. Arrows show matrix cracks and debonded fibres

Figs. 5ab illustrate SEM micrographs of dry (a) and wet (1.7% water absorbed) specimen modified with 3% nano-SiO<sub>2</sub> after 3J impact. Typical impact failure modes observed in this illustration are numerous matrix cracks (arrows). Nanoparticles cannot be observed at this magnification (100x). In Fig 5b debonded fibres are demonstrated (arrow) which is the effect of water immersion. This effect was observed in the previous study [7]. It appears that the same effect (debondings) could be observed at nanoparticle /matrix interfaces following water exposure which resulted in the change of failure mode observed for impacted specimens in wet condition. The weakest point in the material with up to ca. 2% water absorbed was the matrix with numerous debonded nanoparticles which prevented fibre fracture at 3J impact energy. The presence of debonded nanoparticles accounts for the less severe failure in water affected specimens.
