Types of Surface Impurities versus the Quality of Brazed Joints

Abstract: Brazing is one of the primary joining processes increasingly often applied in industry. Because of their mechanical properties, overlap joints are particularly popular when making brazed structures. The use of brazed joints in structures of critical importance requires that particular attention be paid to joint quality, e.g. by the appropriate cleaning of surfaces to be joined. The article presents results of non-destructive tests of brazed joints made in steel S235JRG2. Surfaces used in the tests were deliberately contaminated to simulate the presence of welding imperfections. Afterwards, the test specimens were subjected to non-destructive (visual and radiographic) tests aimed to determine the effect of surface impurities on the quality of brazed joints.

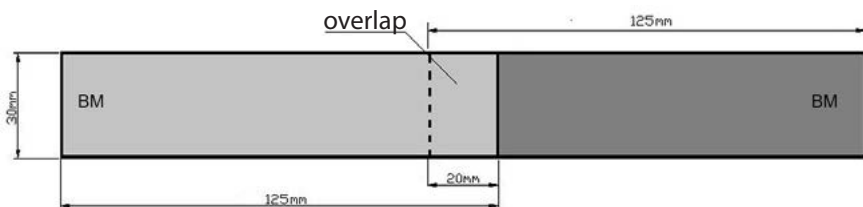
Fig. 1. Schematic overlay brazed joints, BM – base material

The tests aimed to determine the effect of surface contamination types on the quality of gas (oxy-acetylene) overlay brazed joints. The tests involved the use of 1.5 mm thick sheets (125 × 30 mm) made of steel S235JRG2. The sheets were used to make 10 joints presented schematically in Figure 1. Table 1 presents the chemical composition of the base material.

The brazing process was performed using silver brazing metal grade Ag203 (B Ag-44CuZn-675/735) according to PN-EN ISO 17672:2016 (having the form of a wire) and flux 1802 N Atmosin (Castolin), used to dissolve oxides present in the base material. The presence of the flux provided the wetting of elements in the joint by the molten brazing metal and intensified the capillary action in the brazing gap. The flux was used to cover the area referred to as an “overlap” (Fig. 1).
