of Achievements in Materials and Manufacturing Engineering VOLUME 20 ISSUES 1-2 January-February 2007

Hydrogen degradation of high strength weldable steels

J. Ćwiek*

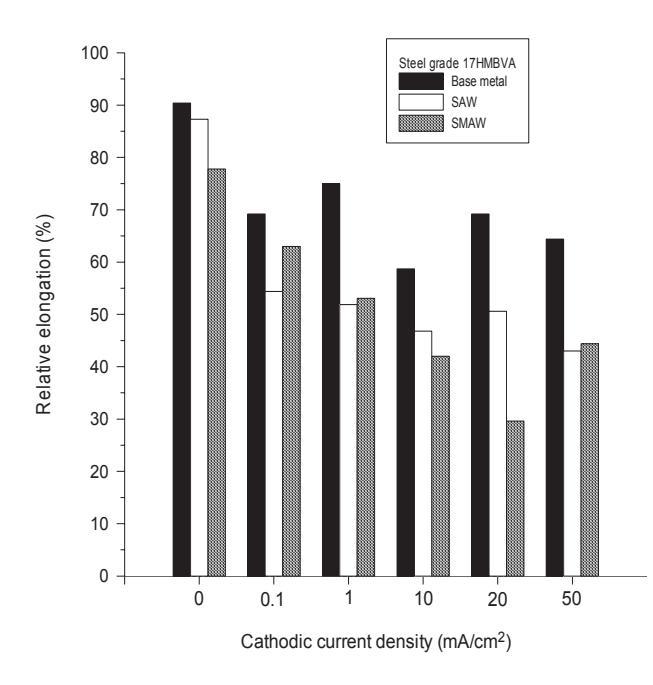
Examples of obtained results for loss of elongation after SSRT tests presents Fig. 1. Observed decrease of relative values of elongation with the increase of current density exhibits a certain minimum. Further increase of current density does not cause higher degradation due to deposits evolution on samples surface and hindering of hydrogen absorption. The loss of elongation was as high as 40-45% for base metals, 40-55% for SAW, and 55-70 for SMAW joints.

Fig. 1. Relative elongation vs. cathodic current density for 17HMBVA steel and its welded joints

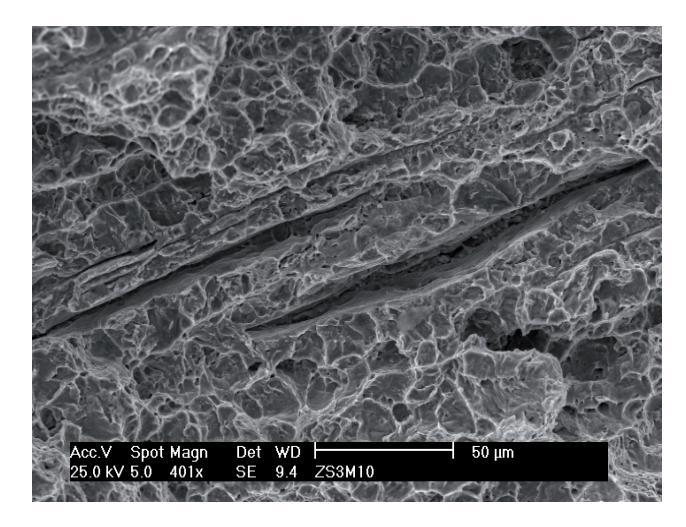
Samples with welded joints tested in air revealed ductile – MVC fracture mode. When cathodic polarization was applied mixed – MVC and quasi-cleavage fracture was observed. At higher cathodic current densities the presence of hydrogen induced microcracks and flakes in weld metal (Fig. 2).

Fig. 2. SEM image of fracture surface of 17HMBVA steel sample with SAW welded joint after SSRT test in seawater, $i = 10 \text{ mA/cm}^2$. Fracture localized in weld metal

Obtained results of SSRT test and fractographic observations suggest that hydrogen-enhanced localized plasticity (HELP) model is the more applicable mechanism of hydrogen degradation. Hydrogen assisted-cracking occurs at load level as high as flow stress (yield strength) of tested steel and its welded joints.

Ductile and quasi-cleavage fracture modes support suggestion that hydrogen interacts with dislocations and increase their mobility, and at the same time hydrogen is transported by mobile dislocations. Hydrogen ions transported with mobile dislocations locally increasing hydrogen concentration which facilitates cracking.

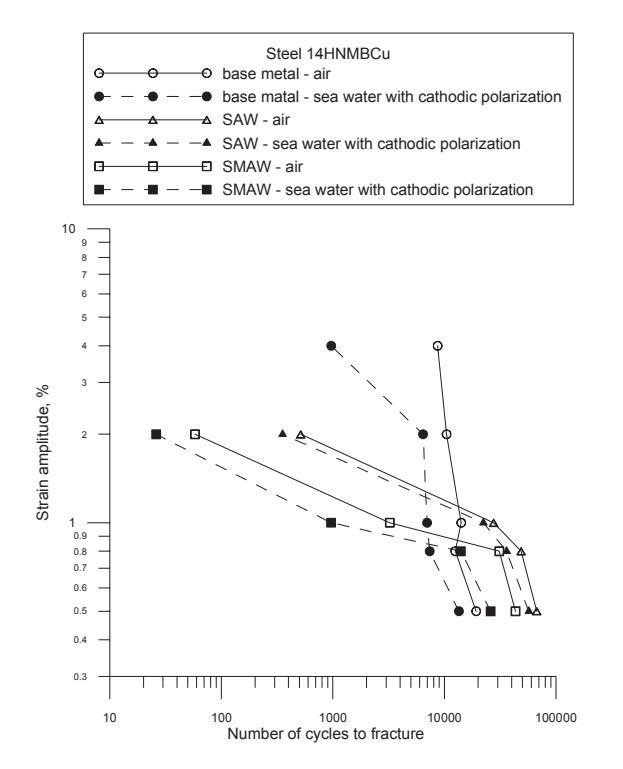
Results of fatigue tests of 14HNMBCu steel and its welded joints are presented in Fig. 3. Significant reduction of fatigue life time (30-90%) due to hydrogen absorption was observed for 14HNMBCu steel. Reduction increased with increase of strain amplitude. Welded joints of 14HNMBCu steel had higher resistance to low-cycle fatigue assisted by hydrogen. It should be noted that low-cycle fatigue test is very severe since plastic deformation is reached.

Fig. 3. Number of cycles to fracture versus strain amplitude for 14HNMBCu steel and its welded joints
