Article The Mechanisms of Degradation of Titanium Dental Implants

Agnieszka Ossowska * and Andrzej Zieliński

Department of Materials Engineering and Bonding, Gdansk University of Technology, 80233 Gdańsk, Poland; azielins@pg.edu.pl

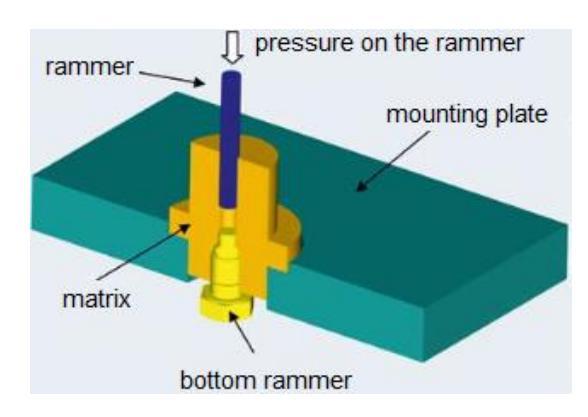
Figure 1. The cold pressing scheme for manufacturing the titanium dioxide specimens by powder metallurgy.

In the second stage, the tests of the dissolution rate of rutile (titanium oxide) were performed in two simulated body fluids (SBF). The starting material was the titanium oxide powder (purity of 98.0%–100%) delivered by Acros Organics (Morris Plains, NJ, USA). Cylindrical samples, of dimensions 6 mm \times 3 mm (diameter \times length), were prepared using the classical powder metallurgy method without a filler. The material was formed in a single-axis pressing process using a force of 2 kN acting on the stamp for 60 s at the position shown in Figure 1.

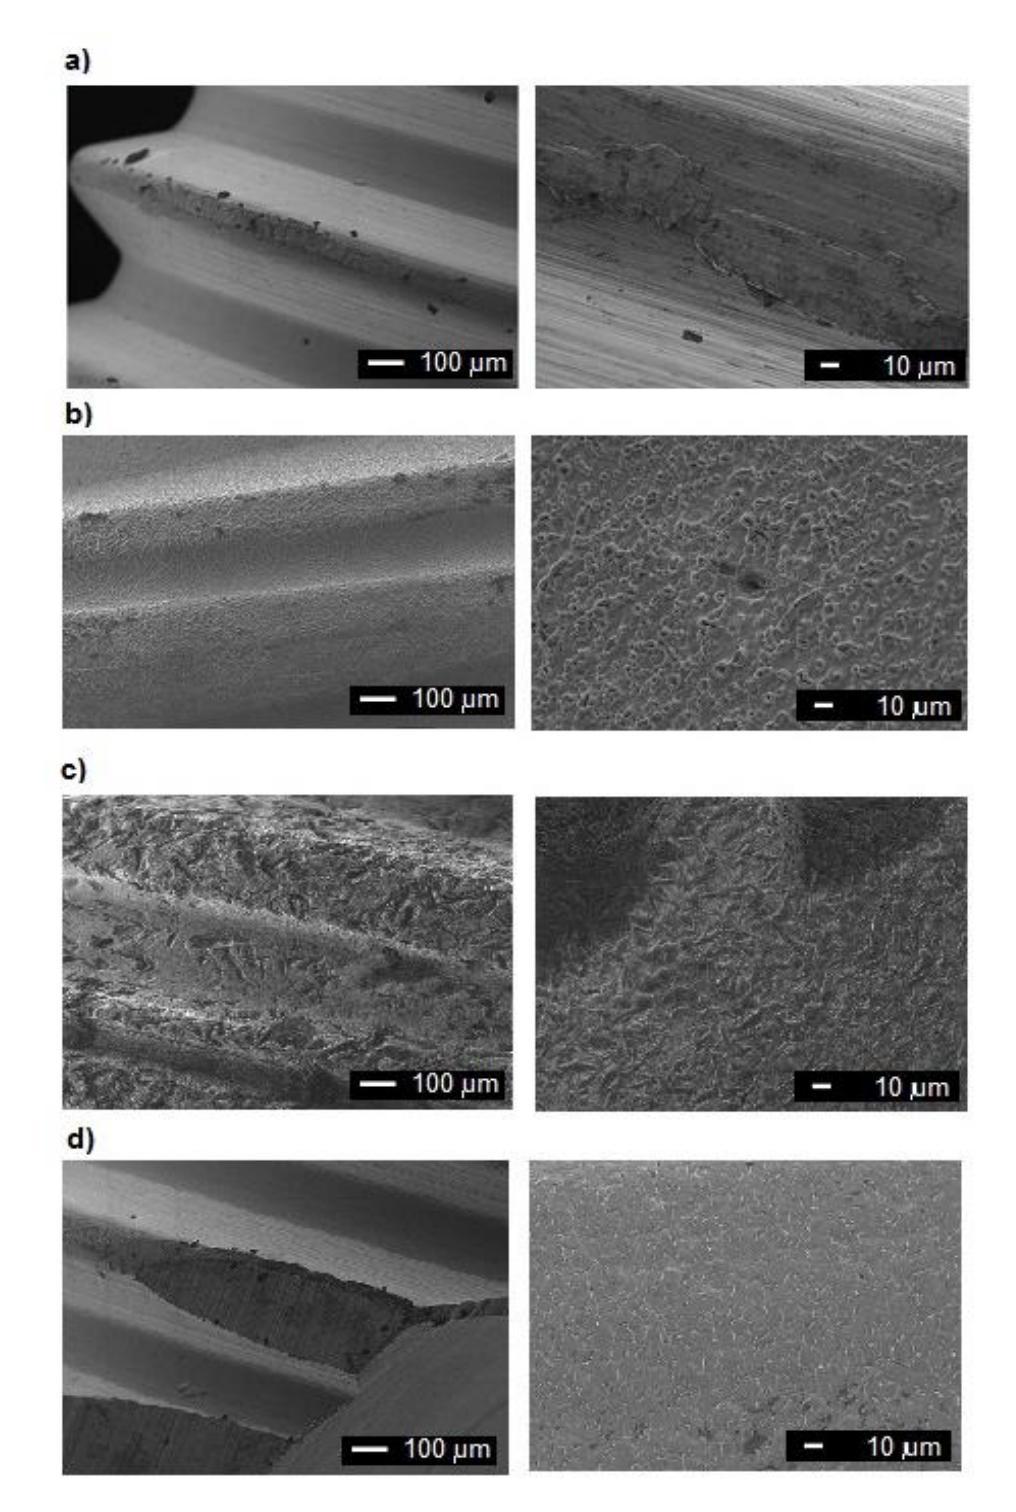
Figure 2 presents the surfaces of different three new implants, produced by two companies, A and B. The layer discontinuities, material defects appearing in the layer, unevenness, numerous rolling scratches, and material allowances resulting from the surface treatment processes are visible before implantation.

Figure 2. Surfaces of new dental implants: (a) A company; (b) B company; (c) C company; (d) D company. SEM.

It is a damage that certainly locally destroys the titanium coatings. However, our investigations showed that several implants before any implantation possessed already imperfect surfaces with such damage forms of the oxide coating as the layer discontinuities (holes/pits), large unevenness,

and rolling scratches. Such defects may initiate the local degradation of an implant, in particular the cracking and pitting corrosion.

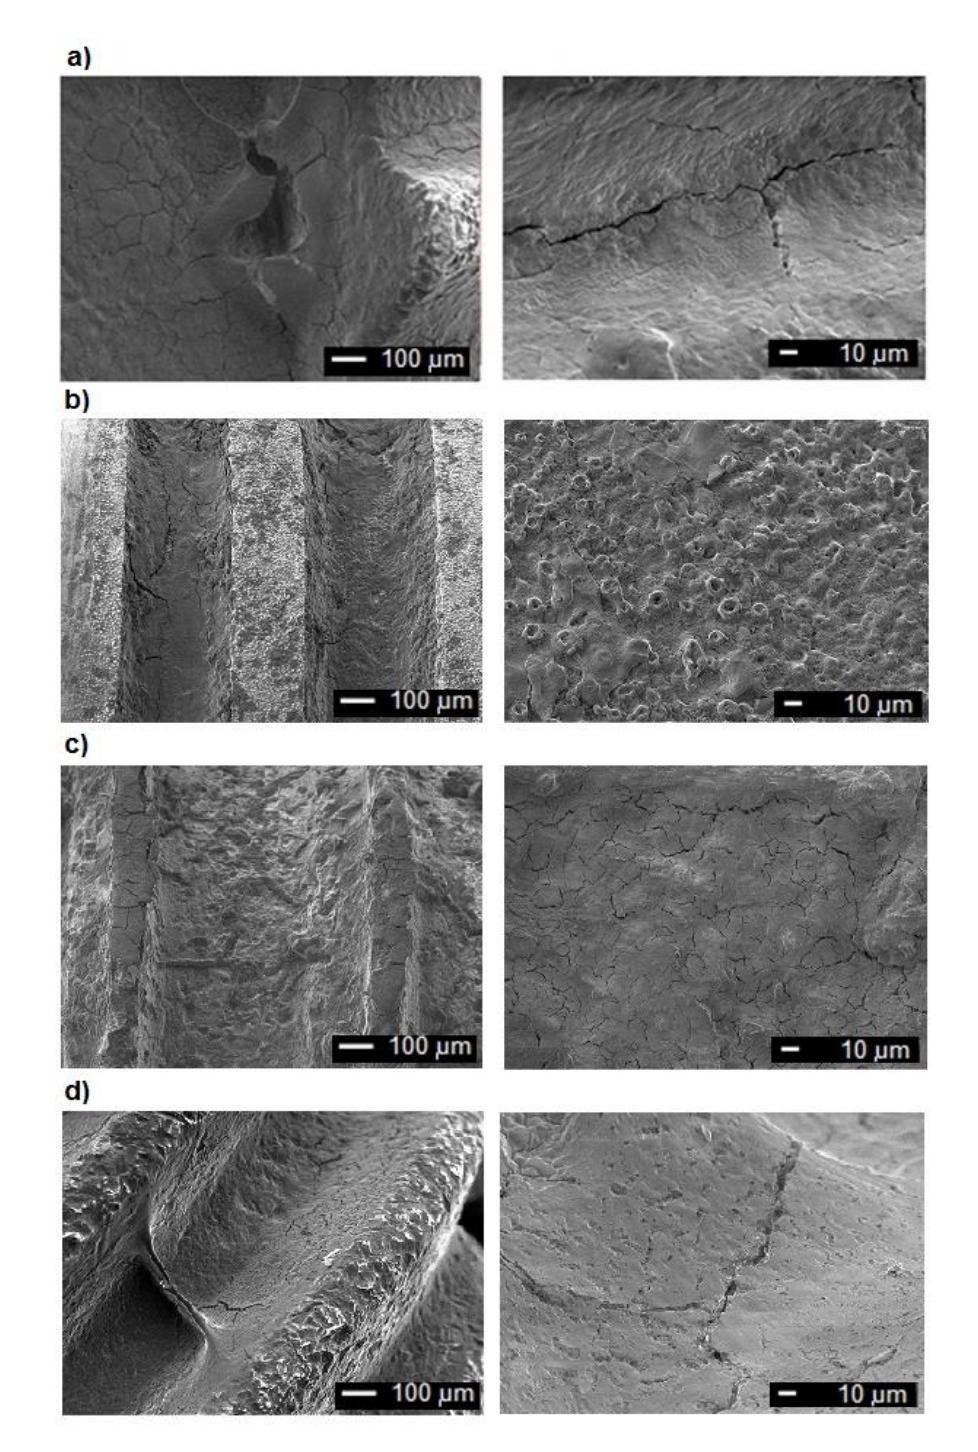
The used implants were obtained from surgeons from the Warsaw Medical University. Only removed implants, among all, which demonstrated clear signs of damage, were selected. When examinations of the used implants (Figure 3) were made, two areas of surfaces could be distinguished. The first was the top of the threads, with characteristic flattened, rubbed bumps, with clearly visible pits on the surface. The second type was the bottom of the threads, in which there is a detachment of the material of the layer from the ground, and numerous deep cracks are visible likely arisen as a result of stress concentration, which are potential places of corrosion initiation and development of corrosion processes in the environment of body fluids and particularly aggressive saliva.

Figure 3. Surfaces of used dental implants: (**a**) A company; (**b**) B company; (**c**) C company; (**d**) D company. SEM.

The examinations of implants used for a relatively short time confirmed the above assumption, even indirectly. The pits are visible on the tops of the threads, and the detachment of the coating on the bottoms. The numerous deep cracks are likely arisen as a result of stress concentration, and can serve as potential places of corrosion initiation and development in the environment of body fluids and particularly aggressive saliva.

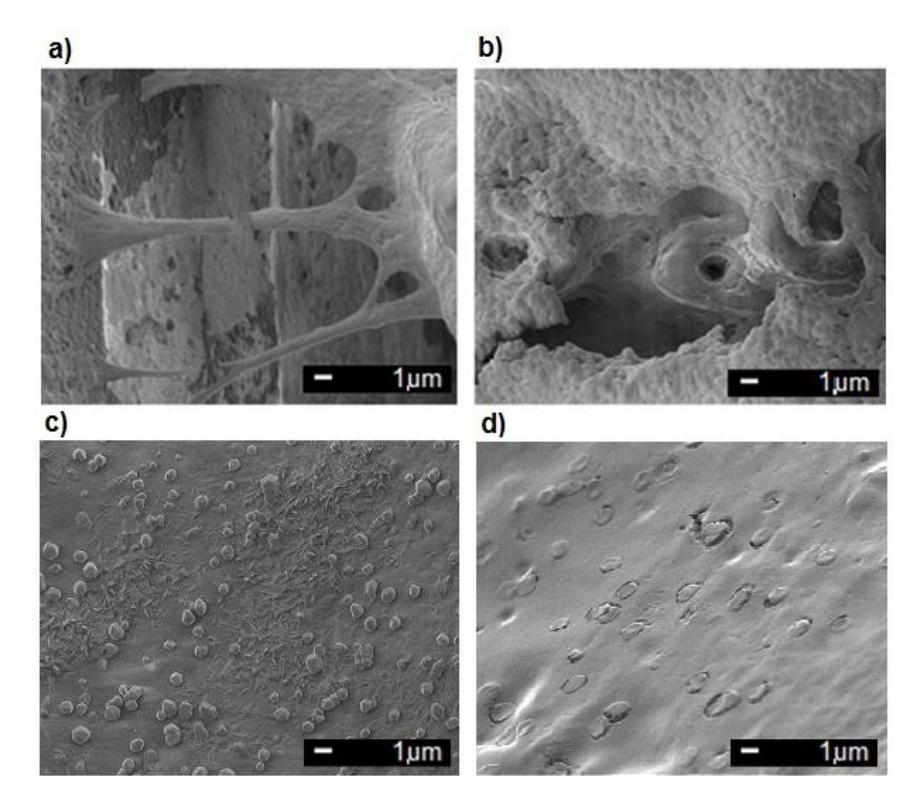
The surfaces of the used implants were subjected to purification or sterilization processes, thanks to which we can observe traces of organic residues on the surface—bacteria and tissues. Surprisingly, the largest clusters of bacterial colonies are located between the tip and the bottom of the thread, on the lateral surfaces. Perhaps this phenomenon is caused by adverse conditions at the tops and bottoms of the threads. Pits are visible on the surface of the thread tops, numerous and deep cracks in the thread cavities, which may indicate a significant impact of the environment and continuous operation of the implant—the influence of tensile forces and friction forces that affect the implant placed in the bone. On the implant surfaces, discontinuities of bone formation (Figure 4a,c) and bacterial colony residues (Figure 4b,d) can be observed, which tightly cover the material.

Figure 4. Organic remains on the surfaces of used dental implants: (**a**) A company; (**b**) B company; (**c**) C company; (**d**) D company. SEM.

The traces of organic residues on the surface were between the tops and the bottoms of the threads. Perhaps this phenomenon is caused by adverse conditions at the tops and bottoms of the threads due to a significant impact of the environment and continuous influence of tensile and friction forces that affect the implant placed in the bone. The detailed mechanism of this phenomenon cannot, however, be proposed at the moment.

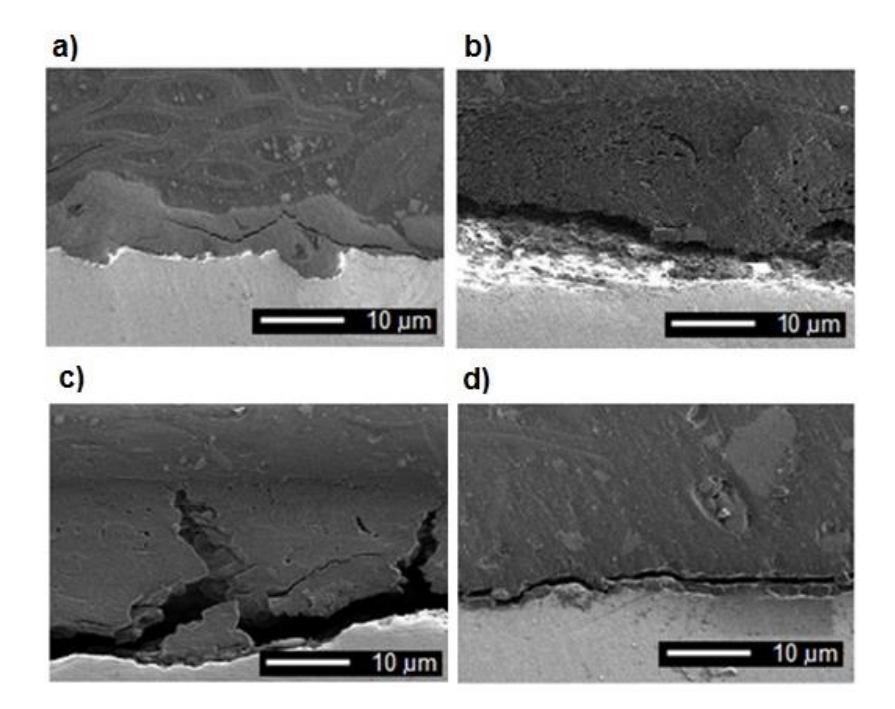
The implant cross-sections (Figure 5) illustrate surface unevenness, numerous discontinuities characterizing the layers produced, material stratification, a significant number of cracks of varying lengths, and arrangement occurring in the coating. They can be ideal for corrosion progress.

Figure 5. Cross-sections of used dental implants: (a) A company; (b) B company; (c) C company; (d) D company. SEM.

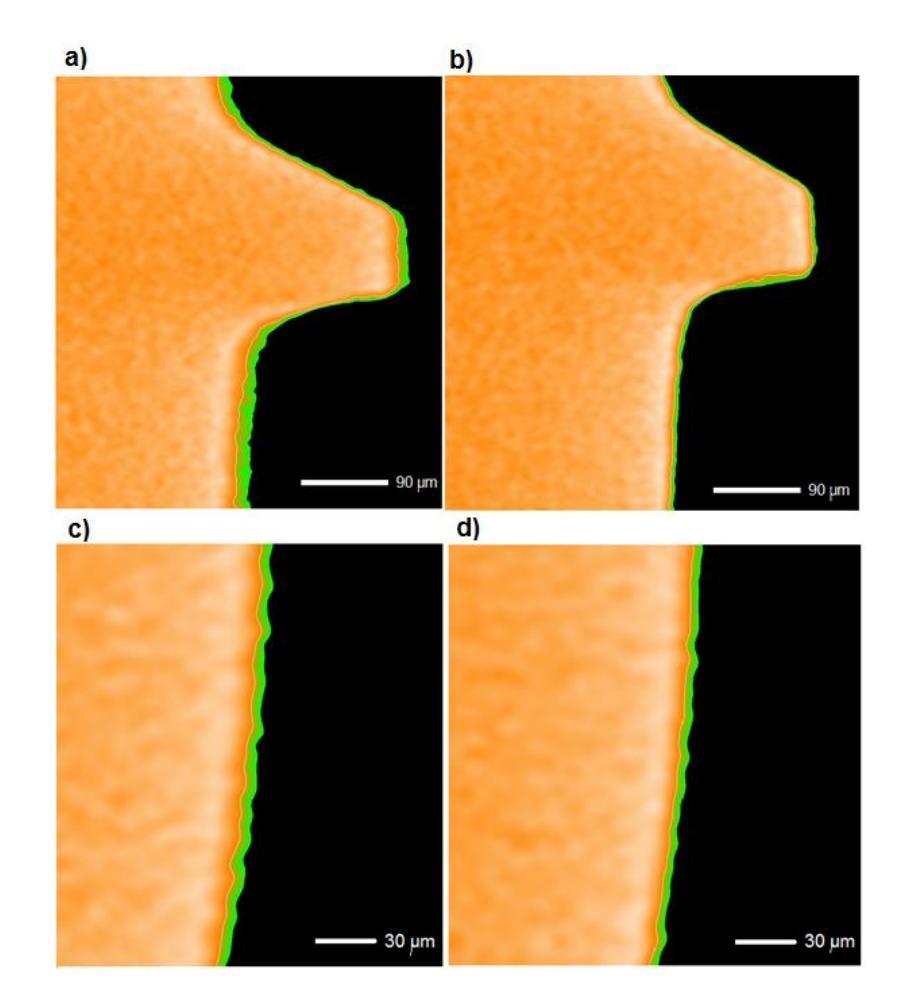
Using computed tomography, the layer thickness distribution on dental implants was depicted (Figure 6). The analysis shows that the thickness of the layers formed on the surface of the implants is diverse and does not evenly distribute. The surfaces of the vertices and thread cavities are characterized by a larger thickness of the coating. The images of the layer thickness distributions on the surface of the dental implants were very similar.

Figure 6. Images obtained by the computed tomography study of the sections: —longitudinal: (**a**) D company; (**b**) A company; —transverse dental implants: (**c**) D company; (**d**) A company.

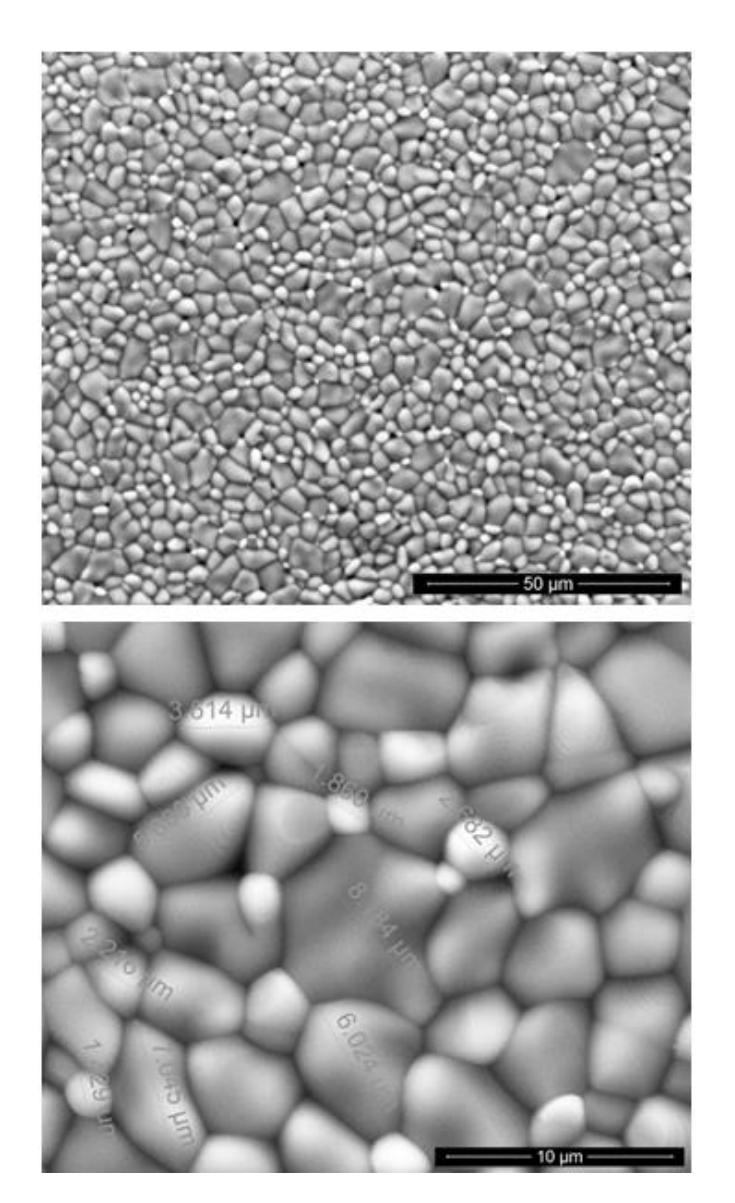
The surface of the samples produced, featuring a slight degree of porosity, is shown in Figure 7. The samples vary in grain size from 1.429 to $8.184 \mu m$.

Figure 7. SEM microstructures of the sample surface after pressing with a force of 2 kN.
