D. Fydrych, T. Kozak

Gdańsk University of Technology, Faculty of Mechanical Engineering, Department of Materials Technology and Welding, Gdańsk, Poland

UNDERWATER WELDED JOINT PROPERTIES INVESTIGATION

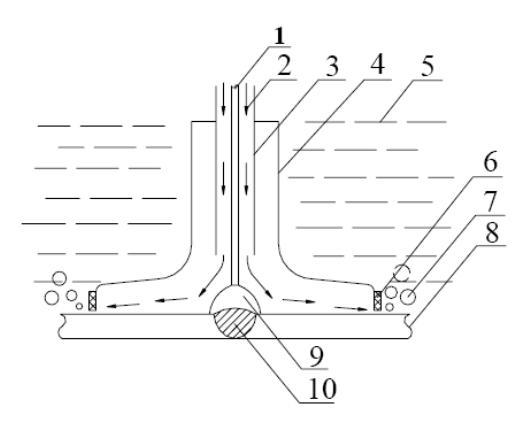
Fig. 1. Welding by local cavity method. 1 – welding nozzle, 2 – welding wire, 3 – shielding gas, 4 – outer nozzle, 5 – water, 6 – elastic cover, 7 – gas bubbles, 8 – welded element, 9 – arc, 10 – weld [3]

In the most cases of practical applications underwater welding is performed in wet or dry environment [1,2,3]. Nevertheless, the local cavity method can be also utilized, especially as mechanized process at depth unavailable for welders [4,5]. The main principle of welding in local cavity is presented in fig. 1. The basic advantage of the method compared to wet welding is removal of water from cavity by shielding gas, so electric arc is localized in a chamber filled by active or inert gas.

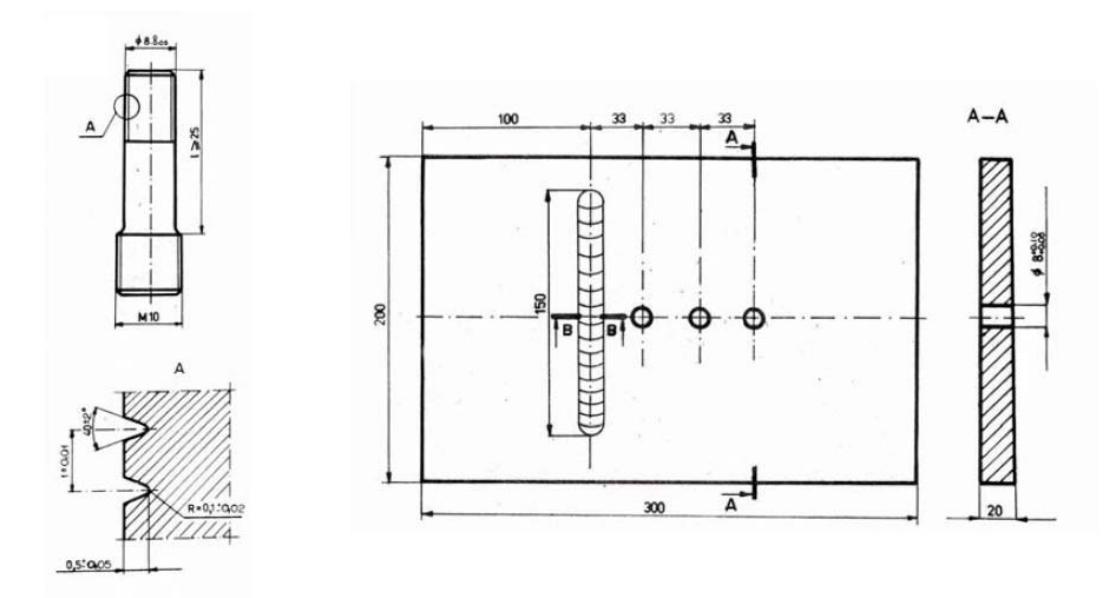
Fig. 2. Implant specimen and basic plate for implant test [5,6]

Cylindrical specimen with circular or helical notch of the tested material is inserted into a borehole of basic plate and then welded to it by one bead. After the welding the specimen is subjected to a static tensile loading. The time until the fracture occurs is measured. The tensile load is maintained for 16 hours if the specimen had not fracture before [6]. The dimensions of helical notched implant specimen and basic plate are shown in fig. 2.

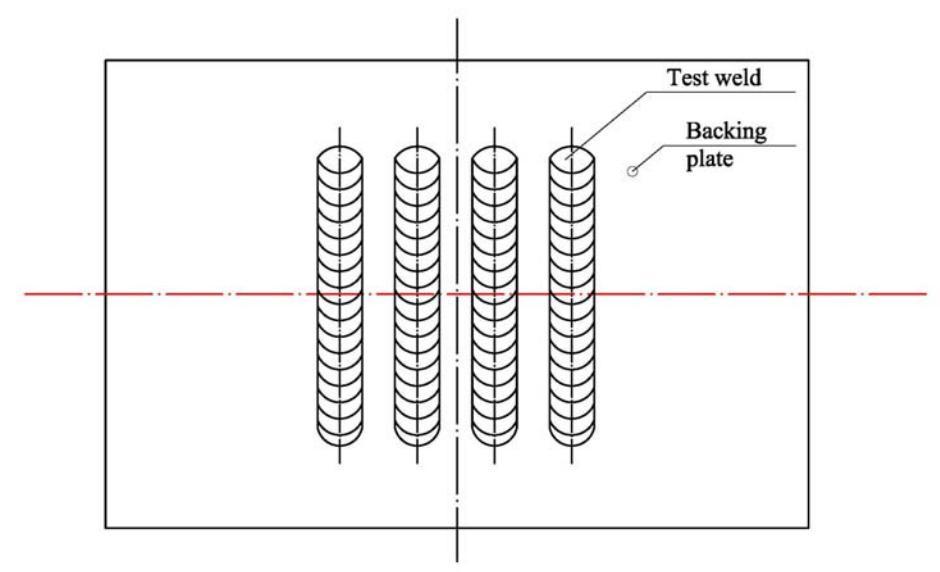
Fig. 3. Schematic view of test welds deposited on basic plate. The horizontal intermitted line shows investigated surface

Specimens were taken from implant tests samples after the tests were conducted in water environment in the following conditions: heat input $e_L=10\div20$ kJ/cm and flow rate of CO₂ shielding gas $W_g=20\div50$ l/min [5]. The way of sampling of cross-sections is shown in the fig. 3. Metallographic sections were prepared using conventional metallographic technique [7].

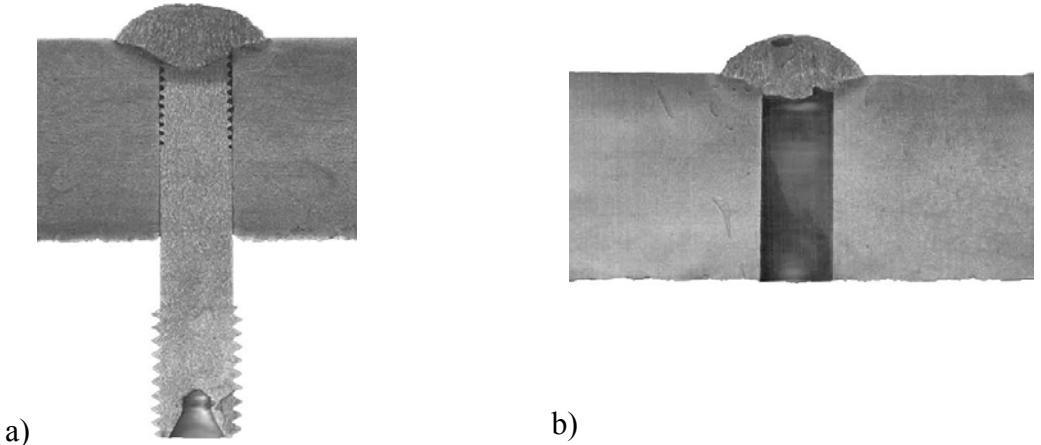
Fig. 4. Macroscopic photographs of implant joints: a) Wg=35 l/min, e_L=15 kJ/cm, σ_i=420 MPa, b) Wg=35 l/min, e_L=15 kJ/cm, σ_i=450 MPa

The welded beads were deposited symmetrically so the conditions of implant tests were fulfilled (fig. 4a). The width of HAZ in tested joints was in the range from 3 to 6 mm. Accordingly to rules of implant test [6] all of the examined specimens fractured in HAZ as it is visible on the exemplary macroscopic photograph shown on fig. 4b.

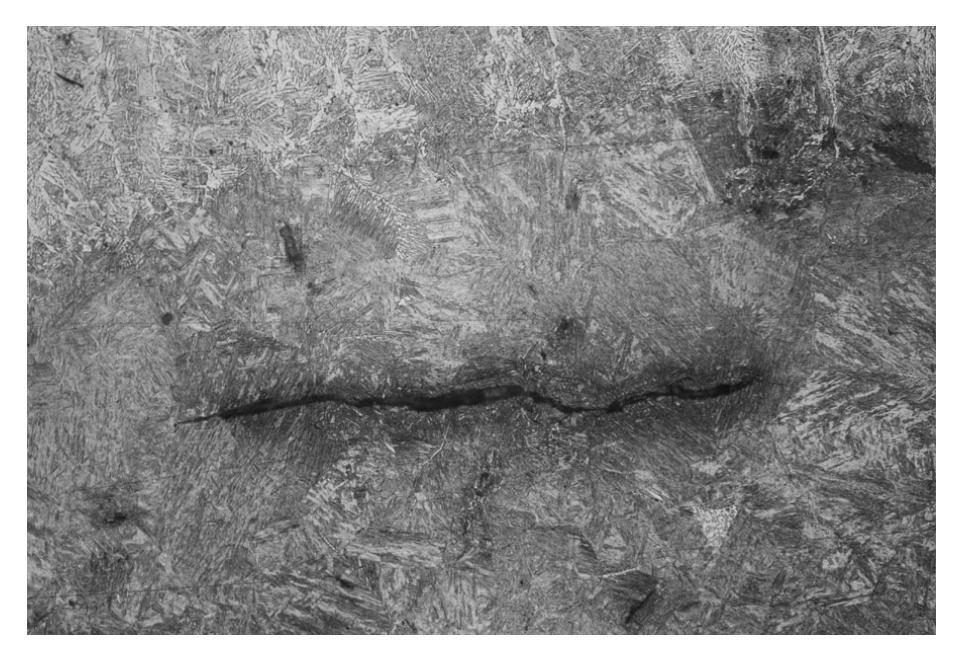
Fig. 5. Exemplary microphotograph of the cold crack in the bainite structure (magnification 200×)

Microscopic investigations of the structure of the tested joints were carried out using a metallographic microscope Neophot 32. An examination of the surface of metallographic sections revealed a number of cracks (fig. 5÷6). Fig. 5 shows micrograph taken from a metallographic section in the close proximity of cold crack path. In HAZ of investigated joints brittle structure - probably bainite is present. As can be seen from fig. 6 crack paths formed in specimen are irregular and branched. They run mainly perpendicularly to axis of implant specimen. In the range of investigation propagation of crack occurred both transgranularly and intergranularly.

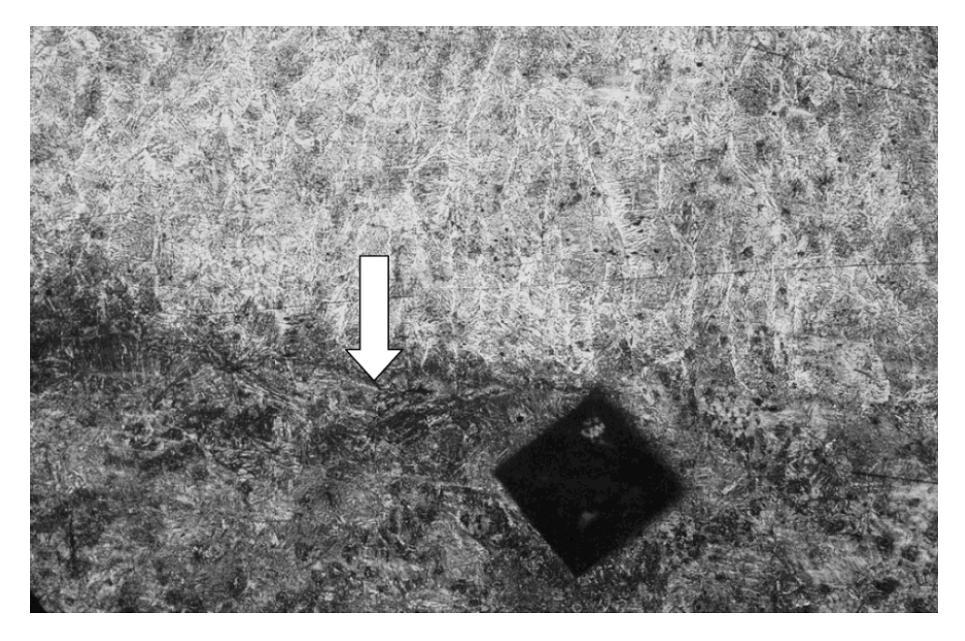
Fig. 6. Microphotograph of fusion line of implant joint: Wg=50 I/min, e_L=20 kJ/cm, HV_{max}=404. Long branched crack is marked by arrow (magnification 100×)

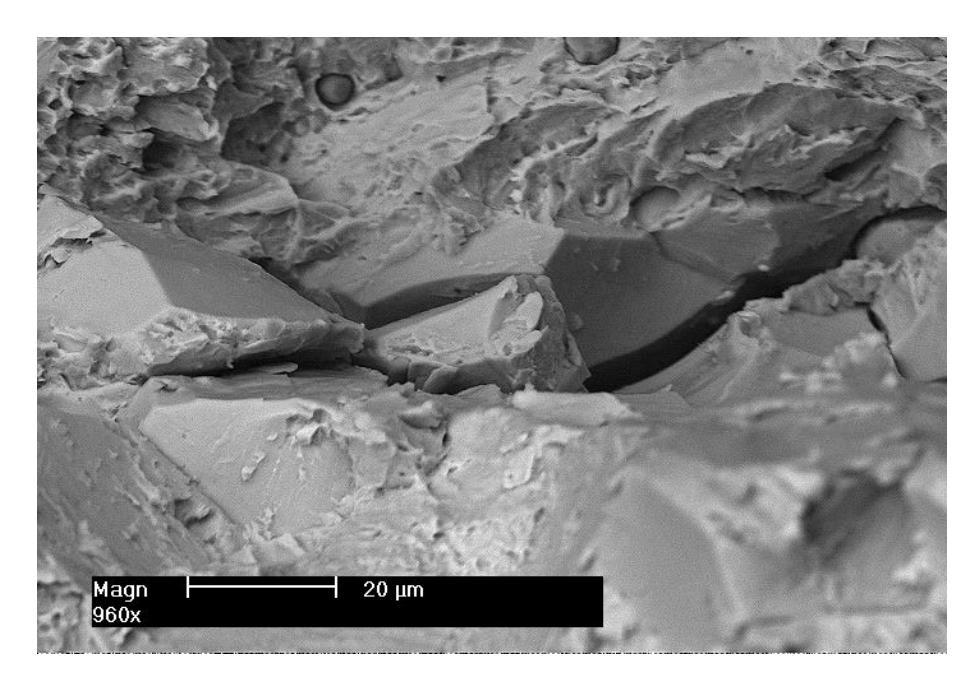
Fig. 7. A part of crack path in the implant specimen: W_g =50 l/min, e_L=10 kJ/cm, σ_i =400 MPa

For a detailed examination of cold cracking, the fracture surfaces of implant specimens were examined using SEM technique. Microscopic investigations of the surface morphology of cold cracks were carried out using scanning electron microscope PHILIPS XL 30 ESEM. In order to eliminate stress as a factor influencing on mode of the fracture, specimens tested only at 400 MPa were investigated. Some typical microstructure regions observed under the microscope are shown in fig. $7\div11$.

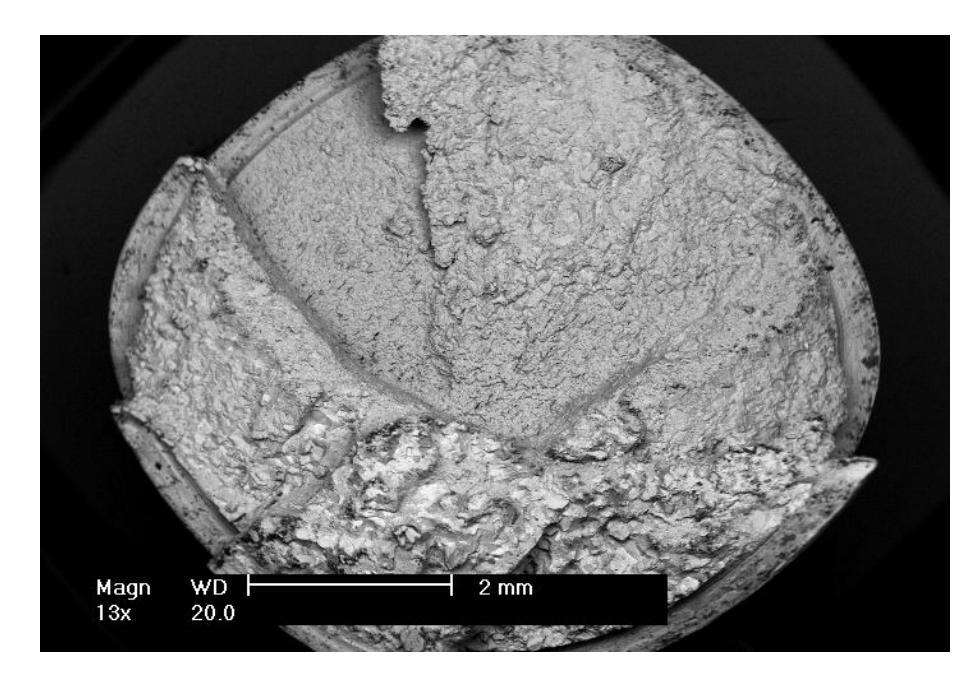
Fig. 8. Overall SEM view of a fractured implant specimen surface: Wg=35 l/min, eL=20 kJ/cm, σ_i =400 MPa

As can be seen from fig. 8 and 9 propagation of cracks runs through several surfaces, so determination of initiation site of the crack is impossible [5]. It was found that in some cases small and rare fully plastic regions are present (fig. 10). As it has already been mentioned, propagation of crack occurred both transgranularly and intergranularly. It should be noted that in bainite or martensite structure cracks run only transgranularly. An example of such situation is shown in fig. 11.

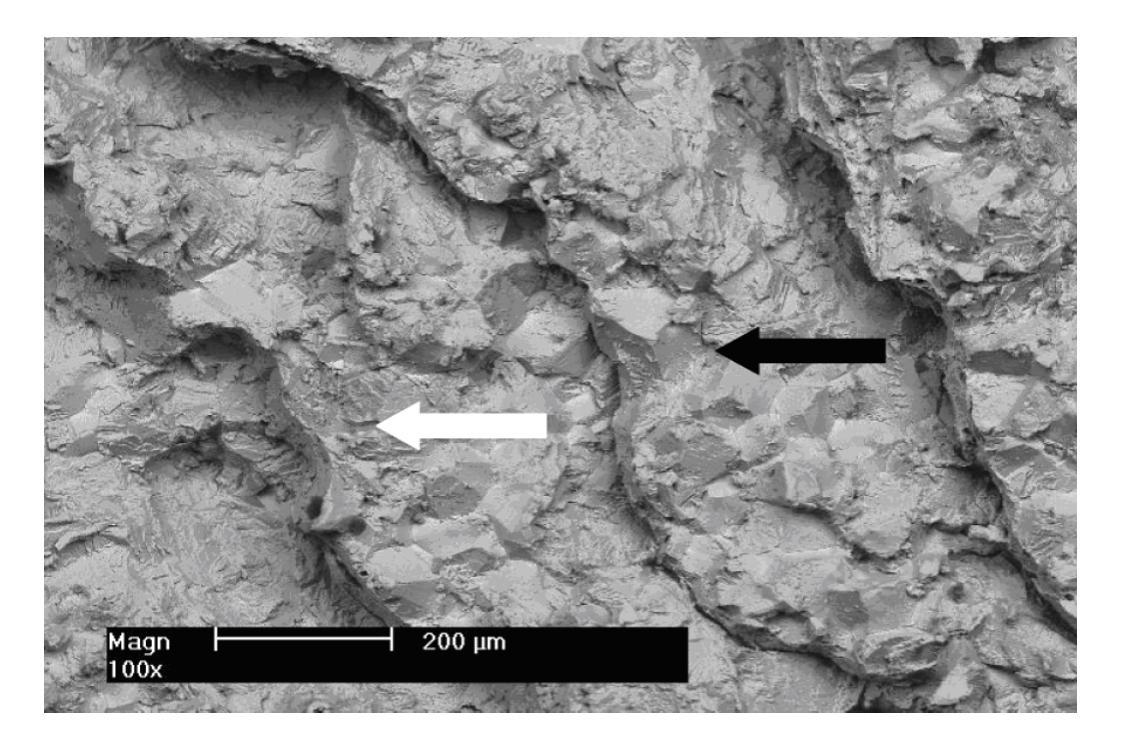
Fig. 9. SEM image of cold crack fracture: W_g =35 l/min, e_L =10 kJ/cm, σ_i =400 MPa. Transgranular (white arrow) and intergranular (black arrow) fracture regions

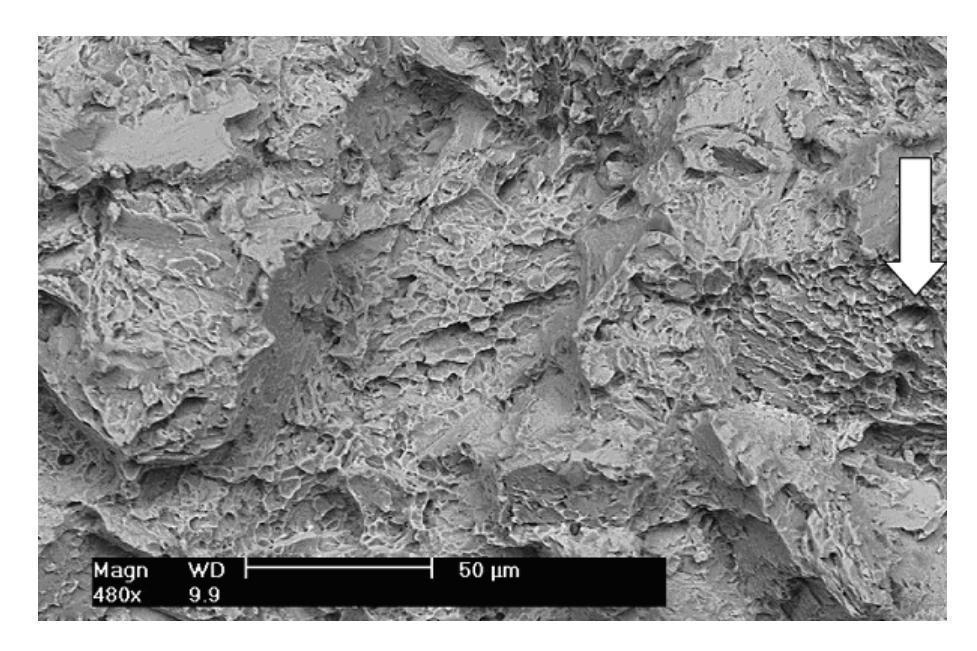
Fig. 10. SEM image of cold crack fracture: W_g=35 l/min, e_L=20 kJ/cm, σ_i=400 MPa. Transgranular and intergranular fracture regions. Exemplary region of plastic fracture is marked by arrow

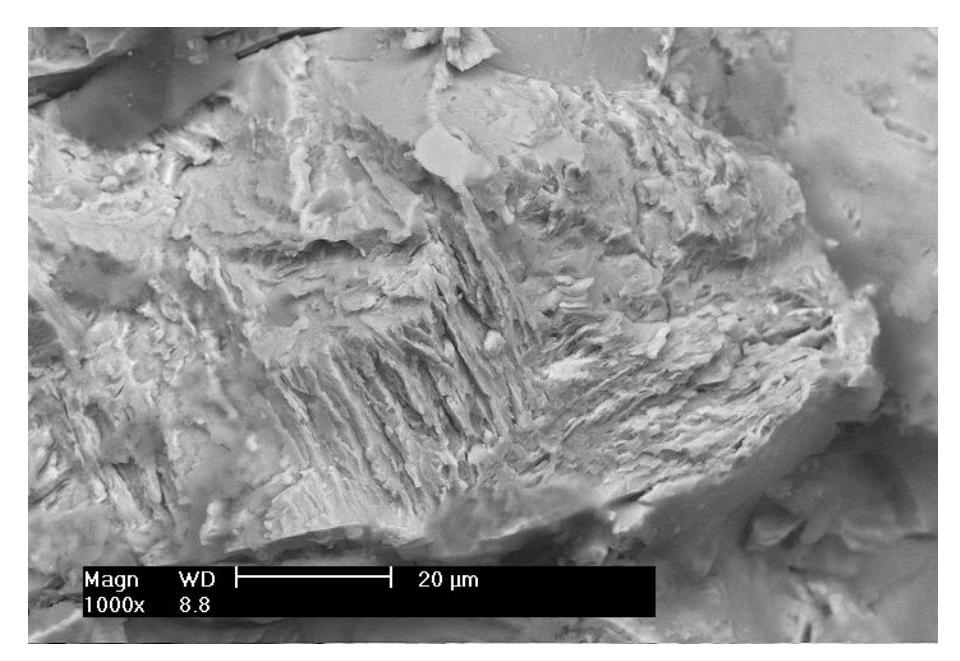
Fig. 11. SEM image of cold crack fracture: W_g =35 l/min, e_L =10 kJ/cm, σ_i =400 MPa. Transgranular fracture in brittle structure

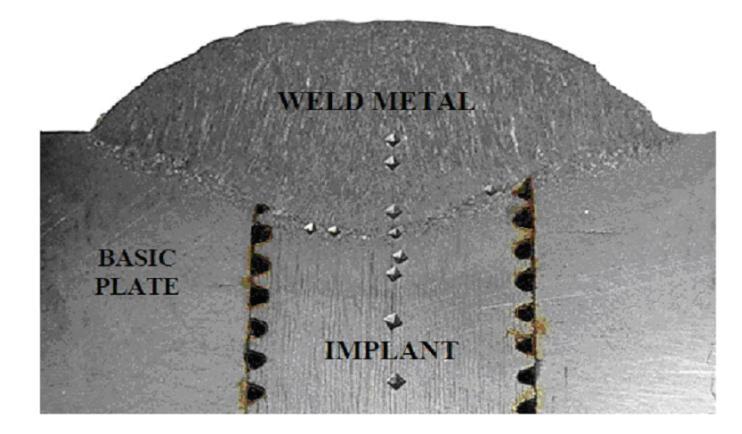
Fig. 12. Photograph of welded joint after hardness measurements: Wg=35 l/min, e_L = 15 kJ/cm, HVmax = 400 (magnification 4×)

Hardness penetration profiles were determined as Vickers hardness HV according to standard [8] in the way shown in fig. 12. The results of these experiments are collected in table 2 and presented in fig. 13÷15. The measured values of HV_{max} are in the range from 351 to 458 and are higher than the 350 HV level stated as typical for bainitic structure. The obtained results suggest that bainite or martensite transformations can

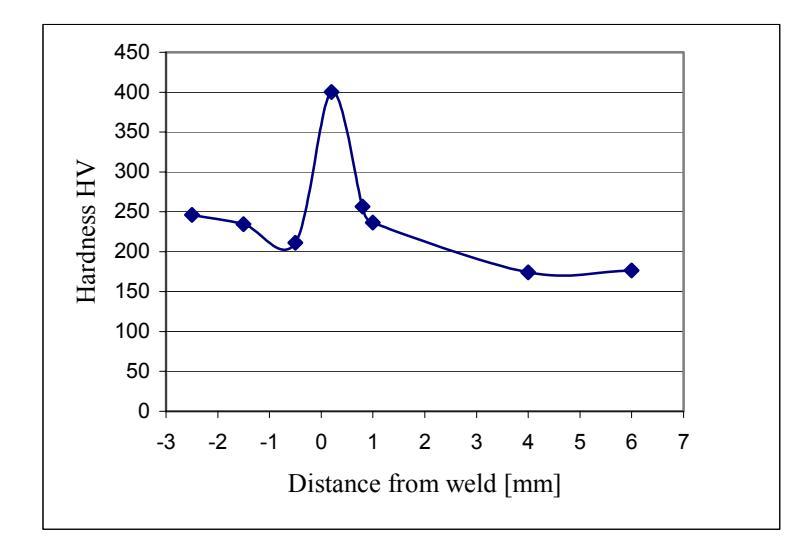
Fig. 13. Distribution of Vickers hardness on the investigated cross section: W_g =35 l/min, e_L=15 kJ/cm, HV_{max}=400

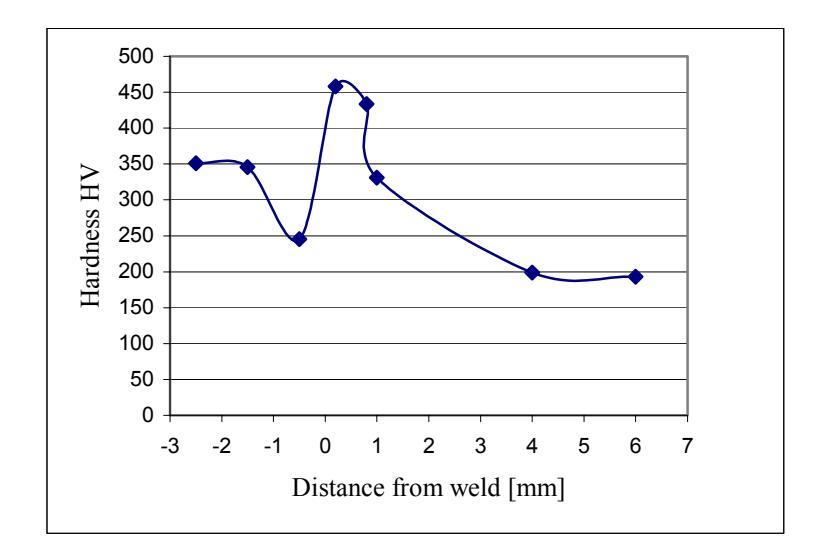
Fig. 14. Distribution of Vickers hardness on the investigated cross section: W_g =35 l/min, eL=10 kJ/cm, HV_{max}=458

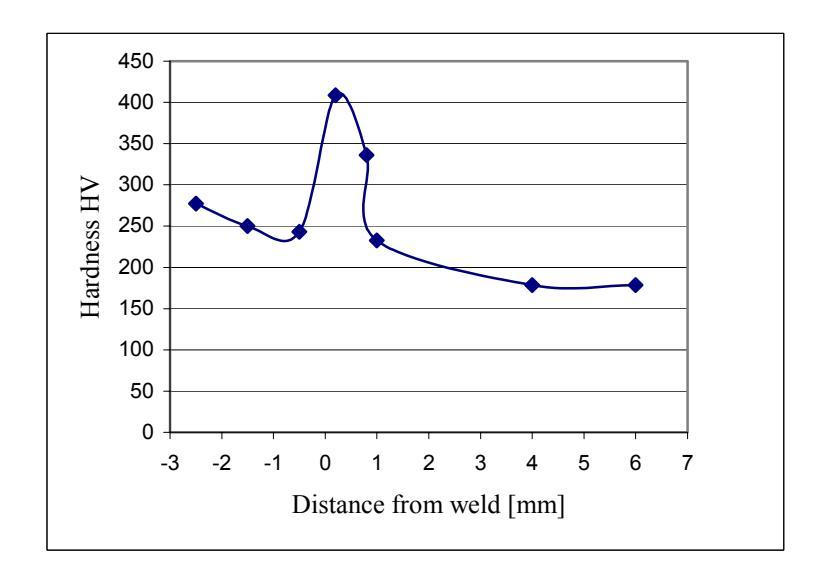
Fig. 15. Distribution of Vickers hardness on the investigated cross section: W_g =20 l/min, eL=20 kJ/cm, HV_{max}=407

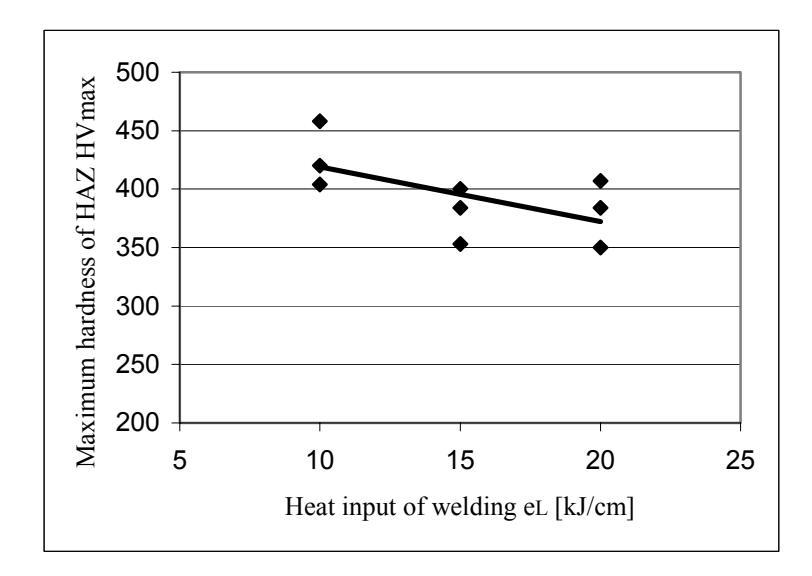
Fig. 16. Relationship between heat input of welding and maximum hardness of HAZ

The values of maximum hardness of implant joints depend on the differences in welding conditions. With the aid of the Statistica software least squares regression was calculated for the results from table 2. Using maximum hardness HV_{max} of heat affected zone as dependent variable and heat input e_L as independent variable the following regression equation was obtained:

$$HV_{\rm max} = 466,05 - 4,7 \times e_{\rm I}$$

with $R^2=0.64$ (determination coefficient) and p=0.05 (level of significance). The relation is presented graphically in fig. 16.
