scientific reports

OPEN Effectiveness of various types of coating materials applied in reinforced concrete exposed to freeze-thaw cycles and chlorides

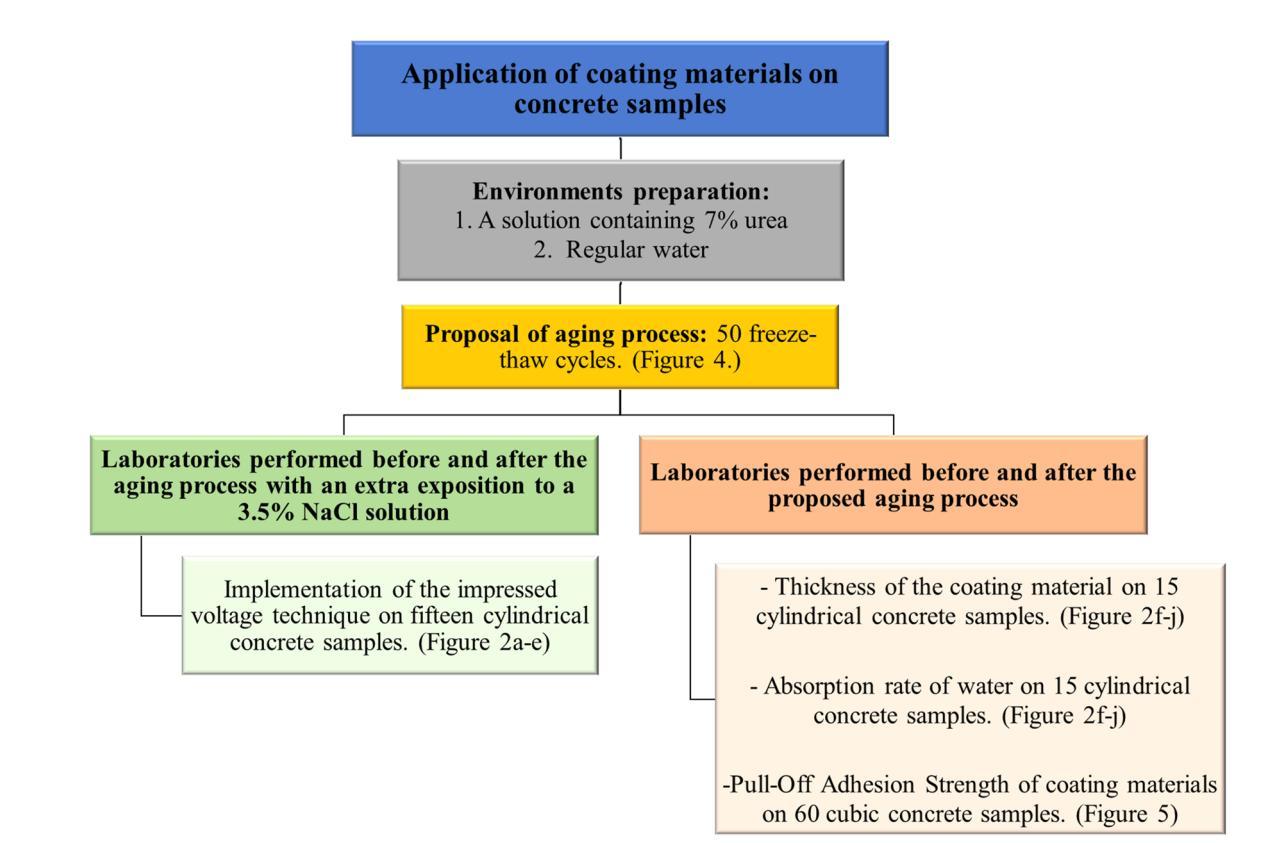
Figure 1. Research methodology.

Experimental procedure. This research study aims to evaluate the effectiveness of different coating materials applied to concrete surfaces exposed to various contaminants. The study will combine quantitative evidence of changes in adhesion strength, absorption, and coating thickness. The findings will contribute to the growing research area on concrete protection in contaminated environments. Figure 1 shows the research methodology used during this study.

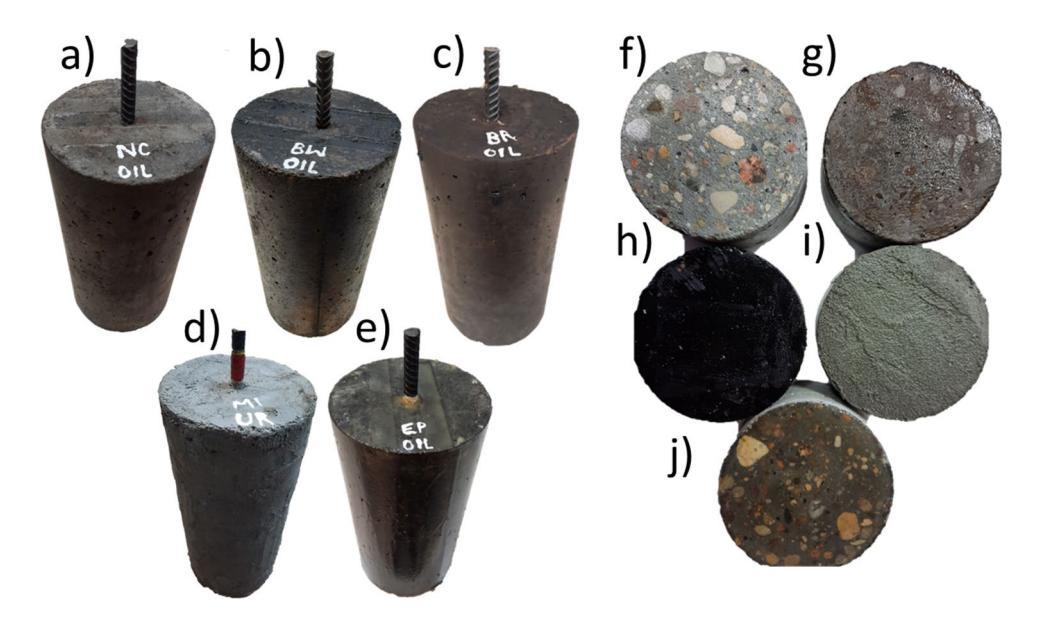
Figure 2. Reinforced concrete samples for the impressed voltage technique: (**a**) EP, (**b**) MI, (**c**) BW, (**d**) NC, (**e**) BR. Concrete samples for water absorption rate: (**f**) NC, (**g**) BR, (**h**) BW, (**i**) MI, (**j**) EP.

In this study three types of concrete samples were utilized. Pull-off adhesion strength tests were performed on cube-shaped specimens measuring 100×100 mm. Cylinders with reinforced concrete measuring 150×300 mm were used for the impressed voltage technique. Additionally, cylinders measuring 100×50 mm were employed to assess water absorption rates. Detailed illustrations of these concrete specimens can be found in Figs. 2 and 5.

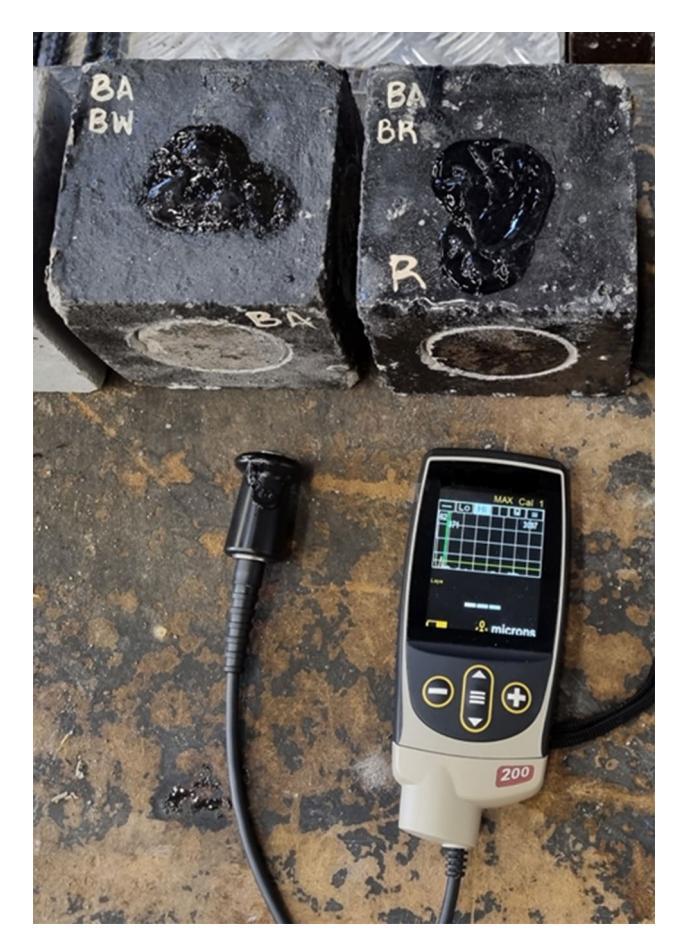
Figure 3. Measurement of coating material thickness.

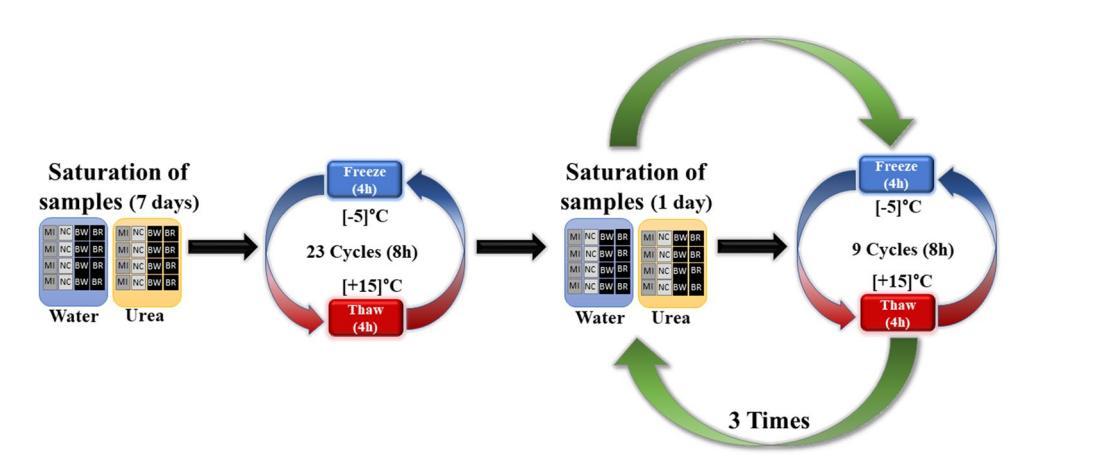
Figure 4. Aging process description. Freeze-thaw cycles and saturation of concrete samples.

Aging process. An accelerated aging test was conducted using a Toropol K-012 frost resistance test chamber, which is commonly employed for assessing the frost resistance of building materials. The specimens were subjected to cyclical freezing in air and thawing in water, while an electronic programmer monitored the cycles.

To simulate freeze-thaw conditions in the laboratory, the test was performed at temperatures ranging between [-5] and [+15] °C. Two solutions were employed to simulate contaminated environments: regular water and urea solution with a concentration of 7%. The aging process, as depicted in Fig. 4, was applied to the samples. Furthermore, each specimen was coated with one of the four materials assessed in this research: BW, BR, MI, and EP. Additionally, a control sample without protection (NC) was included for comparison with the protected samples. After 50 freeze-thaw cycles and a 10-day saturation period, the absorption rate, pull-off adhesion strength, and chloride permeability of each sample were measured.

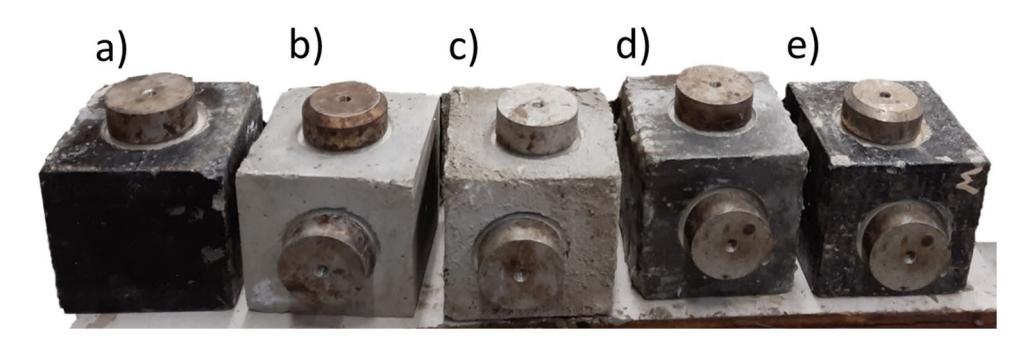
Figure 5. Concrete samples for the pull-off adhesion strength assessment (**a**) BR, (**b**) without coating, (**c**) MI, (**d**) EP, (**e**) BW.

Adhesion strength test. The pull-off adhesion strength of coating applied to concrete surfaces was assessed in accordance with the ASTM D 7234-21 standard⁴. Cubic samples, as illustrated in Fig. 5, were used for the test.

To measure the adhesion strength, a DTH 500 DC testing machine with a maximum tensile strength of 5 kN was employed. Metallic dolls with a diameter of 50 mm and a height of 20 mm were utilized. To ensure accurate measurement, a circular notch was drilled to define the specific surface area to be measured. Subsequently, the metallic dolls were securely attached to the concrete surface using an epoxy material. Prior to the aging process, six pull-off tests were conducted for each coating material and environment type. The same procedure was repeated after the aging process.

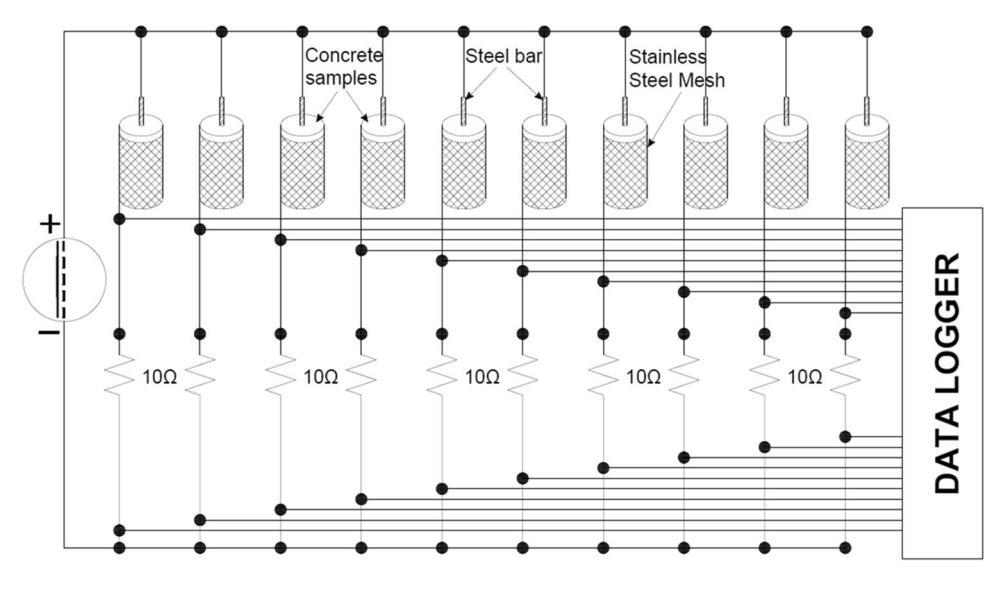
Figure 6. Electrical schematic design for the impressed voltage technique test.

Impressed voltage technique. To assess resistance to chloride ion permeability, the impressed voltage technique specified in the NT BUILD 356 standard²⁸ was employed. A constant direct current of 5 V was applied between a steel bar embedded in the concrete sample and the concrete surface. Furthermore, reinforced concrete specimens were partially immersed in a 3.0% NaCl solution during the test duration.

This test was conducted both before initiating the aging process and after seven days of completing the aging process in both coated and uncoated reinforced concrete samples. The test concluded upon the appearance of cracks or corrosion on the surface of the steel bar. The circuit assembly utilized an external DC power supply, YIHUA 3005D [0-30 V] 5 A, and a measurement data acquisition system capable of connecting ten samples simultaneously. The schematic design is illustrated in Fig. 6.

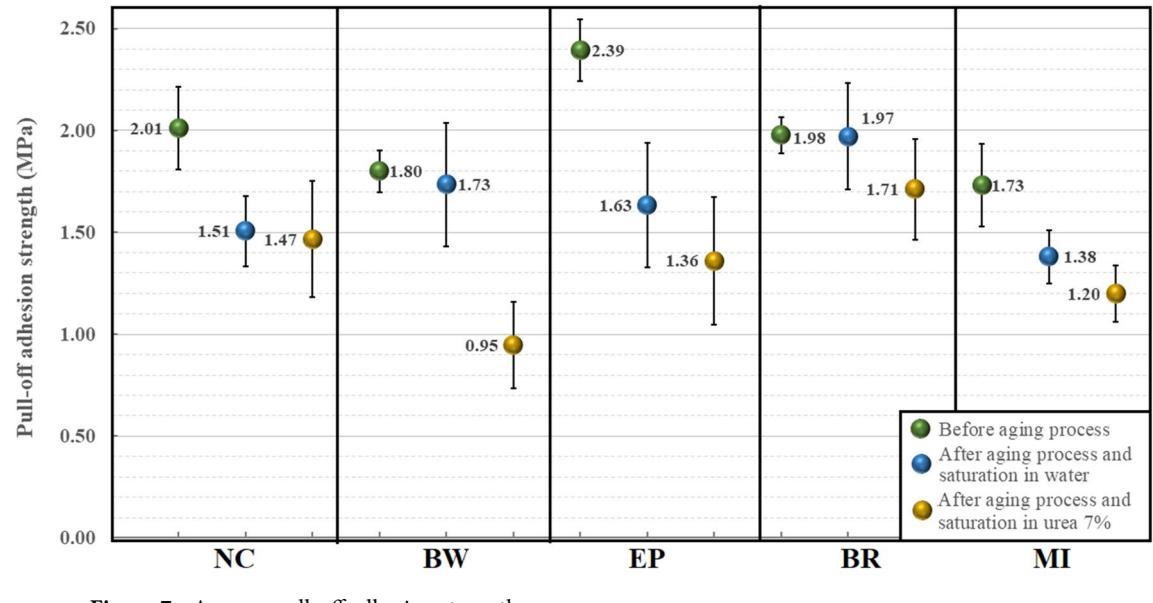
Figure 7. Average pull-off adhesion strength.

The results indicate that exposure to urea led to a decrease in the adhesion strength for all coatings after the aging process. Among the coatings, EP and BW were the materials more affected, exhibiting reductions of 43.09% and 47.22%, respectively, compared to the pre-aging process results. The obtained adhesion strength values for the EP coating, ranging between 1.36 and 2.39 MPa, align with those reported by A. Almusallam et al.¹⁵, who reported values within the range of 1.5 and 3.2 MPa. Similarly, the adhesion strength values for the MI coating align with the findings of Flores-Colen et al.²⁹, who obtained values higher than 1.2 MPa for mineral and cement-based coatings. On the other hand, the BR coating exhibited the least reduction in adhesion strength after the aging process, with reductions of 0.51% for samples saturated in water and 13.63% for samples saturated in urea. This behavior can be attributed to the low water absorption of the material resulting from the presence of hydrocarbon constituents³⁰.

susceptibility to damage during freeze-thaw cycles can be attributed to the sensitivity of epoxy materials to moisture. The cycling of freezing and thawing can introduce additional moisture into the epoxy, particularly if there exist microcracks or pores within the material. The presence of moisture has the potential to weaken the mechanical properties of the epoxy, leading to degradation or failure and ultimately resulting in a reduction in adhesion strength³².

The reduction in adhesion strength observed in BW coatings can be attributed to the formation of ice crystals during the freeze-thaw cycle. The repeated ingress of water followed by freezing can result in an increased moisture content within the material, rendering it more susceptible to damage. The expansion and growth of these ice crystals have the potential to disrupt the integrity of the bituminous material, ultimately leading to cracking and degradation³³.

In contrast, solvent-based coatings (BR) are generally less affected by freeze-thaw cycles compared to other types of materials. This is primarily due to their low water content, which significantly reduces the formation of ice crystals. Solvent-based coatings exhibit better flexibility and toughness compared to water-based materials, allowing them to withstand the stresses and strains associated with freezing and thawing cycles. Their increased resilience and resistance to cracking or delamination contribute to their ability to withstand freeze-thaw conditions³⁴.

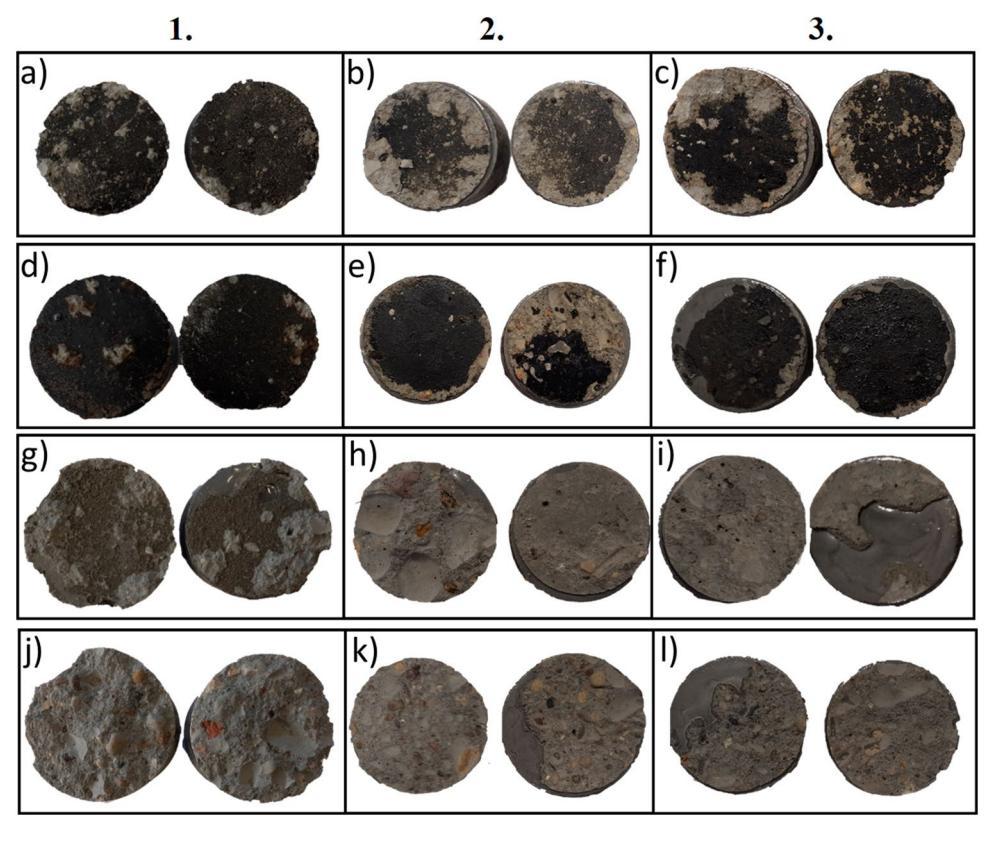
Figure 8. Pull-off adhesion failure types. (1) Samples before the aging process, (2) samples after the aging process and exposure to water, (3) samples after the aging process and exposure to urea—(**a**–**c**) BW, (**d**–**f**) BR, (**g**–**i**) MI, (**j**–**l**) EP.

Figure 8 showcases some examples of the failures encountered during this study. Column 1 presents the samples before the aging process, column 2 shows the samples after the aging process and exposure to water, and column 3 presents samples after the aging process and exposure to urea. In accordance with the failure

types defined in ASTM D 7234-21⁴⁰, all types of coatings exhibit adhesive failure [C] after the aging process and exposure to urea due. This can be attributed to the high contamination levels on the concrete surface caused by the urea components and the aging effects. Substrate failure, as depicted in (j), (k), (l), and (h), is the preferred mode of failure for coatings on concrete^{40,41}. However, it is important to note that the cases of substrate failure observed in Fig. 8b, c for BW cannot be considered valid due to their low adhesion values.

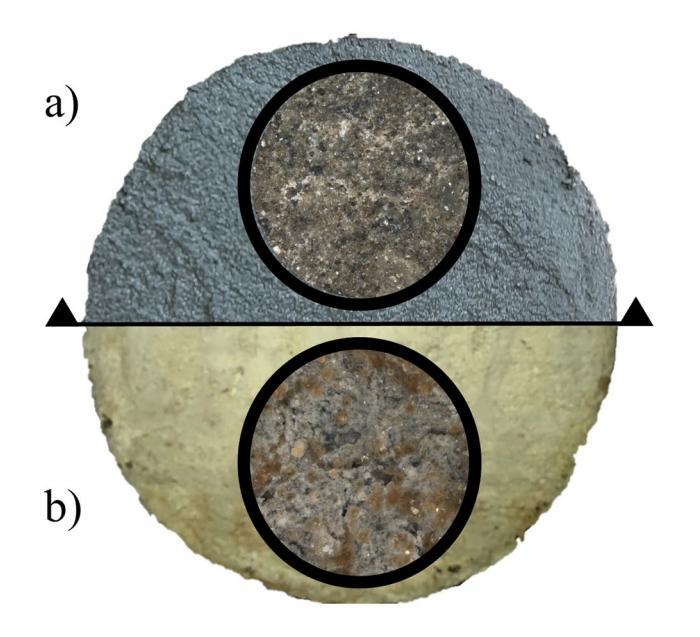
Figure 9. MI micrographs. (a) Before the aging process, (b) after the aging process.

For the MI coating, a noticeable accumulation of calcite crystal was observed after the aging process. This phenomenon can be attributed to the crystallization of urea on the concrete surface. similar results were reported by Ramakrishnan1 et al.⁴² in a study on the development of a self-repairing material able to remedy cracks and fissures in concrete using Bacillus pasteurii, Sporosarcina bacteria, and urea as a curing method. The study revealed the formation of calcite crystals accumulations on superficial cracks, which aided in filling them and reducing the infiltration of contaminants deeper into the concrete. Micrographs of the MI coating before and after the aging process with urea exposure are presented in Fig. 9, captured at a magnification of $10 \times (200 \ \mu m)$ under white light, clearly displaying the accumulation of calcite crystals.

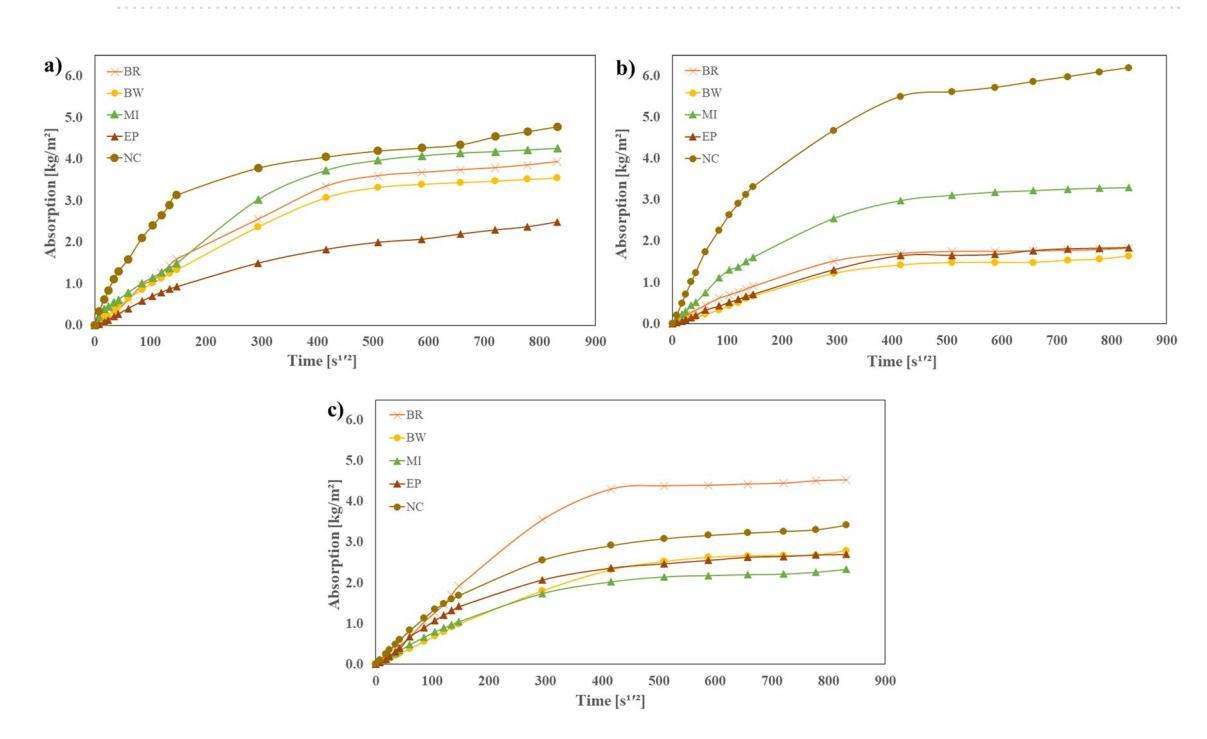
Figure 10. Water absorption rate (a) before the aging process, (b) after the aging process and saturation in water, (c) after the aging process and saturation in urea, 7%.

Water absorption rate. The results of water absorption rate for both coated and uncoated concrete samples before and after the aging process are illustrated in Fig. 10. All results comply with the ASTM C1585-20 Standard²⁷, where a linear relationship for the initial and secondary absorption was observed, with a correlation coefficient higher than 0.98. Figure 10a shows the absorption rate behavior of samples before the aging process, which aligns with a study conducted by Millan et al.⁴³. In their research, similar coating specimens were exposed to salt and regular water to assess their absorption properties. based on these findings, the MI coating exhibited the highest water absorption rate, followed by BR, BW, and EP coatings.

Figure 10b, c present the results of samples saturated with water and urea, respectively, and subsequently exposed to the aging process. These specimens presented a significant reduction in the absorption rate, primarily attributed to the aging process. The absorption rate of samples exposed to urea and protected with MI coating decreased due to the accumulation of salts in the coating surface, resulting in reduced permeability of

the protected concrete. Conversely, for BR and BW coatings, a noticeable reduction in the absorption rate was observed for samples saturated with water and urea. It is evident that the exposure to urea deteriorates the coatings, leading to an increased absorption rate of 146.73% for EP, 247.54% for BR, and 171.16% for BW compared to samples immersed in regular water.

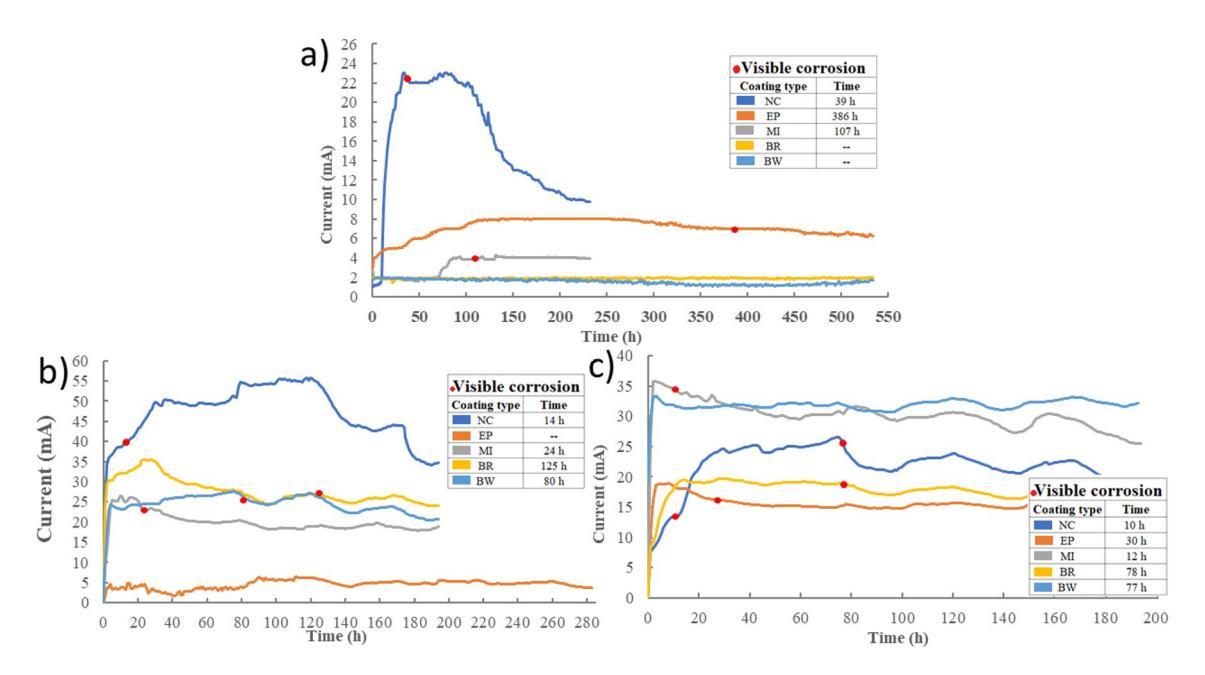
Figure 11. Current intensity curve, (**a**) before the aging process, (**b**) after the aging process and saturation in water, (**c**) after the aging process and saturation in urea, 7%.

Impressed voltage technique. The current intensity curves for samples before and after freeze-thaw cycles, saturated with regular water and urea, are presented in Fig. 11. Prior to the aging process, the maximum current for samples without coating protection was 23 mA, which was 58.18% lower than the samples saturated with regular water (55 mA). This increase indicates that the resistivity of the concrete surface has been compromised after the aging process, allowing for increased penetration of chloride ions into the concrete matrix. On the other hand, samples without coating protection and saturated with urea exhibited a current intensity 52.36% lower than samples saturated with water. This can be attributed to the presence of urea residues on the surface, which partially permeabilize the material and reduce the passe of chloride ions. Ramakrishnan1 et al.⁴².

MI, BR, and BW were the most affected materials by the freeze-thaw cycles. Before the aging process, these samples registered current values of 4.28, 2.08, and 1.98 mA, respectively. These values increased to 26.41, 35.54, and 27.73 mA for samples saturated in regular water and 35.78, 19.72, and 33.37 mA for samples saturated in urea

solution. in the case samples protected with EP coatings, the highest current value of 18.93 mA was obtained in the samples exposed to urea, showing an increase of 235.10% before freeze–thaw cycles and 297.57% for samples saturated in water. These results align with previous findings by with Aguirre et al.⁴⁶, where the highest current value for samples with epoxy coating was reported as 8 mA. Furthermore, it can be observed that, for all samples, the use of coating materials extended the appearance of corrosion products, thus protecting the concrete matrix in a chloride ion environment.

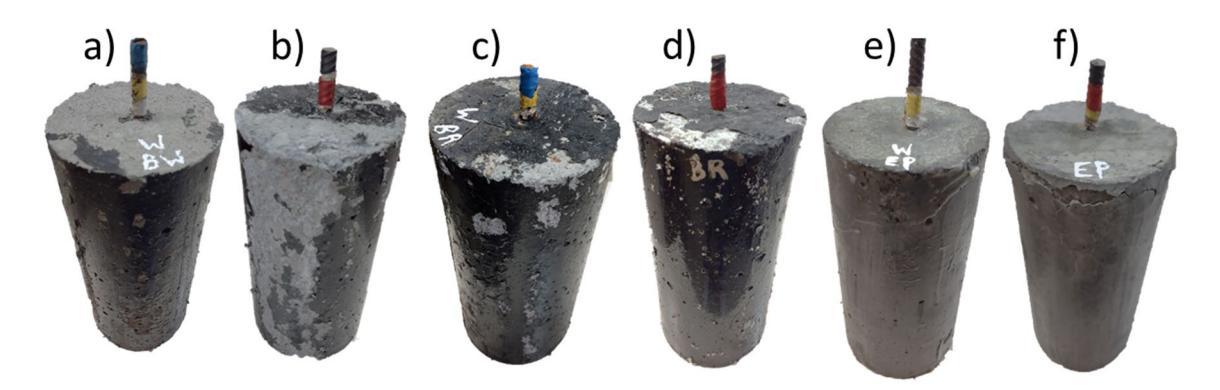
Figure 12. Concrete samples after the aging process. (a) BW water saturation, (b) BW urea saturation, (c) BR water saturation, (d) BR urea saturation, (e) EP urea saturation, (f) EP water saturation.

Figure 12 presents EP, BR, and BW concrete samples after the aging process, revealing visible physical damage in the coating materials. It is important to note that MI coating remained intact and undamaged throughout the aging process, regardless of exposure to water and urea. Similarly, EP samples exposed to water did not present any physical damage, effectively hindering the diffusion of chlorides into the concrete. However, EP samples exposed to urea, as well as BR, and BW samples exposed to water and urea, showed signs of physical damage. Among them, BW samples saturated with urea were the most adversely affected after the aging process.

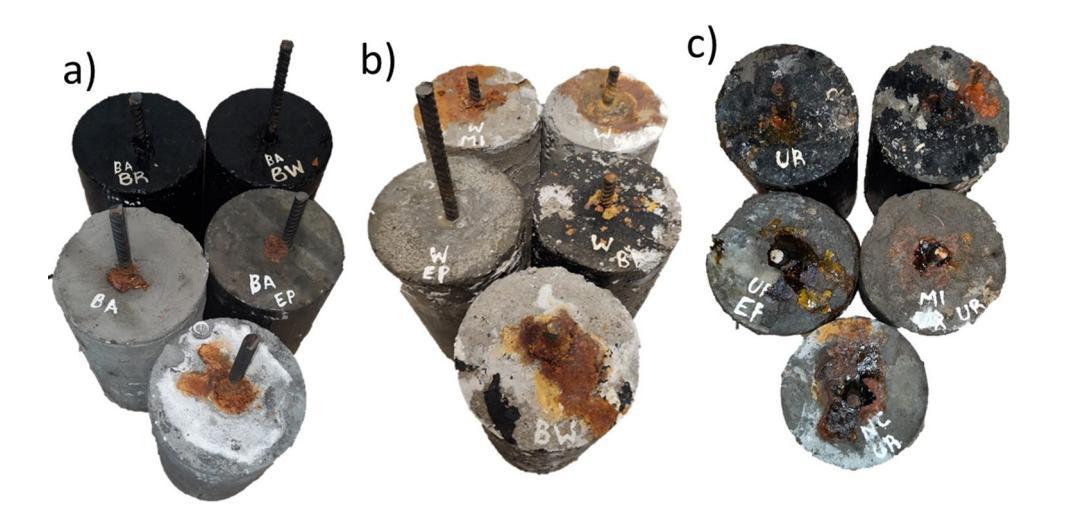
Figure 13. Concrete samples after the impressed voltage technique (a) before the aging process, (b) after the aging process and saturation in water, (c) after the aging process and saturation in urea, 7%.

Figure 13 presents the coated and uncoated reinforced concrete samples after the aging process and corrosion test. None of the specimens presented cracks on the concrete surface during the corrosion test, indicating that all laboratories were concluded once corrosion products became visible. After 22 days of testing, BW and BR samples did not present any corrosion on the concrete surface. In this case, the test was finalized, analyzing the materials' resistance to chloride ions. It is important to highlight that EP samples exposed to regular water did not present any physical damage before the impressed voltage technique. However, the presence of chlorides and the current that passes through the concrete deteriorated the coating material, leading to its fracture and physical damage.
