# Hydrogen Embrittlement and Oxide Layer Effect in the Cathodically Charged Zircaloy-2

Abstract: The present paper is aimed at determining the less investigated effects of hydrogen uptake on the microstructure and the mechanical behavior of the oxidized Zircaloy-2 alloy. The specimens were oxidized and charged with hydrogen. The different oxidation temperatures and cathodic current densities were applied. The scanning electron microscopy, X-ray electron diffraction spectroscopy, hydrogen absorption assessment, tensile, and nanoindentation tests were performed. At low oxidation temperatures, an appearance of numerous hydrides and cracks, and a slight change of mechanical properties were noticed. At high-temperature oxidation, the oxide layer prevented the hydrogen deterioration of the alloy. For nonoxidized samples, charged at different current density, nanoindentation tests showed that both hardness and Young's modulus revealed the minims at specific current value and the stepwise decrease in hardness during hydrogen uptake, softening due to the interaction of hydrogen and dislocations nucleated by indentation test, and hardening caused by the decomposition of hydrogen and disloca

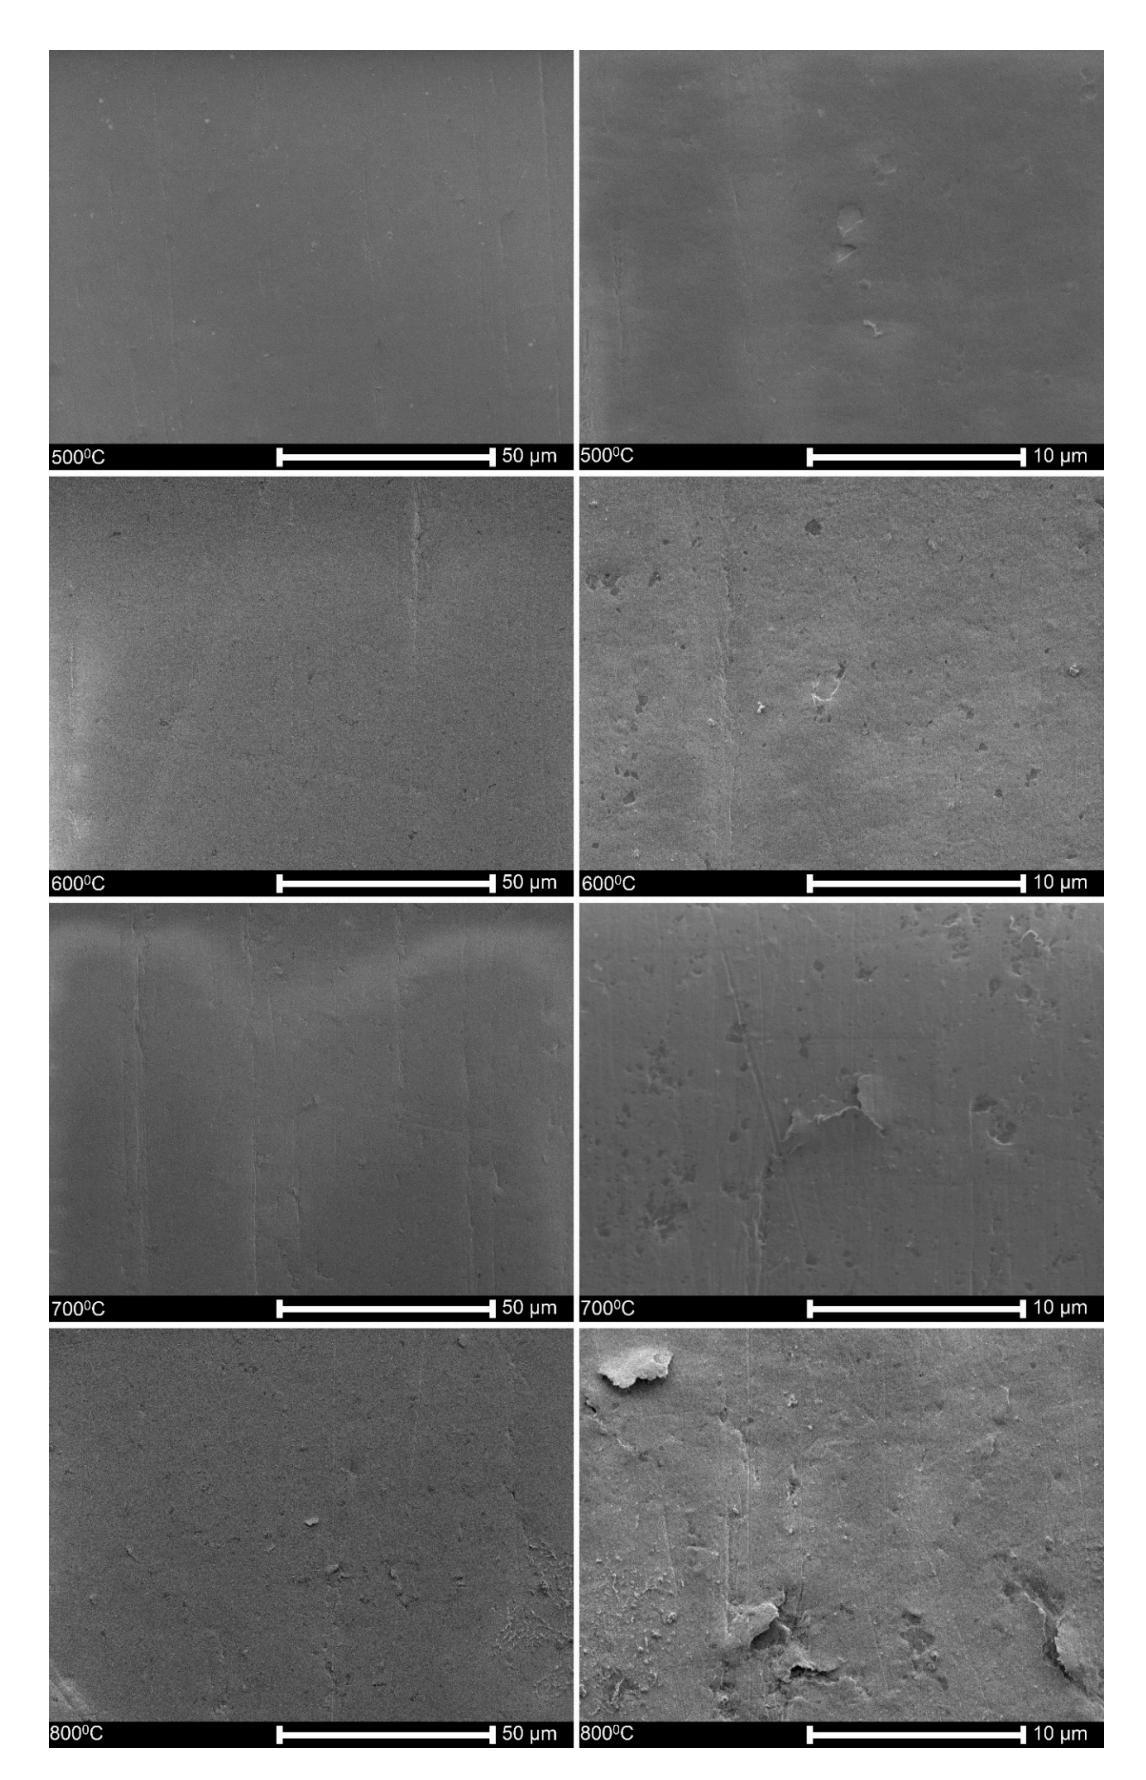
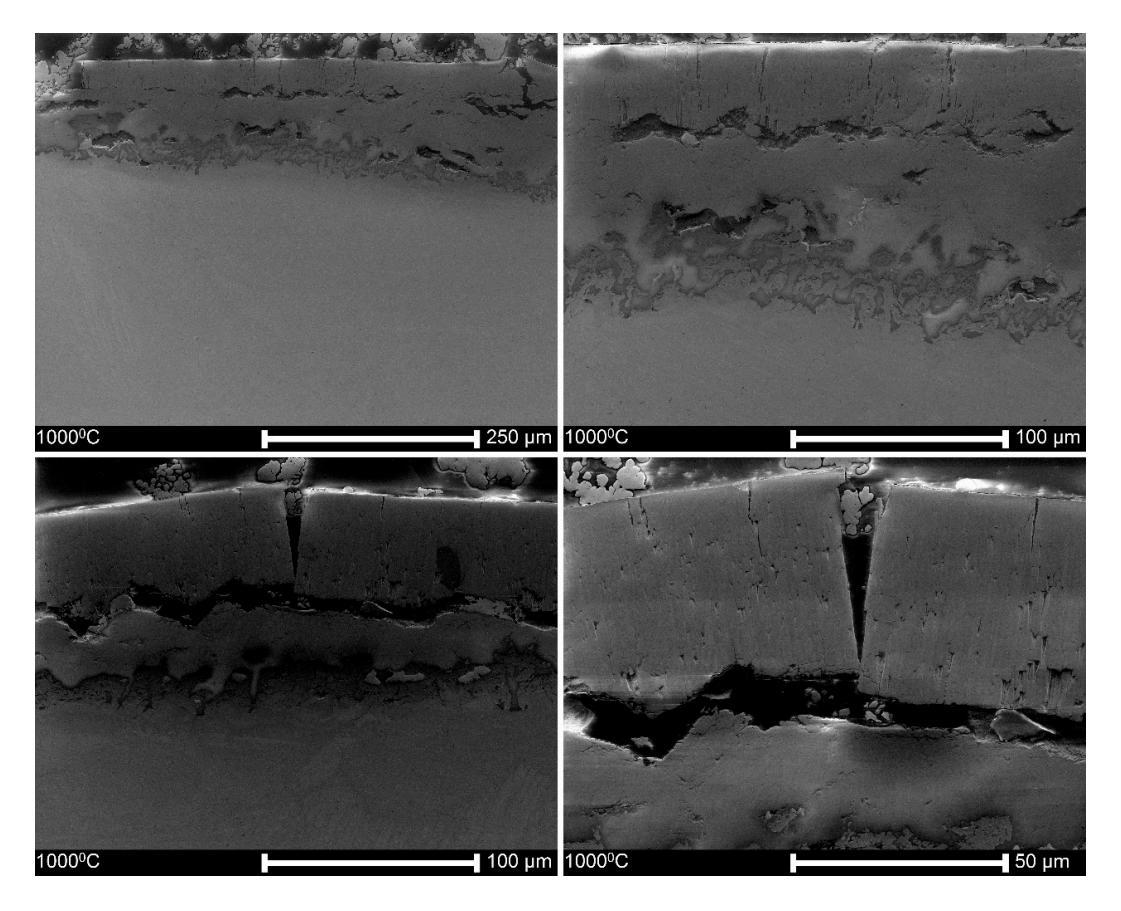
Figure 1 shows that the surfaces of specimens oxidized in a range of temperatures from 500 °C to 1000 °C were distinctly affected by heat treatment. The surfaces after oxidation at 400 °C and 300 °C not shown here, were perfectly smooth and homogenous as no oxide layer was formed. The deterioration of the surface started already at oxidation at 500 °C. Some short cracks appeared on surfaces oxidized at 700 °C, and they propagated and resulted in the descaling of the oxide layers obtained at 900 °C and 1000 °C.

Figure 1. Surface topography of the alloy oxidized at different temperatures.

In regard to the second question, it may be expected that a substantial degradation of the oxide layers after oxidation at 900 °C and 1000 ° C should open the natural diffusion pathways, as shown in Figure 1. However, these oxide layers are still practical barriers against hydrogen absorption after 3-day charging, as shown by an absence of hydrides, displayed in Figure 7. It may be attributed to the appearance of a complex, two-zone structure of the oxide layer, as shown in Figure 2. The outer sublayer seems easily damaged, and the inner sublayer stays still well-adjacent to the substrate. This corresponds to the previous research [71] in which the oxide layer has been shown to be composed of two sublayers: the external one extremely permeable to hydrogen even at over 300 °C, and the inner one, much more impermeable to hydrogen.

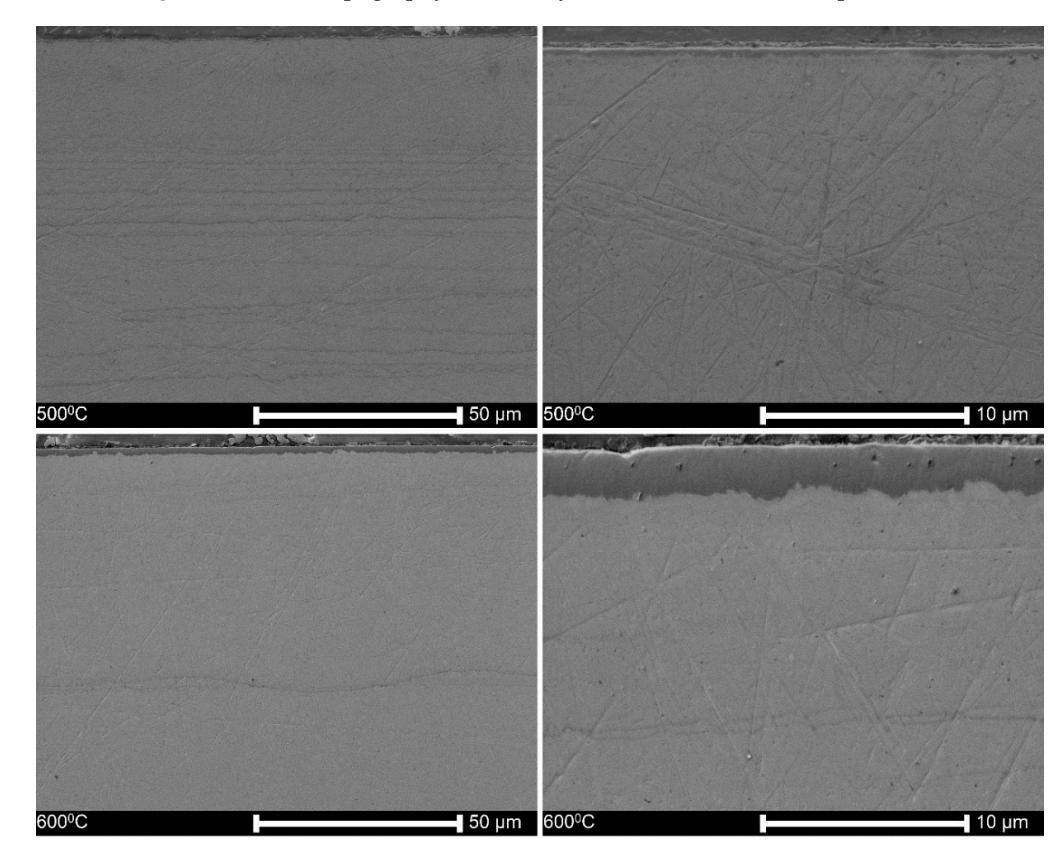
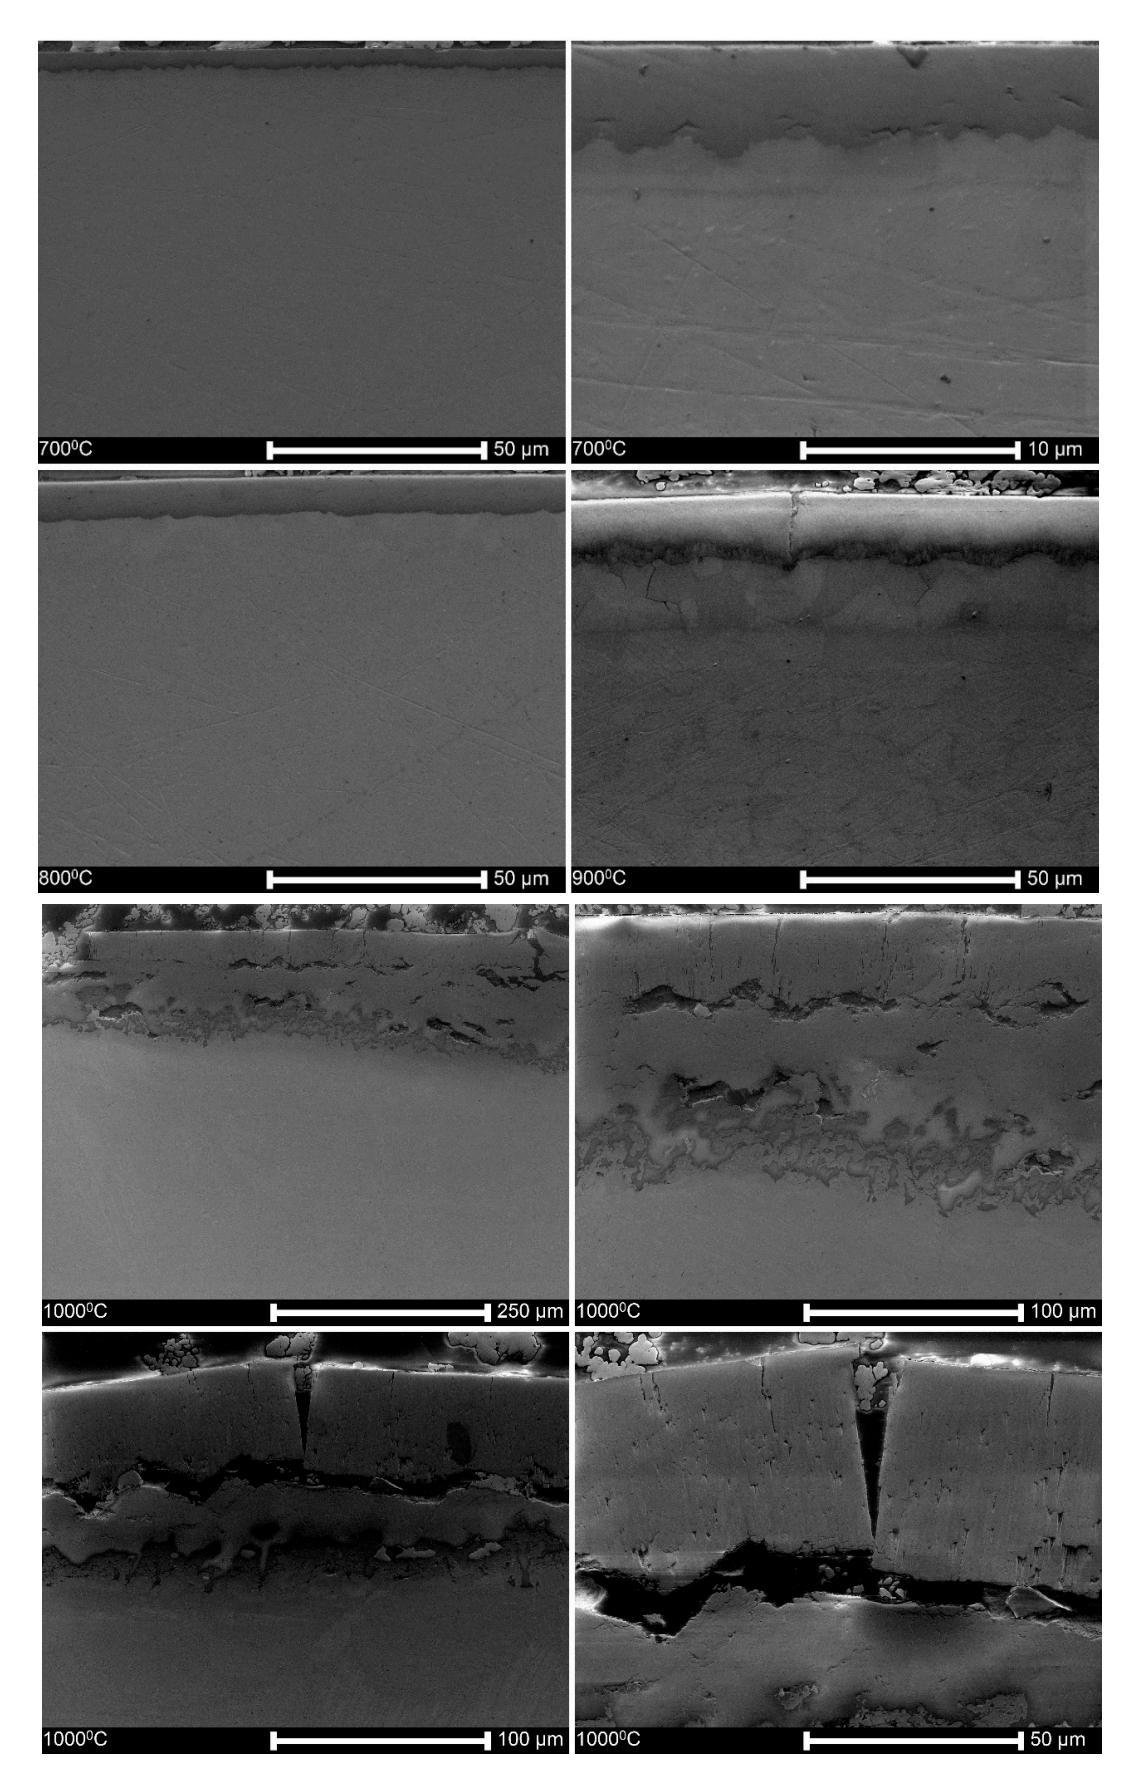
Figure 2 illustrates that the oxide layers are well adjacent to the substrate if the specimens are oxidized at temperatures up to 700 °C. The layers were slightly waived and showed small submicron pores between the elongated columnar grains. There were only single shallow cracks that did not extend across the entire oxide layer. The oxidation at 900 °C and 1000 °C resulted in numerous transverse (circumferential) and single longitudinal cracks passing through the whole oxide layer. Several groups of such cracks were observed with a width of up to 1  $\mu$ m. The pile-ups of the cracks resulted in the descaling of the oxide layers.

**Figure 2.** The cross-sections of the oxide layers obtained at different temperatures, between 500 °C and 1000 °C, as shown in each photo.

The thickness of the oxide layers distinctly depends exponentially on the oxidation temperature, as shown in Figures 2 and 4. The complex structure and the presence of both oxygen and nitrogen can be observed in Figure 3, the latter element postulated in the past as essential for degradation of Zr alloys [65].

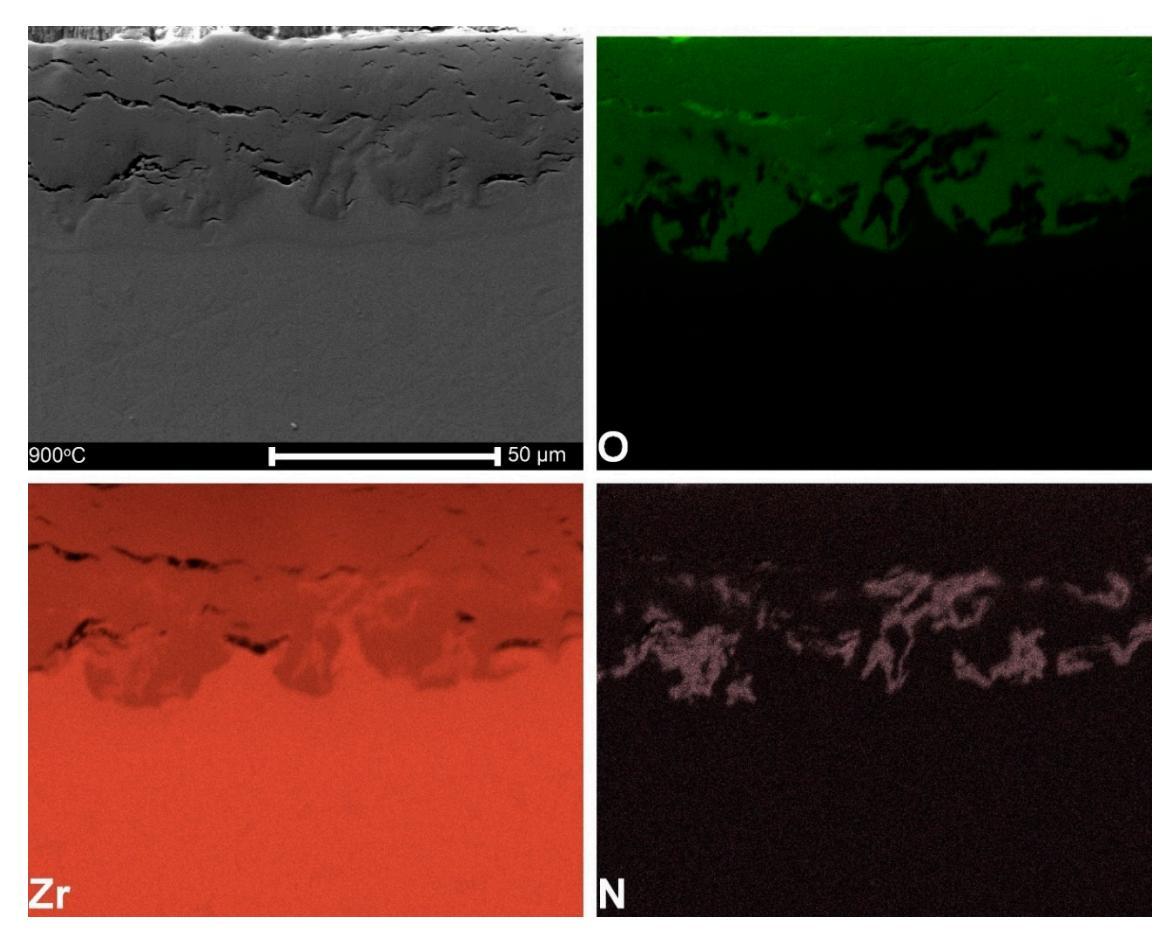
Figure 3 shows the distribution of primary elements within the oxide layer. The oxidation in the air caused the appearance of zirconium, oxygen, and, at some distance, also nitrogen.

Figure 3. The mapping of primary elements within the oxide layer formed after oxidation at 900 °C.

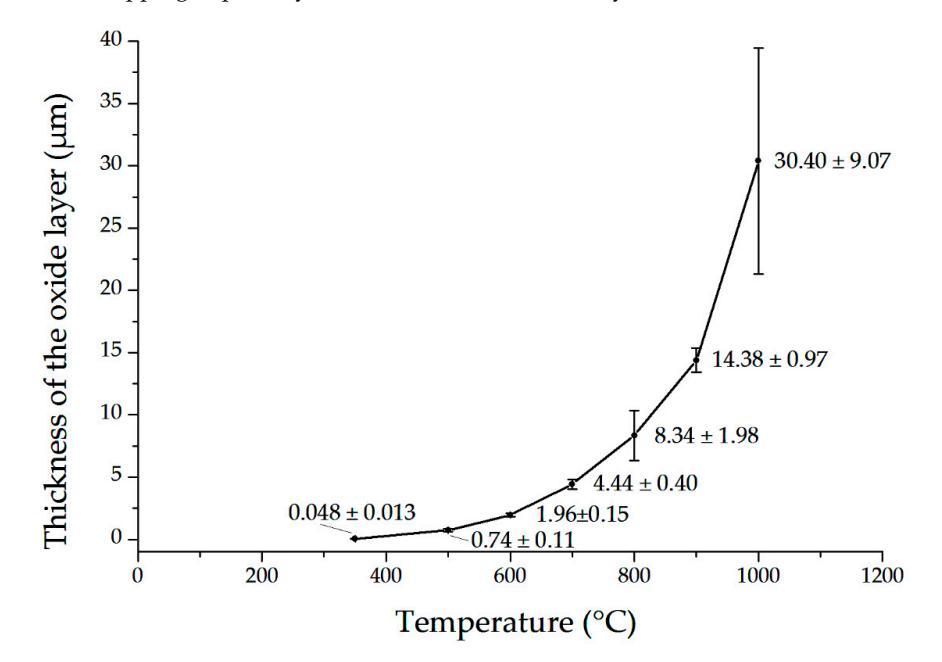
Figure 4 illustrates the relation of oxide layer thickness to temperature. The layer thickness changed from some tens or a hundred nanometers for nonoxidized or oxidized alloys at temperatures of 350-500 °C. At higher temperatures, the growth followed kinetics laws. The width of the oxide layer was the largest near the cracks. The previously performed monitoring of oxidation time [60] showed that after oxidation at 900 °C, the cracks appeared on the surface already after 20 min of oxidation and were relatively long, even up to 35  $\mu$ m. The oxide layer was substantially thicker in this area. The monotonic increase in the oxide layer thickness is in full accordance with previous results.

**Figure 4.** The thickness of the oxide layer formed at a different temperature for 30 min. The means and standard deviations based on five independent measurements are shown.

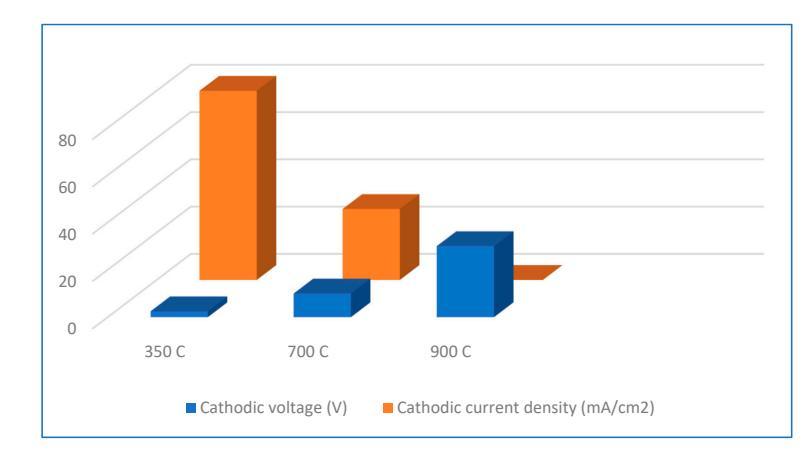
**Figure 5.** Voltage and current density values for specimens oxidized at different temperatures and subject to hydrogen charging.

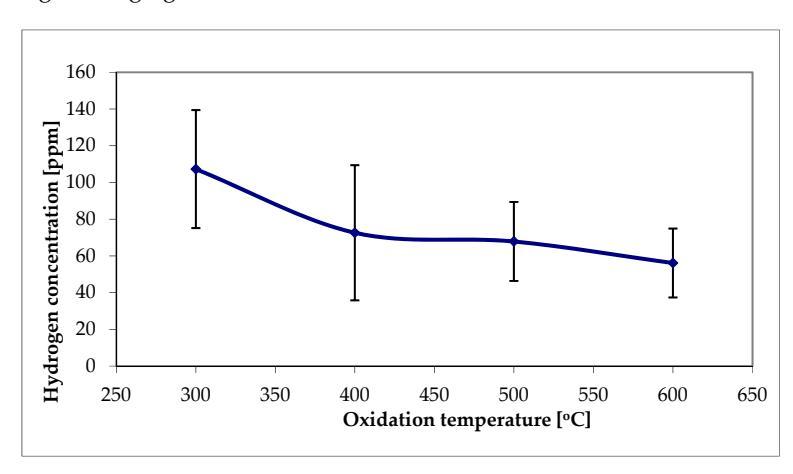
The results of hydrogen content in samples as-received, nonoxidized and oxidized at different temperature for 30 min, hydrogen charged at cathodic current density 80 mA/cm<sup>2</sup> and 72 h charging time and then subject to homogenizing heat treatment at 400 °C for 4 h, are shown as the means and standard deviations (SDs) in Figure 6. All average hydrogen contents were relatively low. The highest values were observed for nonoxidized and oxidized specimens at 300 °C. The hydrogen decrease with increasing oxidation temperature can be noticed.

**Figure 6.** Effect of oxidation temperature on a hydrogen content. The means and standard deviations based on six independent measurements are shown.

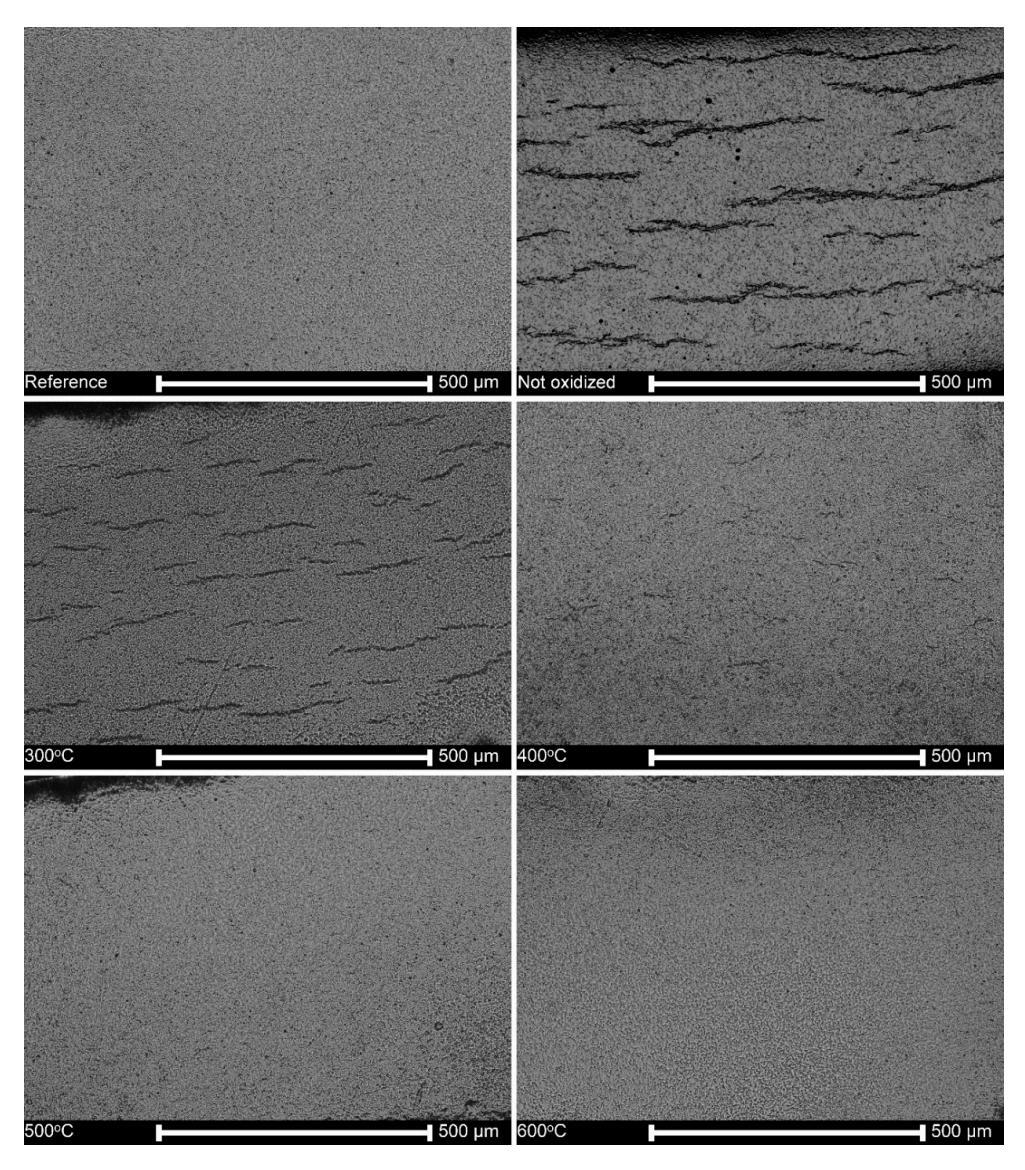
Figure 7 shows the cross-sections of neither oxidized nor hydrogen charged reference samples, and hydrogen-charged samples without oxidation, or after oxidation at different temperatures. The lines of hydrides about 100  $\mu$ m in length, appear randomly distributed in the matrix and branched. Still, they are absent in specimens oxidized at temperatures of 500 °C, 600 °C and above (not shown here).

**Figure 7.** Cross-sections of specimens oxidized at different temperatures and hydrogen-charged at a constant current density of 80 mA/cm<sup>2</sup> for 3 days and homogenized at 400 °C for 4 h.

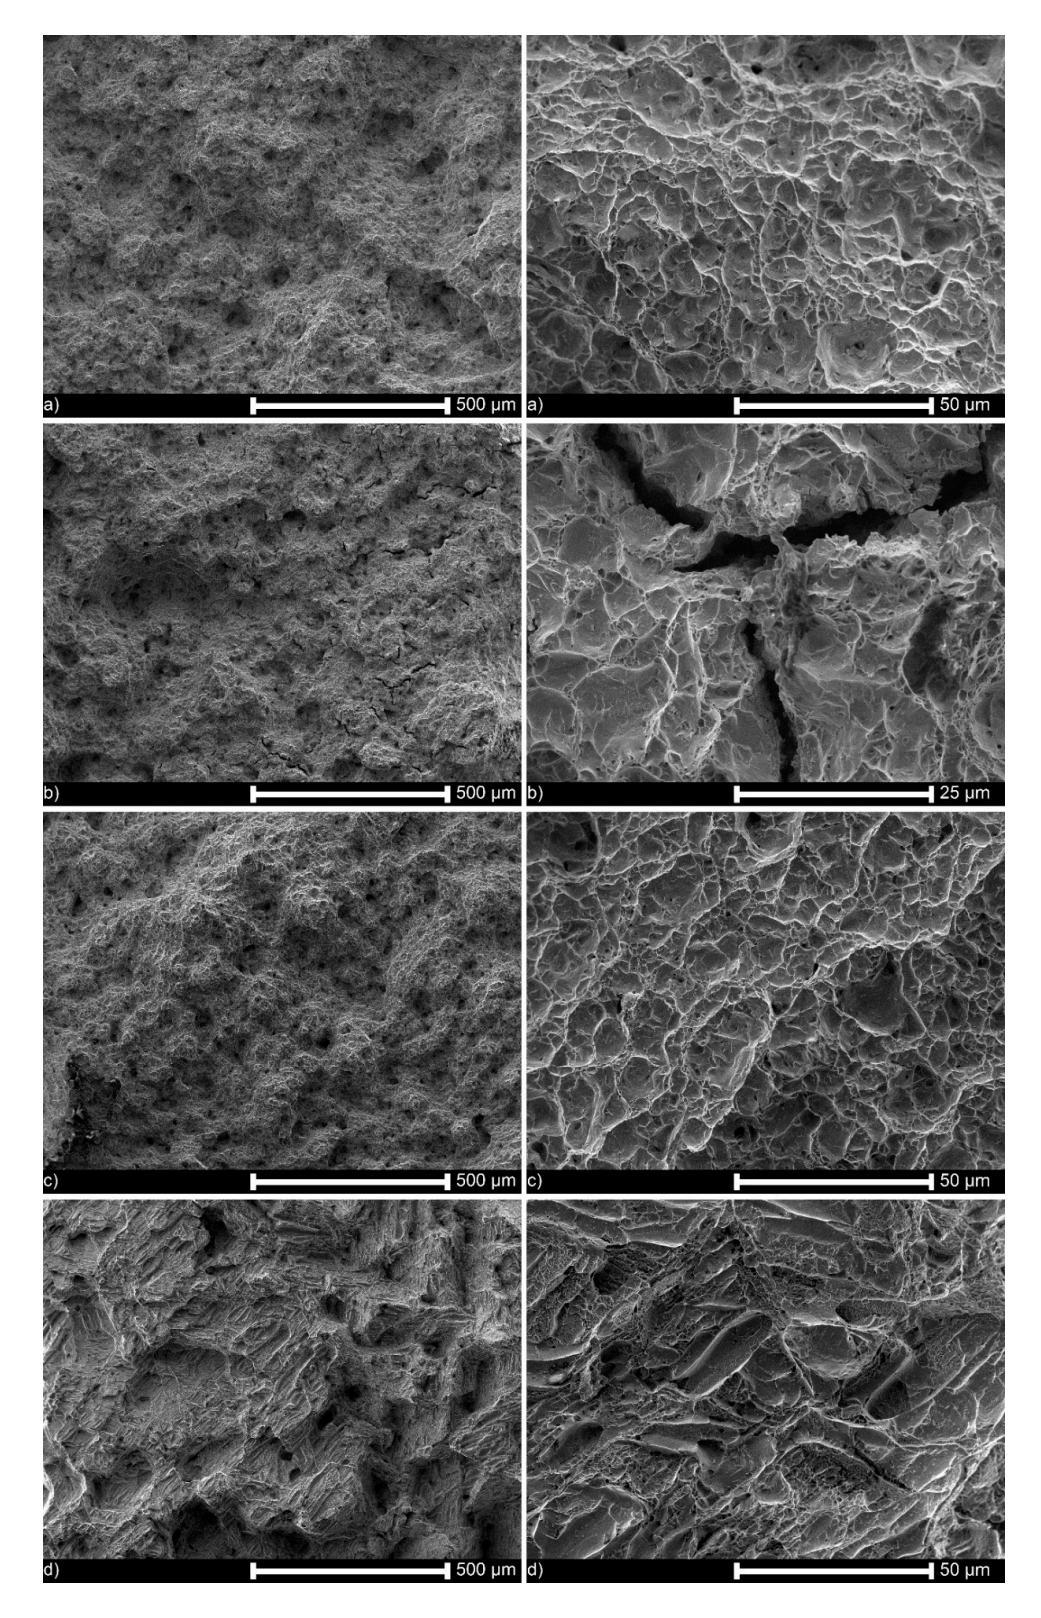
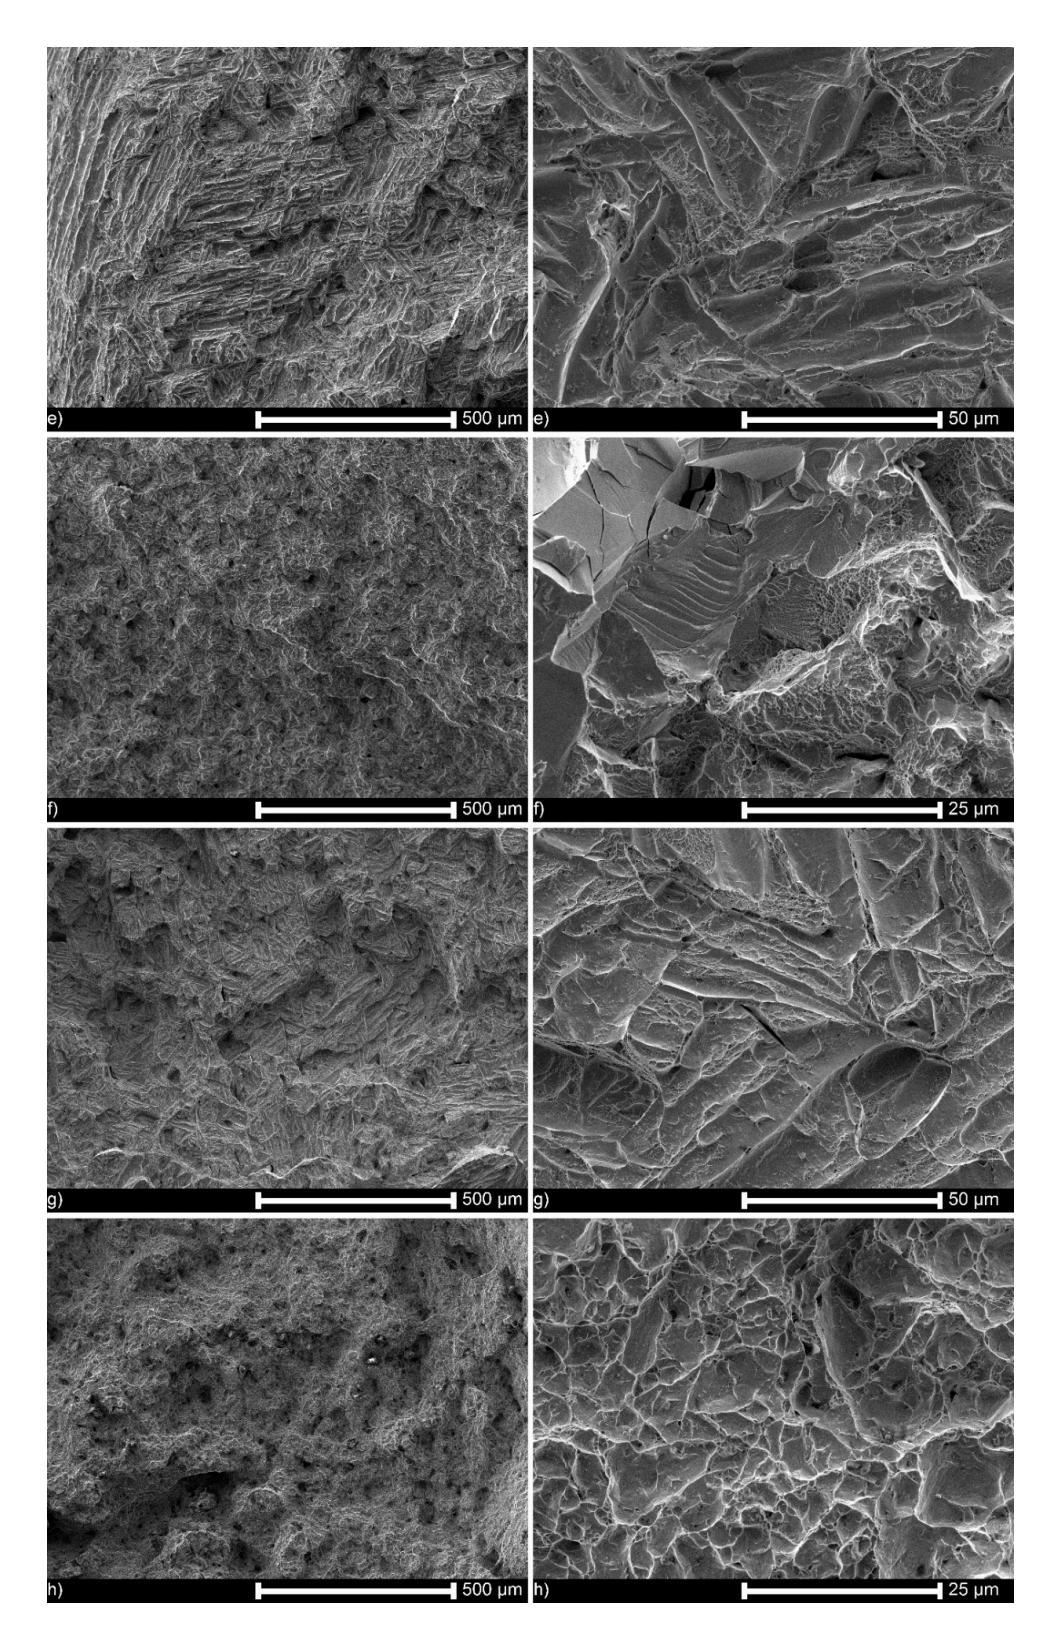
The fracture faces of some selected specimens oxidized at different temperatures and hydrogen charged are shown in Figure 8. For specimens simultaneously hydrogen-charged and tensed shown in Figure 8a, and for reference specimens shown in Figure 8h, a similar ductile fracture is noticed because of minimal hydrogen mobility at room temperature, and its presence only within the thin subsurface layer. On the contrary, the hydrogen charging followed by homogenization at 400 °C for 4 h, a time long enough to achieve the uniform hydrogen concentration across the sample, resulted in deep and frequent internal cracks caused by the decomposition of hydrides. When the oxidation temperature was raised to 700 °C, no hydride-related cracks were observed, as shown in Figure 8c–e. The fracture morphology changed at high-temperature oxidation due to the phase transformation of zirconium in this area of temperatures, as shown in Figure 8d–g. Regarding the mechanism and pathways of

cracks as shown in Figure 8b, the cracks were predominantly transgranular, the fracture itself was quasi-cleavage, and large areas of totally plastic deformation surrounded the cracks.

**Figure 8.** Fracture faces of specimens: (**a**) oxidized at 350 °C, and simultaneously hydrogen charged and tensed, (**b**) oxidized at 350 °C, hydrogen charged and tensed, (**c**) oxidized at 700 °C, hydrogen charged and tensed, (**d**) oxidized at 700 °C and 1000 °C, and tensed, (**e**) oxidized at 700 °C and at 1000 °C, hydrogen charged and tensed, (**f**) oxidized at 900 °C and tensed, (**g**) oxidized at 900 °C, hydrogen charged and tensed, (**h**) oxidized at 350 °C and tensed (reference specimen).

In this study, the metal matrix fractured by ductile mechanism and, almost exclusively, through the transgranular crack path. The cleavage or quasi-cleavage fracture was observed only at the hydride–matrix interface. As no mechanical stresses were imposed during homogenizing treatment, only lines of hydrides were found, and no cracks were observed, as shown in Figures 7 and 9. However, during impact loading resulting in fracture, the cracking proceeded lines of hydrides directly, as displayed in Figures 8 and 10.

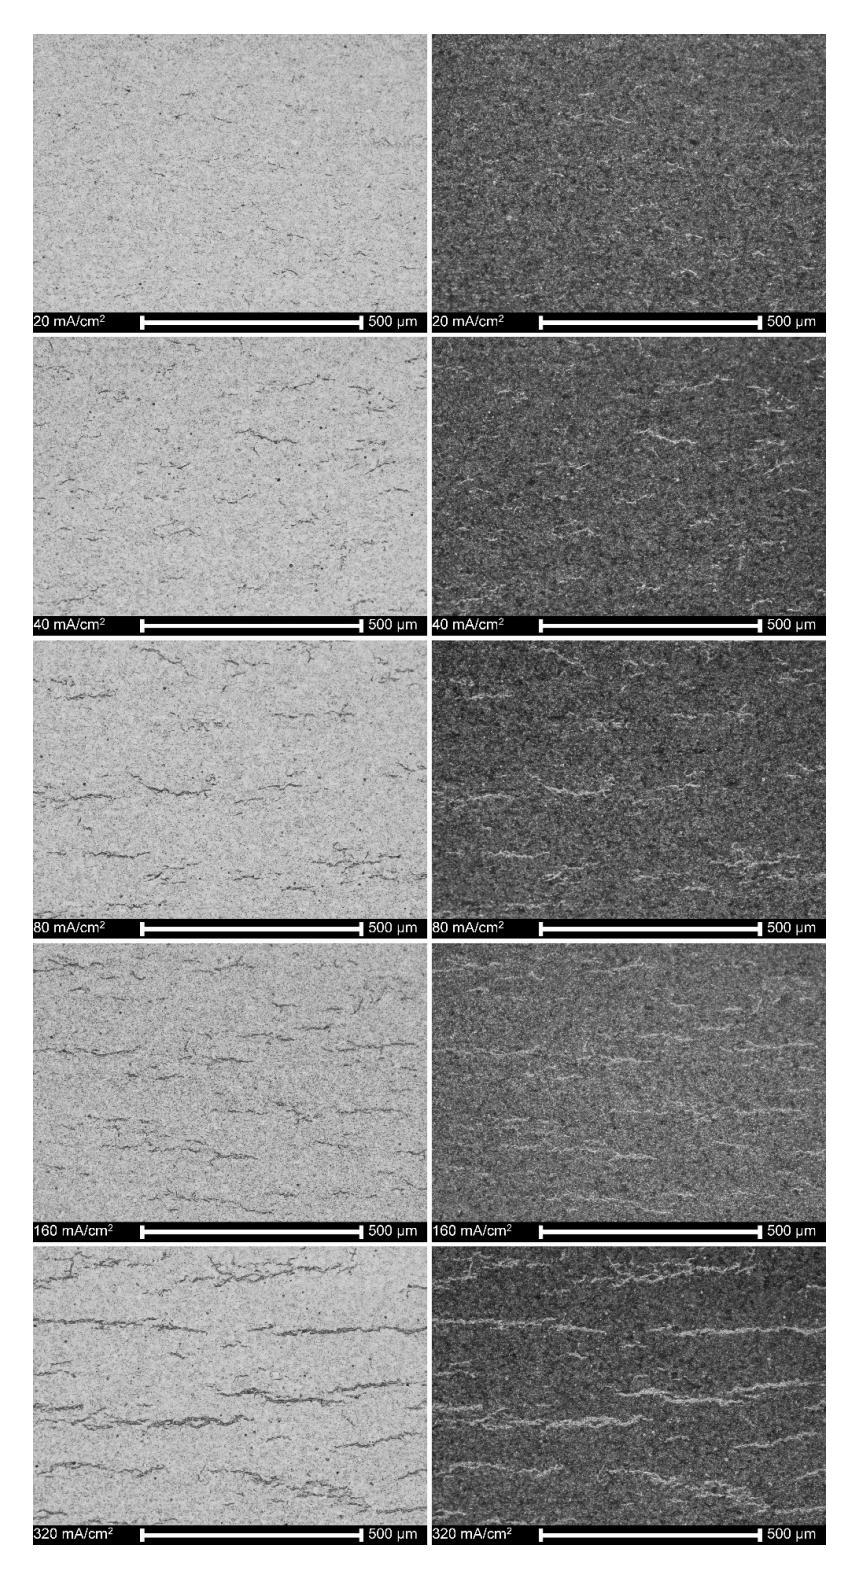
Figure 9 shows that in the absence of the artificial oxide layer, hydrogen can enter the alloy and form lines of hydrides after the homogenizing heat treatment. They appeared even at a cathodic current density of as low as 40 mA/cm<sup>2</sup>, in an amount increasing with applied current. Figure 10 confirms this observation. The fracture mechanism was mostly ductile or mixed, and to a great extent, brittle near the cracks.

**Figure 9.** The cross-sections of nonoxidized specimens charged at different cathodic current densities (on left—the light area; on right—the dark area).

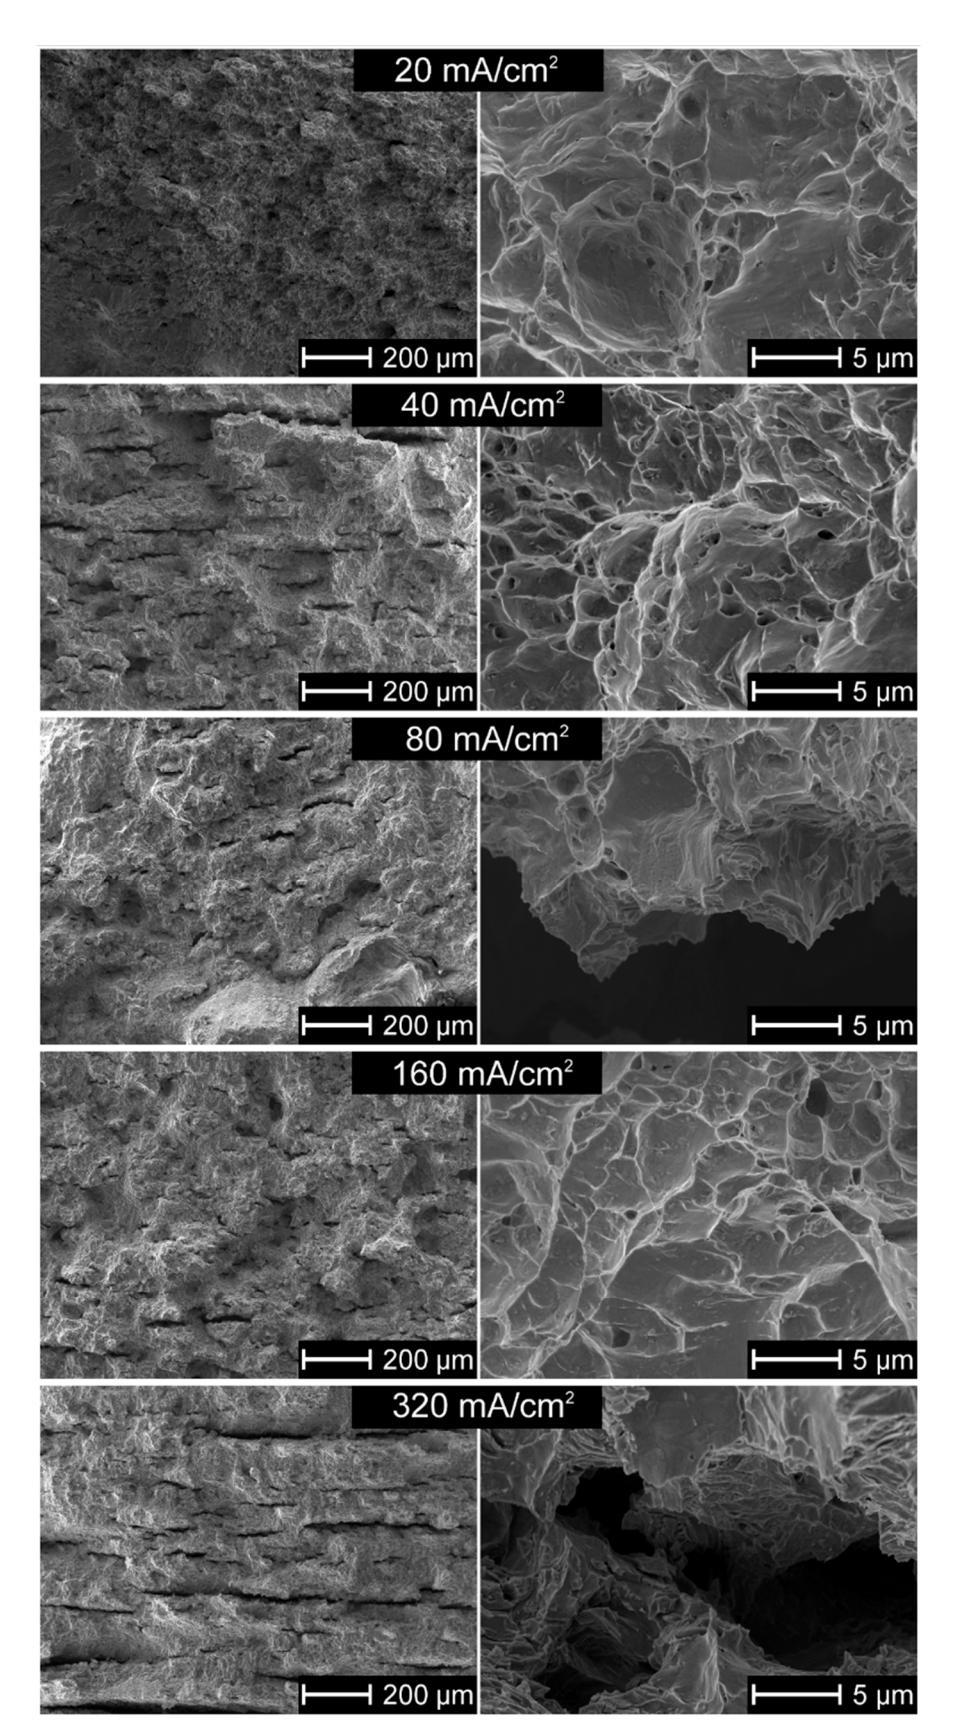
Figure 10. Fracture faces of nonoxidized specimens charged at different cathodic current densities.

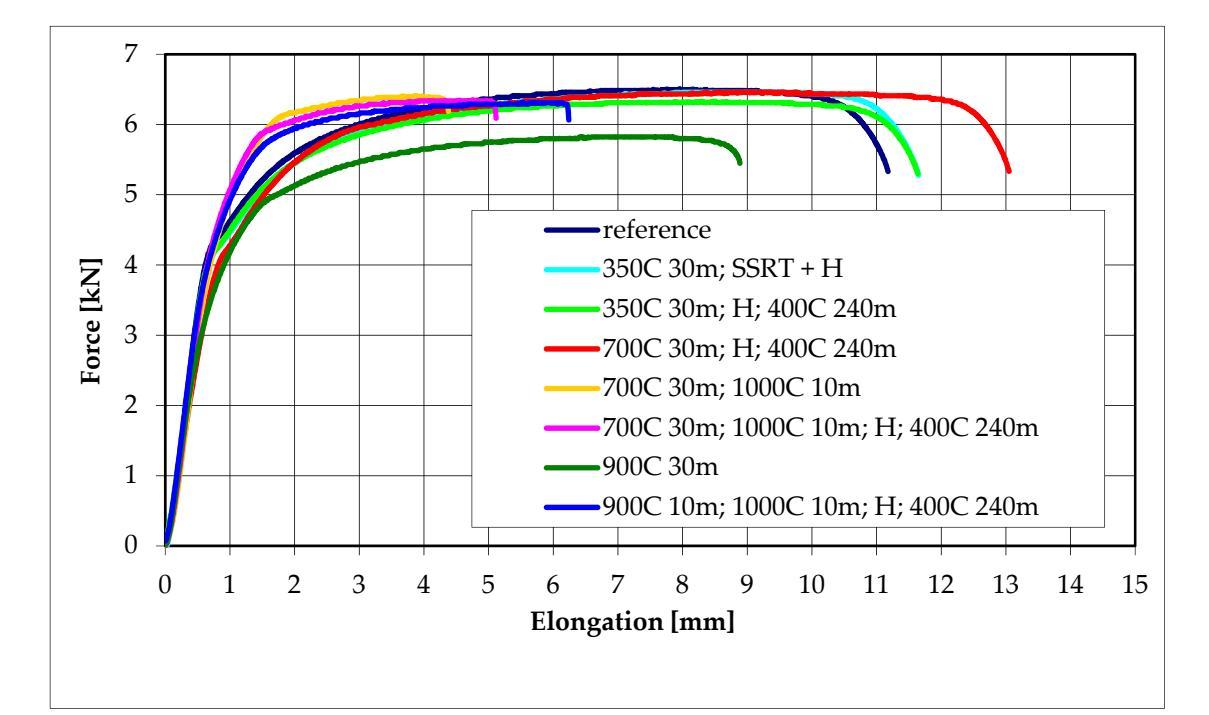
The stress–strain curves are shown in Figure 11 for specimens nonoxidized (reference), and for those oxidized and hydrogen charged at different conditions. The hydrogen charging had a small and complex effect on tensile properties. The samples, tensed and charged simultaneously, demonstrated the highest tensile strength and those charged, annealed and tensed—a little smaller tensile strength and similar elongation. The noncharged specimens had comparable tensile strength and lower elongation. The oxidation at 900 °C caused an apparent decrease in plasticity. Hydrogen presence slightly increased the elongation of the tested alloys and did not affect the tensile strength within the limits of experimental error.

**Figure 11.** Stress–strain relationships for specimens oxidized at different temperatures of 350 °C, 700 °C and 900 °C followed by oxidation at 1000 °C for 10 min, either hydrogen charged during slow strain rate test or hydrogen charged at a constant current density of 80 mA/cm<sup>2</sup>, homogenized at 400 °C for 4 h and then tensed.

The effects of hydrogen on stress-strain curves in slow strain rate tests were minor. The only distinct loss of elongation after oxidation at 900 °C is likely to originate from grain recrystallization at this high temperature, as no hydrogen can enter the specimen at a current value of zero. The hydrogen absorption seems to result in moderate softening, likely by interstitial hydrogen, as discussed later. The results are by some earlier reports [36,37]. The effects of interstitial hydrogen and hydride phases are opposite, but the distinct loss of plasticity observed in other studies [39–42] can appear at high hydrogen content and a significant number of hydrides. The separation of these effects is not easy at low hydrogen content. The slow strain rate tests have never been made for simultaneously tensed, and hydrogen-charged Zr alloys. For many metallic materials, the slow strain rate tests in the corrosive or hydrogen-containing environment have shown the initiation of cracks on the surface and their significant progress during tensile tests. Such behavior has been considered due to the hydrogen screening of dislocations, a decrease of their mutual interaction, and movement of dislocations at lower flow stress, i.e., local softening of material at macroscopically brittle fracture known as the HELP mechanism. As shown by these results, such behavior seems impossible for "frozen" hydrogen. Locally, oversaturated interstitial hydrogen solution may decrease the dislocation interaction energy and be a cause of softening, and the HELP mechanism might operate. However, like in other metals in which hydrogen solubility is very low at room temperature, and hydride forms may appear, the HEDE can be an active mechanism at low hydrogen contents and HDC at higher temperatures and

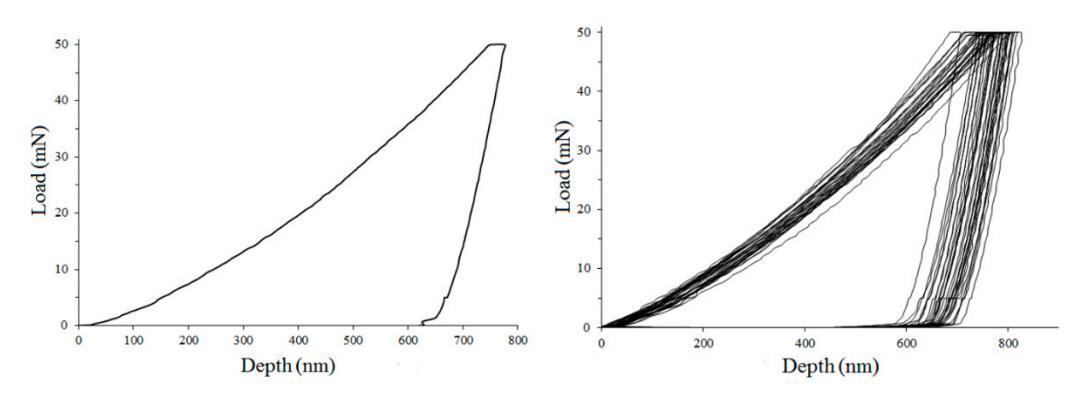
Figure 12 shows typical stress–strain curves for a single run and a series of nanoindentation tests. The obtained results are shown in Figure 13 and in Table 2. The load–displacement plots were related to hydrogen content. The minima in hardness reduced Young's modulus, plastic wok, and indent depth were observed.

Figure 12. Typical stress-strain plots for nanoindentation test.

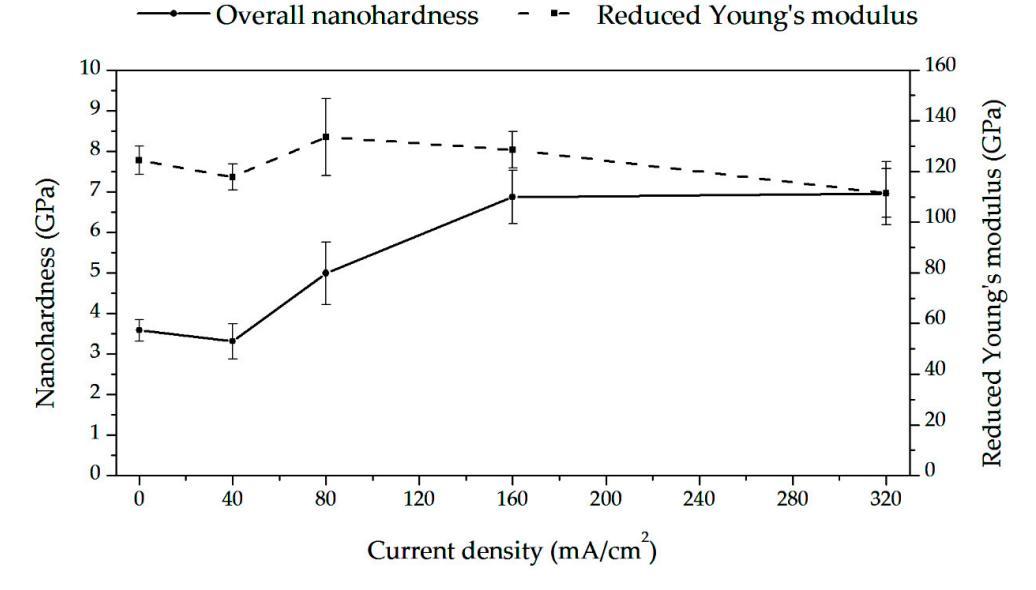
**Figure 13.** Hardness and reduced Young's modulus vs. cathodic current density. The means and standard deviations based on ten independent measurements are shown.

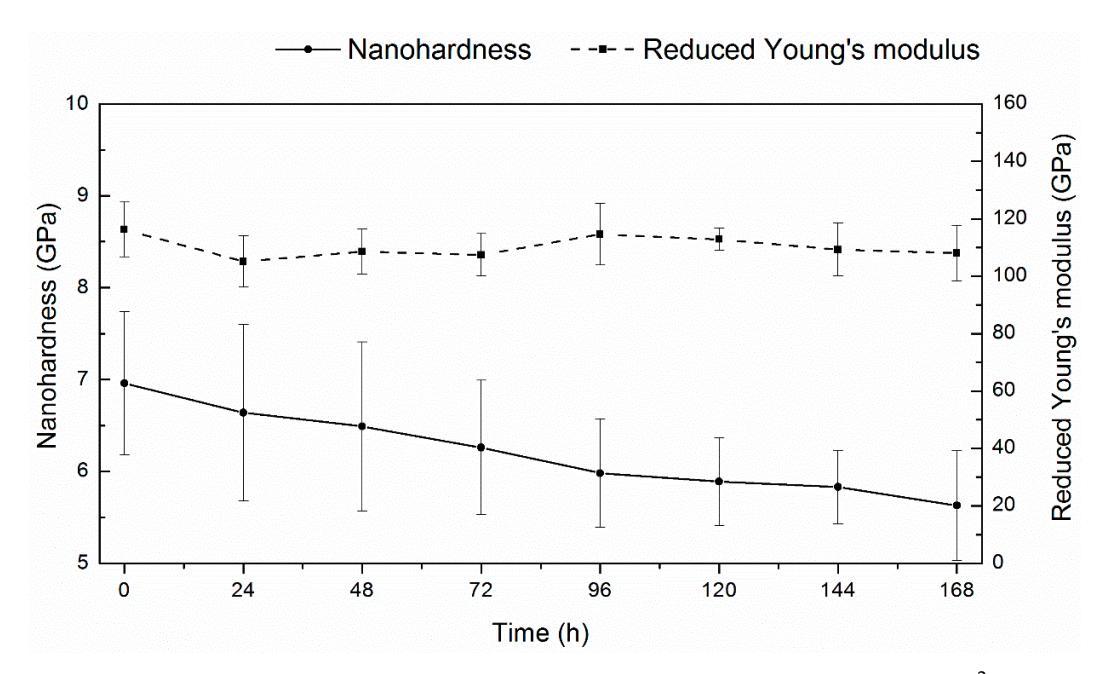
The results of the planned tests (see Table 1) are shown in Figure 14 and Table 3. The hardness was shown to slowly and monotonously decrease during outgassing, and Young's modulus possessed a relatively stable value. The plastic work and indent depth slightly increased, and elastic work remained constant.

**Figure 14.** Hardness and reduced Young's modulus of the specimen charged at 320 mA/cm<sup>2</sup> and after left at room temperature for hydrogen desorption. The means and standard deviations based on ten independent measurements are shown.

The gradual decrease in hardness after charging is due to hydrogen desorption following the decomposition of hydrides. The recovery process occurred partially as the final hardness value was about 5.5 GPa, much higher than 3.5 GPa measured for the reference specimens. That assumption regarding a substantial contribution of cracks into hardness was already expressed [102–105].
