# Hydrogen Embrittlement and Oxide Layer Effect in the Cathodically Charged Zircaloy-2

Abstract: The present paper is aimed at determining the less investigated effects of hydrogen uptake on the microstructure and the mechanical behavior of the oxidized Zircaloy-2 alloy. The specimens were oxidized and charged with hydrogen. The different oxidation temperatures and cathodic current densities were applied. The scanning electron microscopy, X-ray electron diffraction spectroscopy, hydrogen absorption assessment, tensile, and nanoindentation tests were performed. At low oxidation temperatures, an appearance of numerous hydrides and cracks, and a slight change of mechanical properties were noticed. At high-temperature oxidation, the oxide layer prevented the hydrogen deterioration of the alloy. For nonoxidized samples, charged at different current density, nanoindentation tests showed that both hardness and Young's modulus revealed the minims at specific current value and the stepwise decrease in hardness during hydrogen uptake, softening due to the interaction of hydrogen and dislocations nucleated by indentation test, and hardening caused by the decomposition of hydrogen and disloca

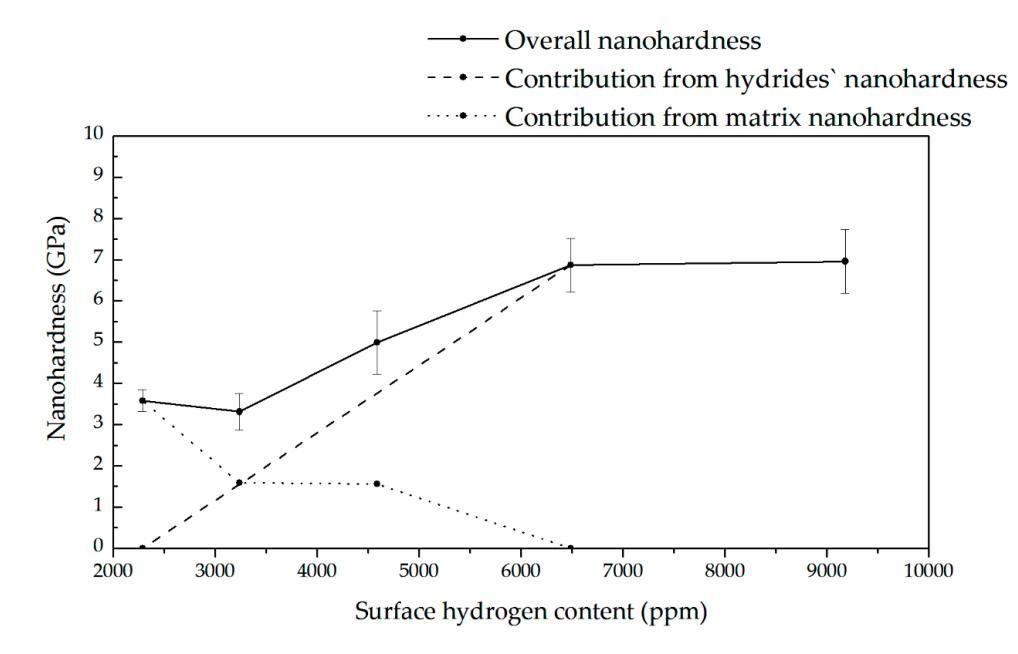
The observed changes in hardness and Young's modulus with hydrogen content are caused by the softening that may be attributed to interstitial hydrogen and by the hardening due to hydride phases. Figure 15 demonstrates the proposed runs of two components related to hydrogen in matrix and content. The shown surface hydrogen contents were calculated, taking into account the average hydrogen contents shown in Figure 6 and the known Sievert's law, i.e., proportional relation of hydrogen content to cathodic current density. Figure 16 shows, very approximately compares total surface hydrogen content at one arbitrary applied hydrogen diffusion coefficient at room temperature.

**Figure 15.** Proposed runs of two components, hydride and hydrogen interstitial solutions, of hardness over surface hydrogen content. The means and standard deviations based on ten independent measurements are shown for the upper curve.

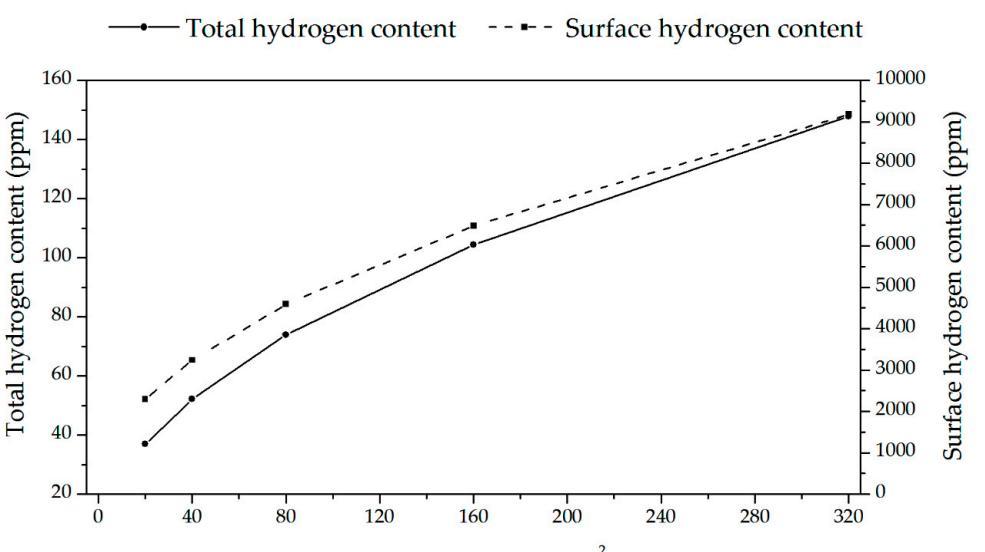
**Figure 16.** Recalculation of total hydrogen content to surface hydrogen content at different cathodic current densities.
