# Article The Influence of a Photovoltaic Micro-Installation on the Low-Frequency Parameters of Electricity at PCC and Its Impact on the Thermal Characteristics of Selected Devices

**Abstract:** This manuscript illustrates the measurement results of parameters describing the quality of energy at the PCC (point of common coupling) of a photovoltaic micro-installation that can significantly affect devices in the same power grid. The analyses reflecting heating of selected devices used in domestic installations, which were performed in an isolated laboratory environment, are also indicated. The conducted study aimed at checking the thermal characteristics of the chosen equipment, i.e., AC/DC power supply, LED and fluorescent light sources, a step-down transformer at synergistically higher voltage harmonics and constant component in the network voltage. The tests were carried out at the disturbance levels recorded at the site of the photovoltaic micro-installation. The conducted tests aimed at indicating the presence of an increased level of synergetic disturbances in the vicinity of micro-photovoltaic installations. Based on the research, recommendations were made for photovoltaic mi

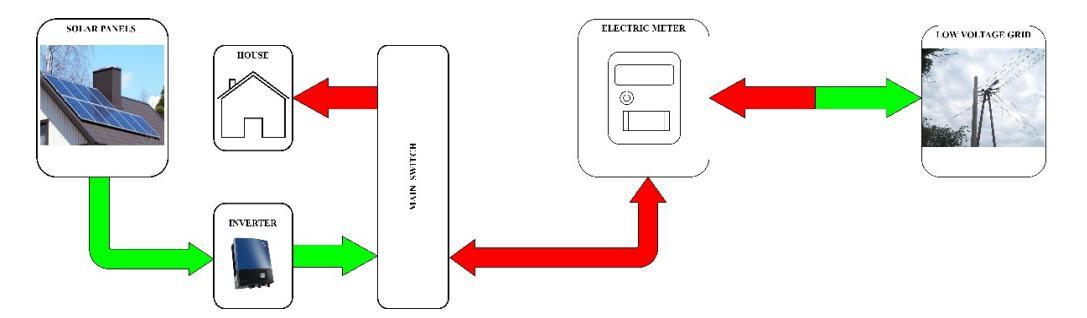
Figure 1. Typical photovoltaic micro-installation without energy storage.

In the case of low-frequency disturbances, it often causes a range of problems occurring in power networks and end devices. It is related to frequently occurring additional thermal and electrical effects, which are the reason of, among others, accelerated aging processes [15,16]. Additionally, there may be miscellaneous damages related to malfunction of devices under the influence of existing disturbances. Such effects have been observed in various parts of the world where renewable energy installations have grown rapidly. The article presents the results of observed disturbances that occurred in the LV supply network. The tests were commissioned by one of the power network operators due to an increased number of electrical equipment and apparatus failures in a certain area. Additionally, there were reports from end users regarding various damages to electrical devices. The primary reported remark was overheating of devices powered from the LV grid. Actions taken by the operator showed that a low-power photovoltaic installation was connected to the grid in the area in question. The connected installation was a typical 1-phase installation mounted in the energy operator's area of operation. The mentioned low-power installation consists of a set of PV modules (14 pcs) and an inverter enabling cooperation with the grid (as in the Figure 1); however, there was no energy storage.

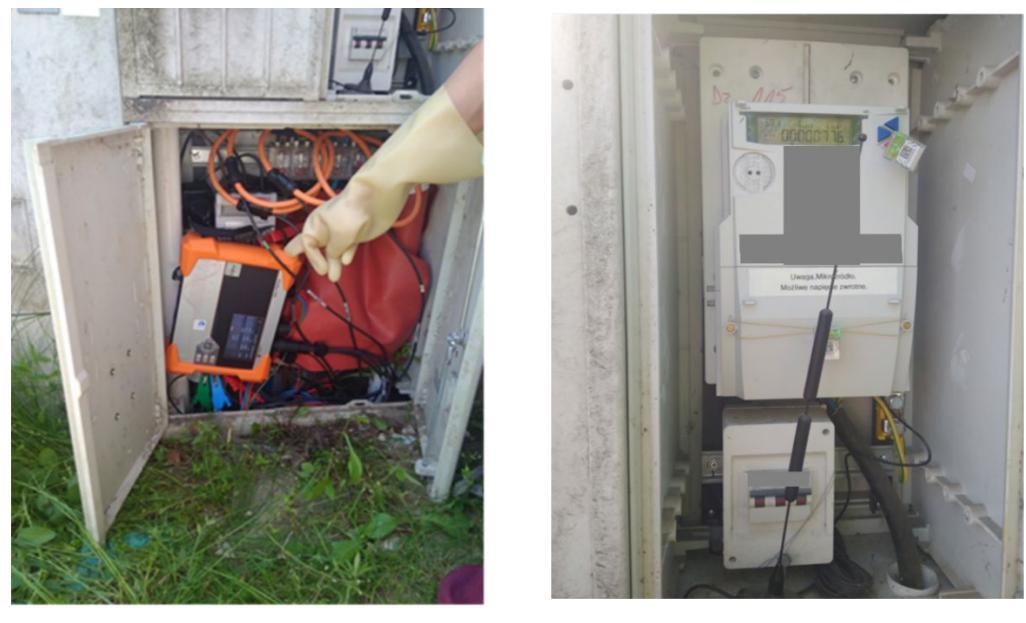
Figure 2. The installation site at PCC (a) PQ-BOX 200, (b) electric meter.

The analyses of the LV network, at the PCC behind electricity meter placed at the network side, were taken. Figure 2 illustrates the PCC. The measurements were performed with the PQ–BOX 200 (A. Eberle GmbH & Co. KG, Nürnberg, Germany) meter during 7 days in June.

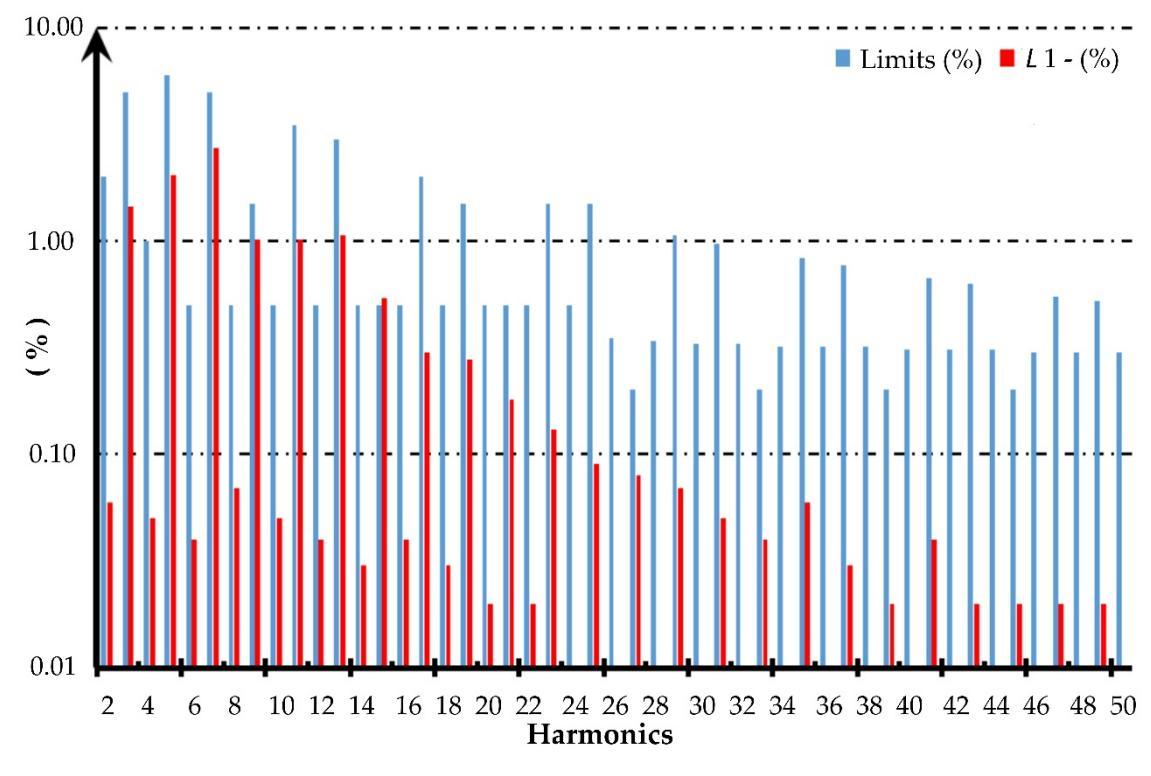
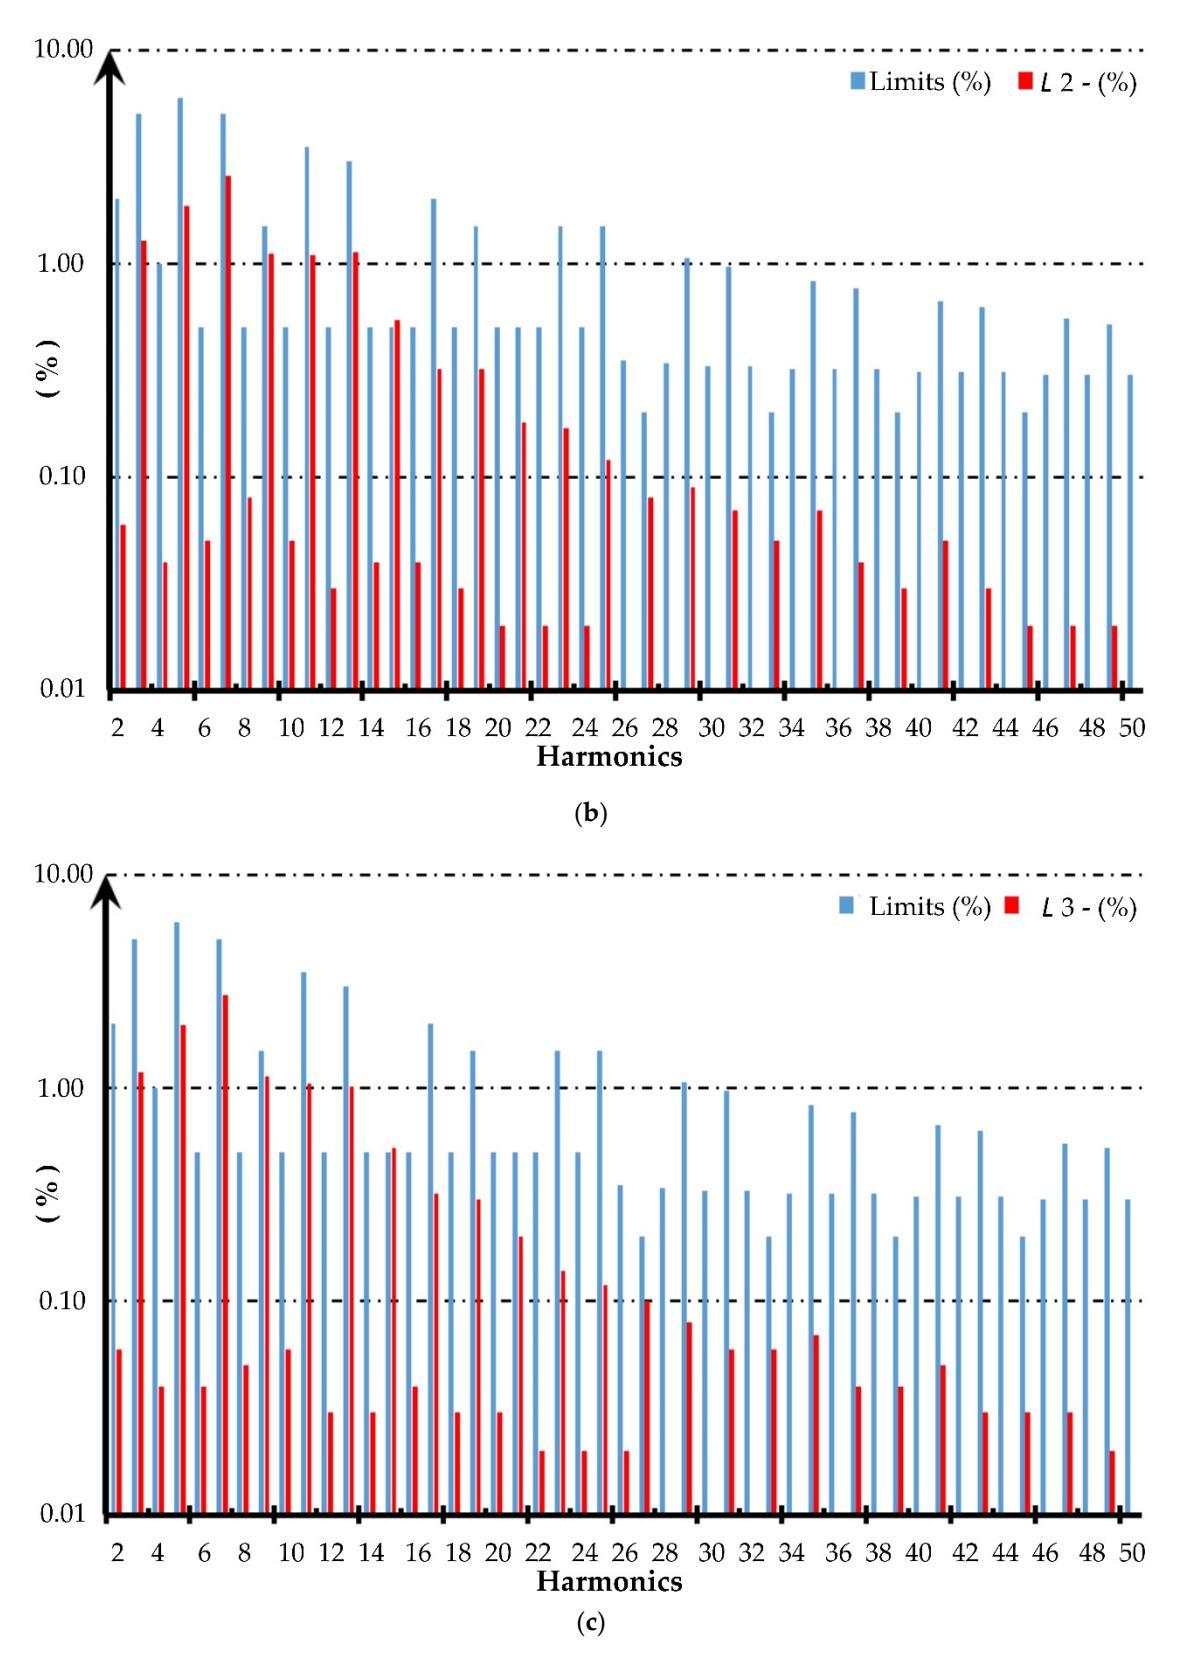
Figure 4. Harmonics in the supply voltage: (a) phase L 1; (b) phase L 2; (c) phase L 3.

Figure 4 represents the distribution of harmonics in individual phases *L* 1, *L* 2, *L* 3 during the measurement period, where the x axis represents harmonics, while y axis percentage share of a given harmonics. The measured values are marked in red, the permissible limits of individual harmonics are shown in light blue.

The conducted analyses illustrated a relatively high level of disturbances in the voltages measured near the monitored photovoltaic installation. The measurements showed a significant share of harmonics in the supply voltage. The THD (Total Harmonic Distortion) was exceeded in all three phases reaching their maximum in the L 2 phase at the value of 18%. It should also be noted that the individual harmonics are exceeded against the applicable limits only at the 15th harmonic level. Their occurrence, however, at such levels should be considered uncommon. The recorded disturbance levels are typical of industrial networks rather than household networks. At the same time, the power flows in individual phases indicate a substantial discrepancy in power between the individual phases at the facility. Only the *L* 1 and *L* 2 phases are loaded, while in the *L* 3, the power consumption is negligible. This indicates a very uneven load of individual phases at the facility. Additionally, in each phase there is a constant component that reaches the value of 18 V in the L 2 phase for a period of over 12 min. The presence of a constant component in the supply network at levels up to 500 mV was monitored by the authors at various installations. Yet, its presence at higher levels, and for a relatively long period of time, may be the reason of overheating of some mains-operated devices. The laboratory tests carried out in isolated conditions reflected that the presence of harmonics only in supply voltages with THD levels of 18% is not the source of significant temperature increment, which are at the level of are approximately of 4 °C. Only the synergistic occurrence of harmonics and the constant component considerably increases the heating level of some devices equipped with magnetic circuits. This applies in particular to circuits powered from supply transformers, where the recorded increment in temperature rises from the level of  $\Delta T \approx 20$  °C to  $\Delta T \approx 50$  °C. In the case of newer power electronics solutions, the recorded temperature increments are trivial.

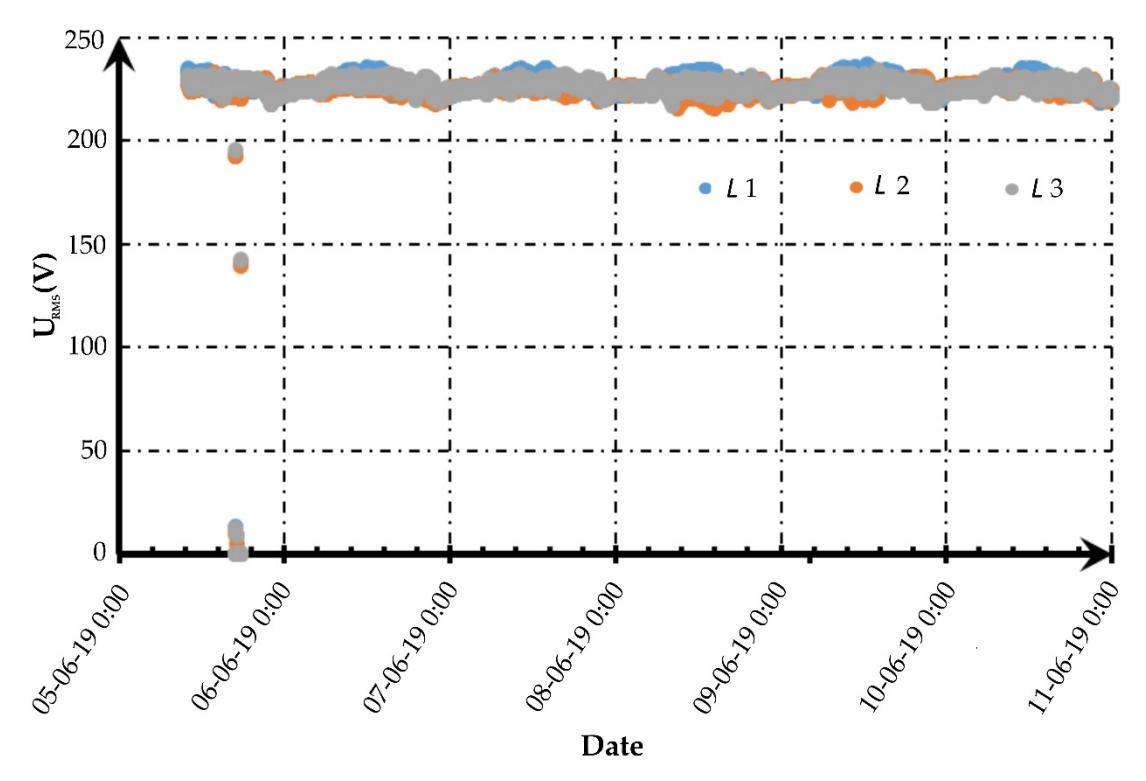
Figure 5 shows the changes in the RMS voltage during the measurements.

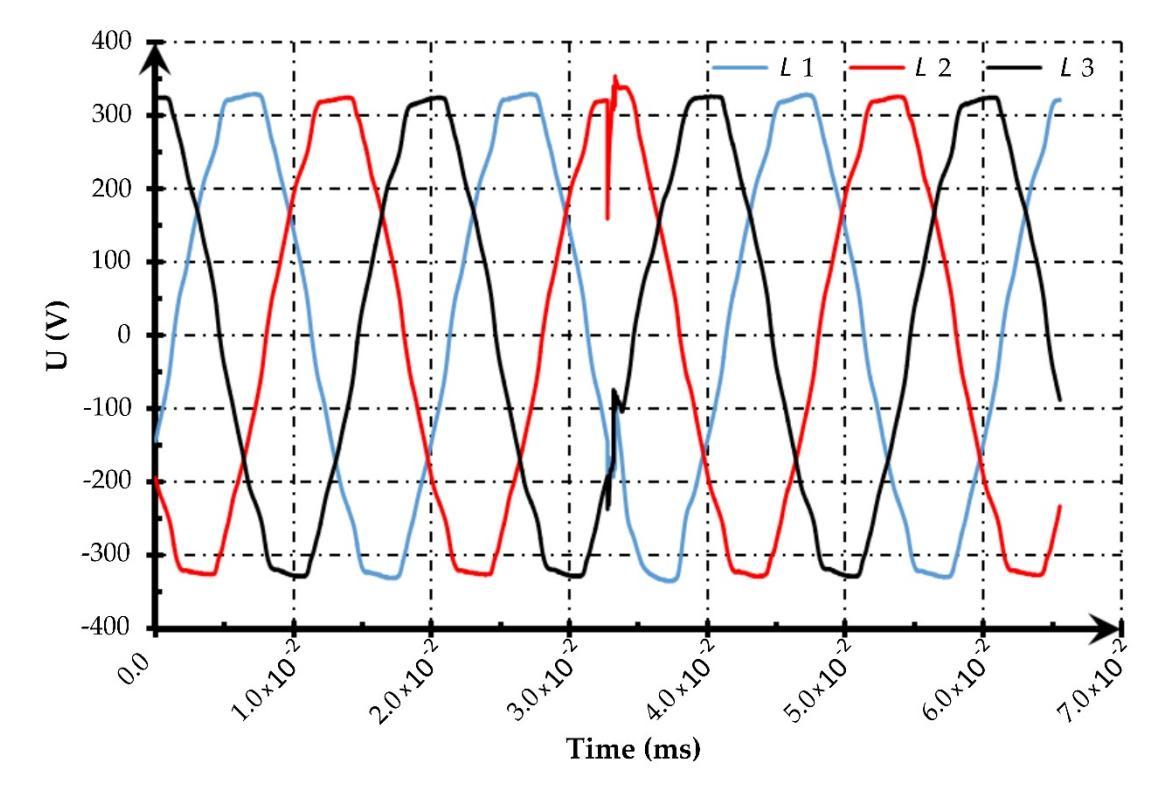
Figure 6. Rapid changes in voltage example 1.

Figures 6 and 7 illustrate typical rapid changes in the instantaneous voltage U (t) resulting from voltage commutation collapses that were recorded in the phase waveforms.

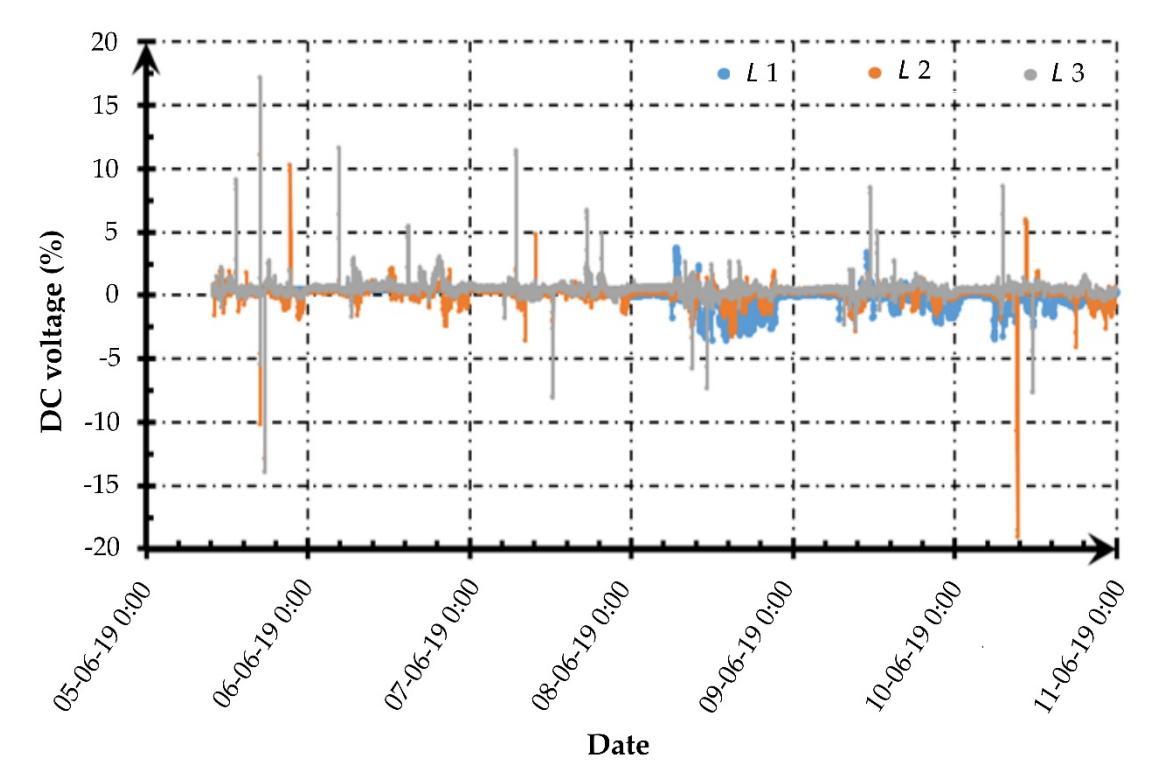
Figure 8. Constant component (DC) in voltage.

There was also a constant component ( $U_{DC}$ ) in the measured voltage waveforms, which is presented in Figure 8, where DC voltage is presented as the percentage of rated voltage -230 V.

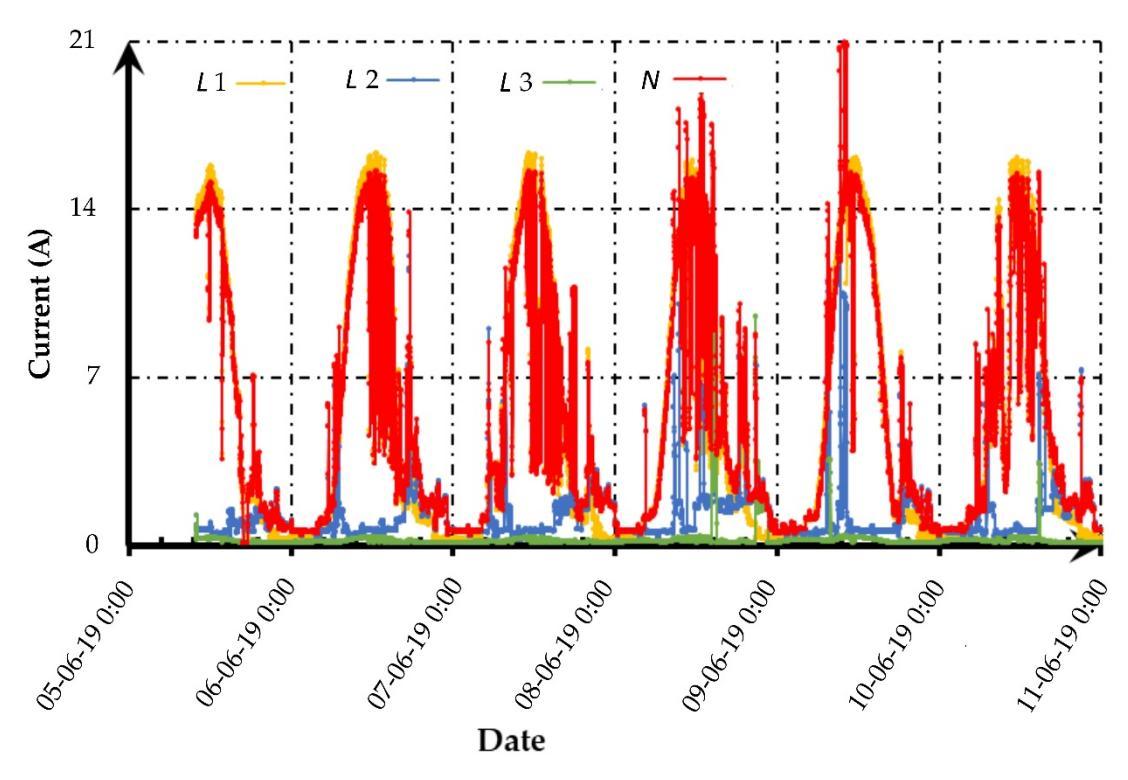
Figure 9. Currents variation during measurements.

Figure 9 shows the measurement of the currents in the individual phases.

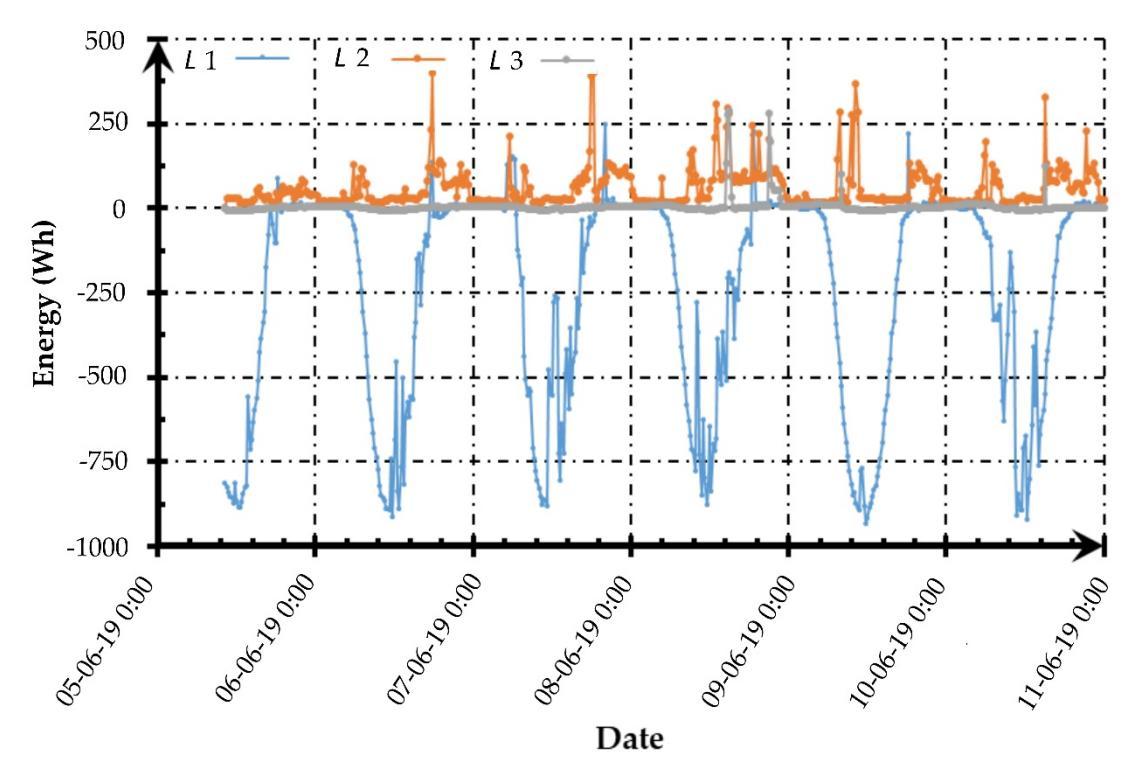
Figure 10. Currents variation during measurements.

The analyzed energy flows indicate a significant disproportion between individual phases, which can be seen particularly in Figure 10, showing energy flows in the facility in individual phases.

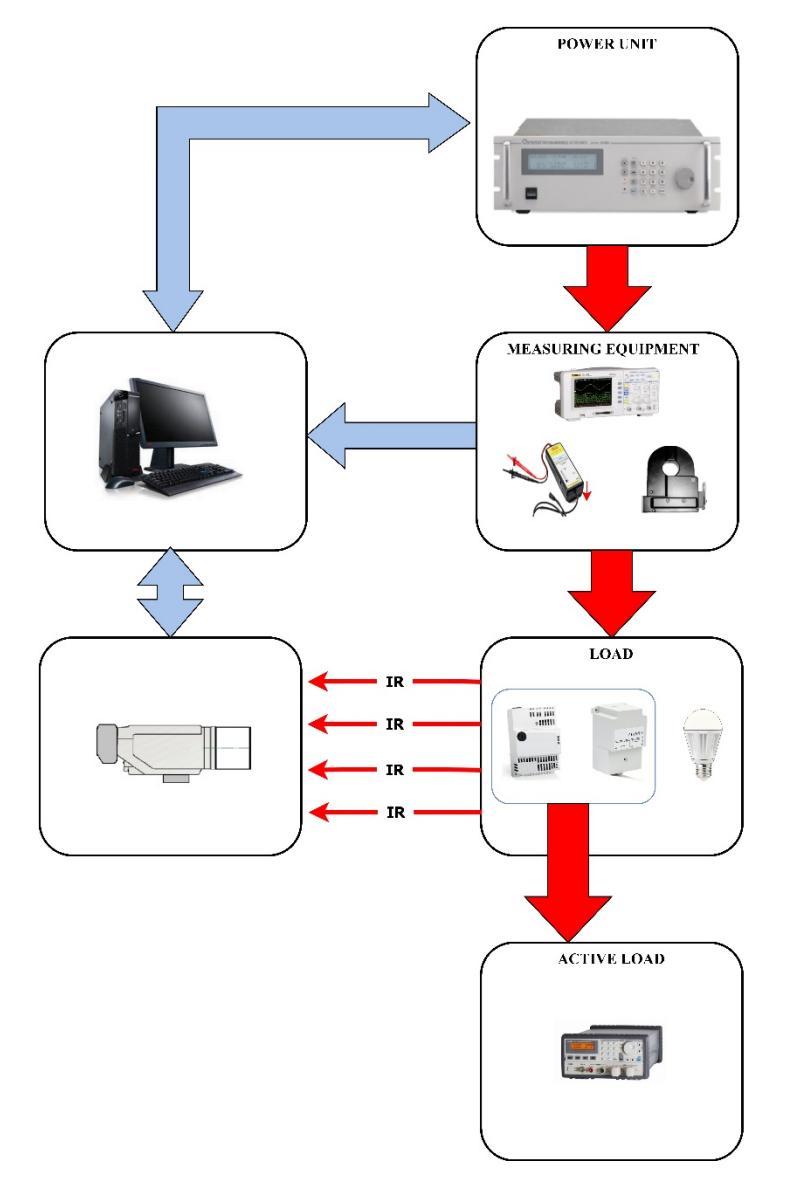
Figure 11. Applied measurement system.

Selected systems were also tested. They were chosen on the basis of recipients' declarations, who indicated which elements and systems in their installations were damaged. The testing, in an insulated environment with a distorted voltage supply, was related to power supplies used in fire alarm systems, LED lighting source, fluorescent lighting source and two step-down transformers typically used for various electronic or electrical devices. During the measurements, basic electrical parameters as well as temperature fields were monitored. For the tests of LED lighting sources, a controlled power supply type 61503 by Chroma was applied. The tests were carried out in the measurement system presented in Figure 11, which also included: R&S RT – ZD 01 (Rohde&Schwarz GmbH&Co. KG, Germany) voltage probe, ALCL - 40 D (Multi measuring instruments Co., Ltd., Tokyo, Japan) current probe, RIGOL 1102 D (Rigol Technologies, Inc., Suzhou, PRC) oscilloscope, VIGOcam v.50 (VIGO System S.A, Ozarow Mazowiecki, Poland) the thermal imaging camera with a reference field, and ARRAY active load 3712A (Array Electronic Co., Ltd., Nanjing, PRC) used as load for objects in test. The load was selected at the level of 75% of the rated power of the devices (this applies to the tested power supplies and power transformers).
