# Analysis of passenger car crash with a cable barrier installed with anti-glare screens on a horizontal convex road curve with 400 m radius

**Abstract.** High-tension cable barriers have been used on roads for a relatively short period compared with other types of road barriers. Hence, there remains a need for further research on various crash scenarios. An important issue is the performance of a cable barrier on a road curve, particularly when a vehicle impacts the convex side of the barrier. To address this issue, the analysis in this study considers a system of anti-glare screens installed on a cable barrier that is often used on the horizontal curves of roads to protect drivers from the glare of the headlights of oncoming traffic. The responses of the cable barrier and car are evaluated based on a full-scale crash test and a numerical simulation. The forces in the cables during impact and the influence of the anti-glare screens on the behavior of the cables are also investigated. Additionally, an analysis of the energy absorbed by the car and barrier subparts is performed. This study confirmed that cable barriers work properly and provide the highest level of safety; the stud

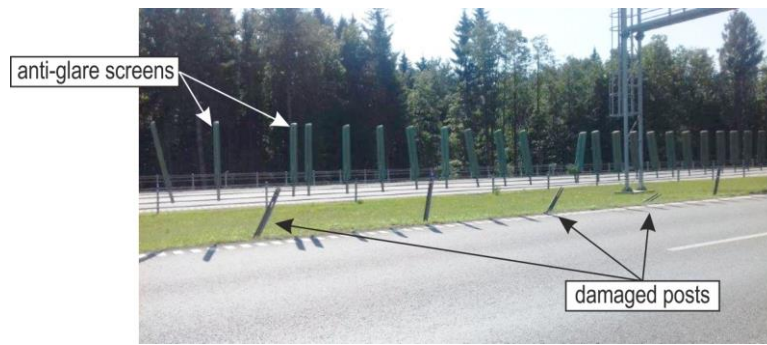
**Fig. 2** Photograph of a damaged cable barrier with anti-glare screens (source: GDDKiA, Poland).

66 be observed, as shown in Fig. 2. In this particular case, the damage to the system, including the deflection of  
67 a few posts and the sliding of several screens, implies that the impact energy was not significant.  
68 Notwithstanding, the question remains about how that system would have behaved and how the anti-glare  
69 screens would have affected the crash outcome if the impact energy was higher.

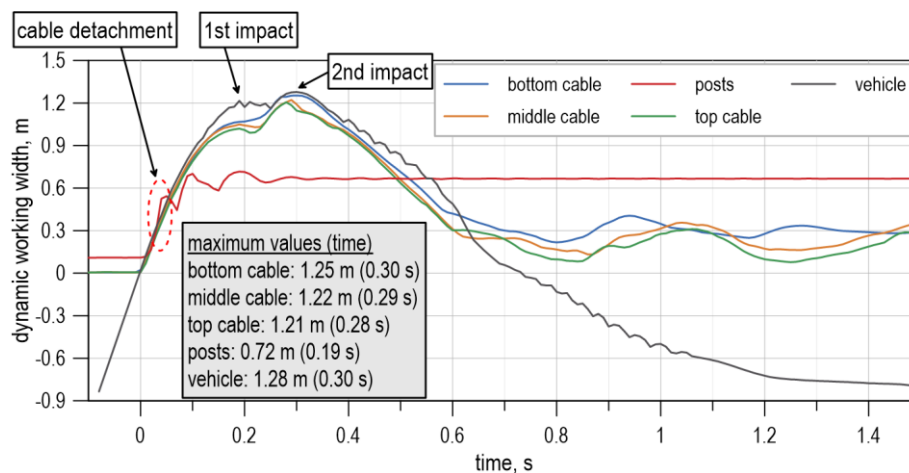
1  
 2  
 3  
**Fig. 7** Maximum dynamic lateral positions of subsystems during crash calculated from undeformed traffic side of barrier (dynamic working width).

320 vehicle. That is also visible in Fig. 7 at time  $t = 0.06\text{--}0.56$  s, that is, the values of the dynamic position of the  
 321 posts (approximately 0.66 m) are smaller than those for the car and the cables. At time  $t = 0.19$  s, the dynamic  
 322 lateral position of the car front reached its maximum. Next, the barrier began to rotate and redirect the car back  
 323 toward the road. Then, at time  $t = 0.30$  s, the rear end of the car impacted the barrier for the second time in the  
 324 place that had been previously damaged by the front end of the car. The two aforementioned impacts are  
 325 illustrated in Fig. 7. It is worth noting that a similar phenomenon occurred in crash tests with long vehicles  
 326 such as buses. First, the front of the vehicle impacted a barrier, and subsequently, the rear of the vehicle hits  
 327 the previously damaged section again (Wilde et al., 2017). In the analyzed crash test, the second impact of the

328 rear end resulted in the cables and vehicle reaching their maximum dynamic working widths. The object with  
 329 the greatest dynamic lateral position was the car, and this value determined the working width  $W_m = 1.28$  m at  
 330 time  $t = 0.30$  s. The maximum lateral position of the cables was 1.25 m, which was 3 cm smaller than that of  
 331 the car. This is because the cables cut into the body of the vehicle during the crash. A similar effect was  
 332 observed in the full-scale crash test, and it is discussed in the section concerning the car damage (Section  
 333 3.1.4). It is worth mentioning that the deflection of the bottom cable was greater than those of the middle and  
 334 top cables. In the gray box shown in Fig. 7, the maximum values of the dynamic working width for the  
 335 considered subparts are summarized.

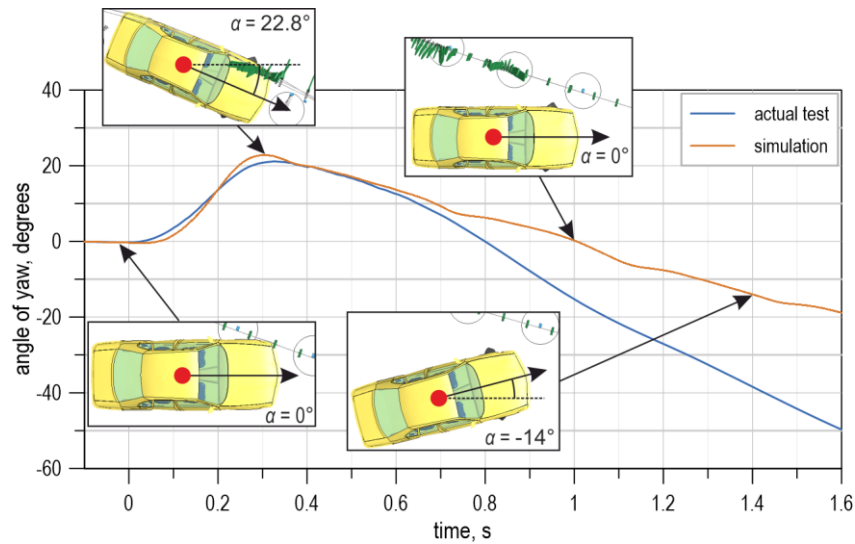
Fig. 8 Variations in yaw angle

336 Here, Fig. 8 shows the yaw angle of the car, wherein the yaw angles for the selected time steps are depicted  
 337 in the boxes. After the strike, in the first phase (time  $t = 0.0\text{--}0.3$  s), the actual vehicle rotated clockwise up to  
 338  $21.1^\circ$ , and in the simulation, the maximum yaw angle was  $22.8^\circ$ . Next, at time  $t > 0.30$  s, the vehicle was forced  
 339 back onto the road by the barrier. In the second phase, the vehicle began to turn counterclockwise. In the full-  
 340 scale crash test, the car left the barrier at time  $t = 0.71$  s. In the simulation, this occurred at time  $t = 0.75$  s. As  
 341 observed in Fig. 8, the values of the yaw angle during the contact between the car and the barrier (time from  
 342 0.0 to 0.75 s) were similar in the actual test and the simulation. In the crash test, at time  $t = 0.8$  s, the longitudinal  
 343 axis of the car coincided with the original direction of impact, that is, the yaw angle of the car was  $0^\circ$ . In the

344 simulation, this happened at time  $t = 1.0$  s. Next, the car continued to rotate counterclockwise as observed from  
 345 the graphs in Fig. 8 and the snapshots in Fig. 5 and Fig. 6. After departure from the barrier, the car in the full-  
 346 scale test experienced greater rotations than that in the simulation. The differences in the behavior of the car  
 347 after leaving the barrier may result from, among others, the age and technical conditions of the vehicle. Finally,  
 348 the subpart with the highest value of the lateral position was the post, and they determined the static  
 349 (permanent) working width. In the actual test, the static working width equaled 0.76 m for post no. 10, and in  
 350 the simulation, it was 0.67 m for post no. 11.

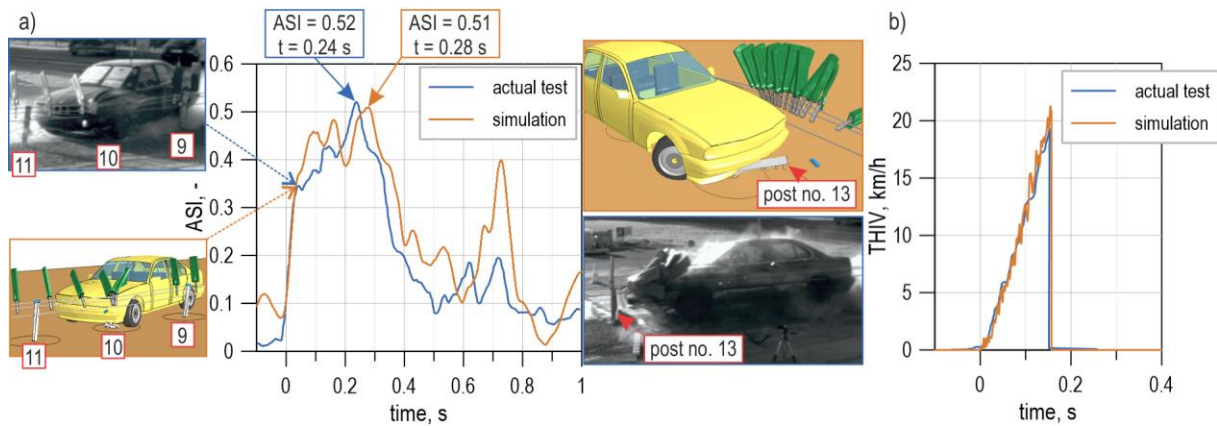
Fig. 9 Impact severity indices: a) ASI and b) THIV.

364 metrics, which were implemented in the RSVVP software (“Roadside Safety Verification and Validation  
 365 Program RSVVP, [www.roadsafellc.com/NCHRP22-24/RSVVP/](http://www.roadsafellc.com/NCHRP22-24/RSVVP/), date of access 01.02.2018,” 2018). The  
 366 metrics are listed in Tab. 4. The values of the metrics allow us to conclude that the ASI and THIV curves from  
 367 the crash test and simulation are similar. The obtained ASI and THIV values indicate that the barrier provided  
 368 the highest impact severity level of A (ASI < 1.0; THIV < 33 km/h).

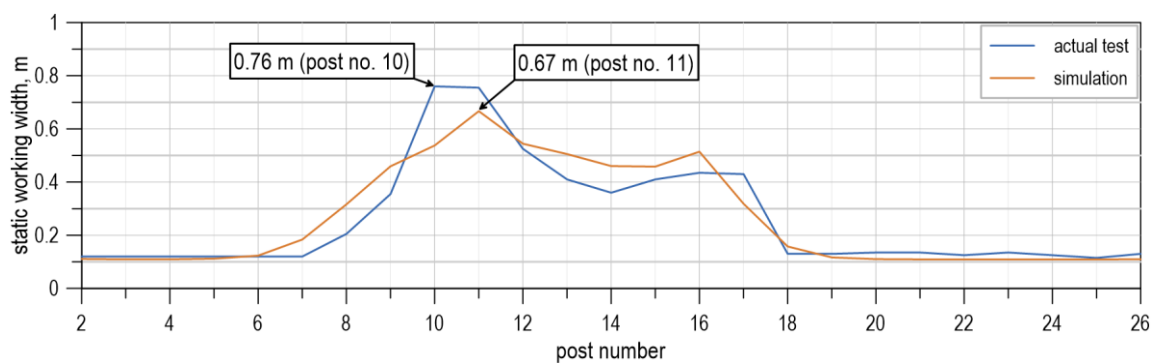
393 **Fig. 10** Static (permanent) working width for posts.  
394

374 The overall view of the damage to the system in the simulation is similar to that obtained in the crash test.  
375 The static working width of each post is shown in Fig. 10. The wire ropes did not rupture in the actual test or  
376 simulation. A general view of the barrier after a crash is shown in Fig. 11.

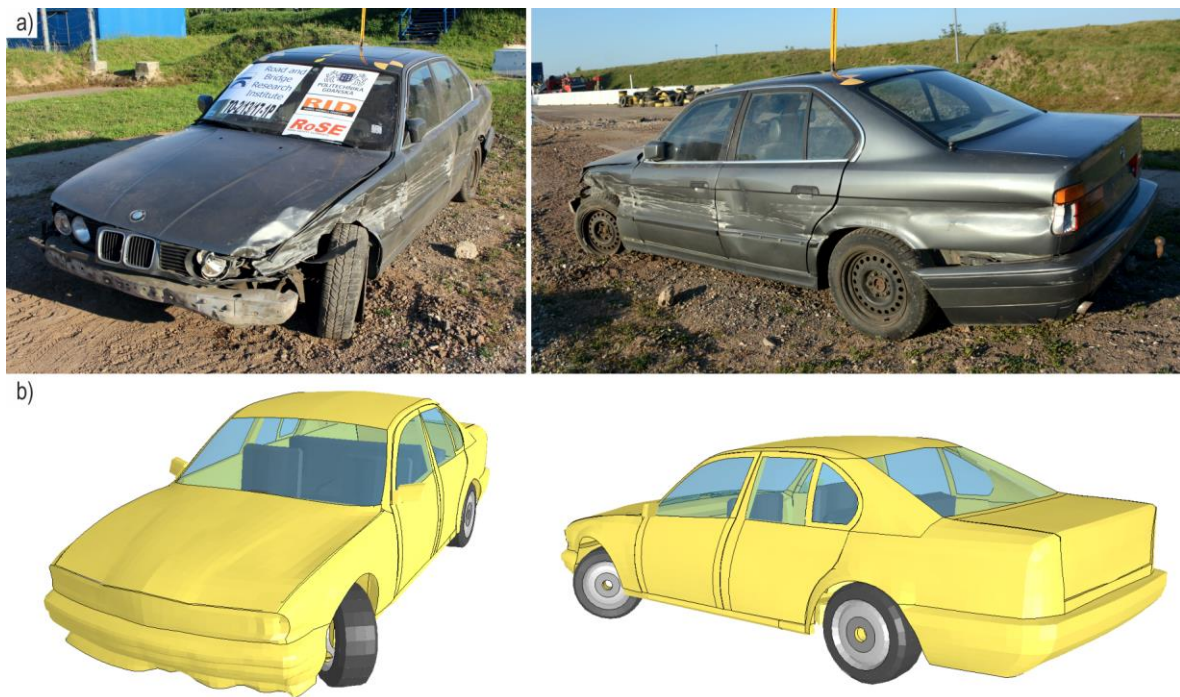
Fig. 14 Damage to the vehicle: a) crash test and b) simulation.

A comparison of the damage to the numerical car model and actual car is shown in Fig. 14. In the crash test, the front left of the car, including the bumper, fender, hood, and wheel, was damaged. The deformation along the left side of the car body, at the height between the wheel and door handles, was caused by the cables. The left side of the rear bumper was detached. The left-wing mirror was damaged; however, it did not detach from the car. The front and rear lamps on the left were broken.

In the simulation, the front of the car was damaged, similar to the actual car. The maximum value of the effective plastic strain was 0.254, and the area of damage was limited to the front left. There was no deformation of the cables along the left side of the car, as observed in the actual test. This is because of the simplified car model, and the average size of the shell FE side was approximately three times the diameter of the wire rope. Therefore, the model used did not capture all details of the damage. The VCDI index was LS0000000 in both actual and numerical tests.

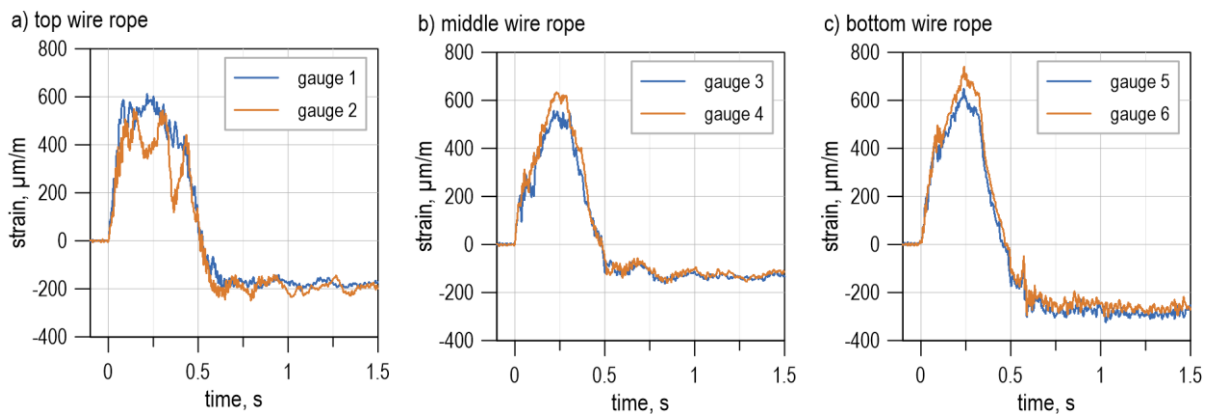
Fig. 15 Strain vs. time curves from the crash test: a) top turnbuckle, b) middle turnbuckle, and c) bottom turnbuckle.

The strains in the turnbuckles were measured during the actual impact test using six strain gauges. Here, Fig. 3-b shows the strain gauges on the actual system. Strain gauges 1 and 2 measured the strains in the top turnbuckle, gauges 3 and 4 in the middle turnbuckle, and gauges 5 and 6 in the bottom turnbuckle. Therefore, two strain gauges were installed on each turnbuckle. These measurements allowed for the determination of the forces in the turnbuckles. It was assumed that the forces in the cables were the same as those in the turnbuckle. The results are shown in Fig. 15.

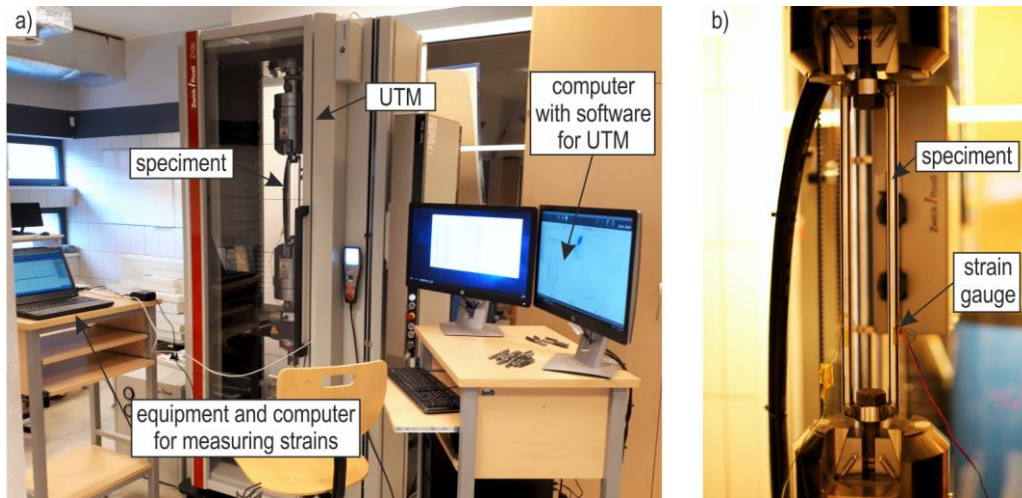
447  
 448 **Fig. 16** Laboratory tests of turnbuckle: a) test stand and b) turnbuckle with strain gauge.

To obtain the values of the axial forces in the cables, laboratory tests on the turnbuckles were conducted using a universal testing machine (UTM). The test stand and specimens are shown in Fig. 16. The forces in the turnbuckle were acquired from the UTM and the strains from the strain gauge. These tests were used to determine the force–strain relationship, which allowed for the assessment of the axial forces in the cables during the crash. Furthermore, Fig. 17 presents a comparison of the forces in the turnbuckles obtained from the crash test and simulation, and Tab. 5 summarizes the maximum forces and the time of their occurrence. For the purpose of analysis, the greater force determined from the two strain gauges for each turnbuckle was chosen as the maximum force in the cable. Furthermore, Fig. 18 shows a comparison of the summation of axial

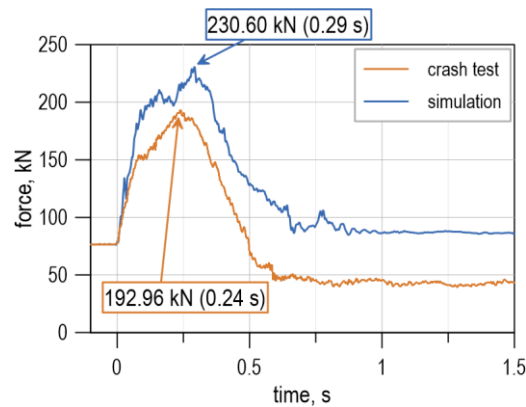
**Fig. 18** Comparison of total axial force in cables from numerical simulation and crash test.

444 forces in cables over time obtained in the simulation and crash test. The values from the test were calculated  
 445 as the sum of the values from the strain gauges for which the maximum forces for the cables were obtained,  
 446 i.e., from strain gauges 1, 4, and 6.

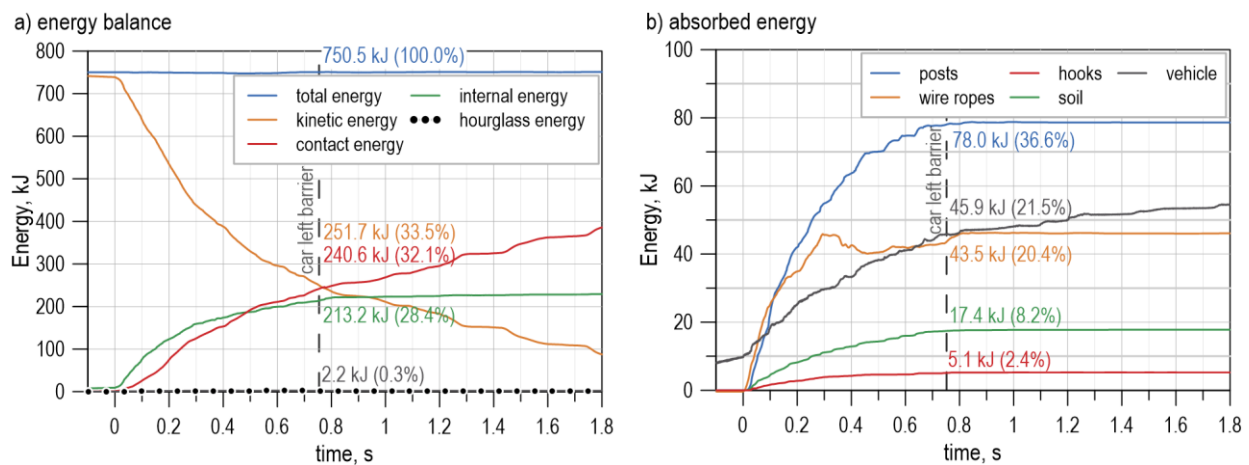
Fig. 20 Energy analysis in the numerical simulation: a) energy balance and b) energy absorption by the subparts of the system.

The energy balance obtained from the numerical simulation is shown in Fig. 20-a. The total energy spent throughout the crash event was constant and equaled 750 kJ. At the moment of the car departing from the barrier (vertical dashed grey lines in Fig. 20), the kinetic energy was 33.5% of the total energy; contact energy, 32.1%; and internal energy, 28.4%. After the departure of the car from the barrier, internal energy remained approximately constant. However, the kinetic energy, which mainly consisted of the kinetic energy of the vehicle, decreased because of the reduction in the speed of the vehicle owing to the frictional forces between the tires and the ground. This, in turn, causes an increase in the contact energy. The hourglass energy (black dotted line) was at a low level in relation to the other components of the energy, which satisfied the criteria included in the report (“PN-EN 16303:2020. Road restraint systems - Validation and verification process for the use of virtual testing in crash testing against vehicle restraint system,” 2020).

Here, Fig. 20-b shows the amount of absorbed energy owing to the deformation and damage to the parts of the barrier and vehicle. The posts, hooks, cables, soil, and vehicle were considered. In the first phase of the impact, to the moment of working width occurrence ( $t = 0.30$  s), most of the impact energy was absorbed by the posts (54.9 kJ) and the cables (45.6 kJ). After the maximum lateral deflection of the cables was reached, the vehicle began to be pushed back onto the road, and the wire ropes began to return part of the absorbed energy to the vehicle. At the moment of departure of the car from the barrier, the posts absorbed 36.6% of the total absorbed energy (the average amount of absorbed energy by one damaged post was 6 kJ); the car, 21.5%; the cables, 20.4%; the soil, 8.2%; and the hooks, 2.4%. After leaving the barrier, only the internal energy of the car increased.
