# Analysis of the state of preservation the historic arcaded houses in Vistula Delta listed in the National Inventory of Historical Monuments

**Abstract:** Historic arcaded houses are part of the material heritage of the Vistula Delta. Unfortunately, their number is decreasing year by year. The article is the result of a query of available sources and field research carried out by the author in 2015-2020. The paper presents the current state of preservation the historic arcaded houses in Vistula Delta listed in the National Inventory of Historical Monuments. Criteria for the selection of test objects are described. The author has prepared a tabular list of arcaded houses with information about their location, type according to Kloepfel statistics, date of construction, technical condition and functions. The summary of the analysis are pie charts with a statistical presentation of the data collected by the author during the research.

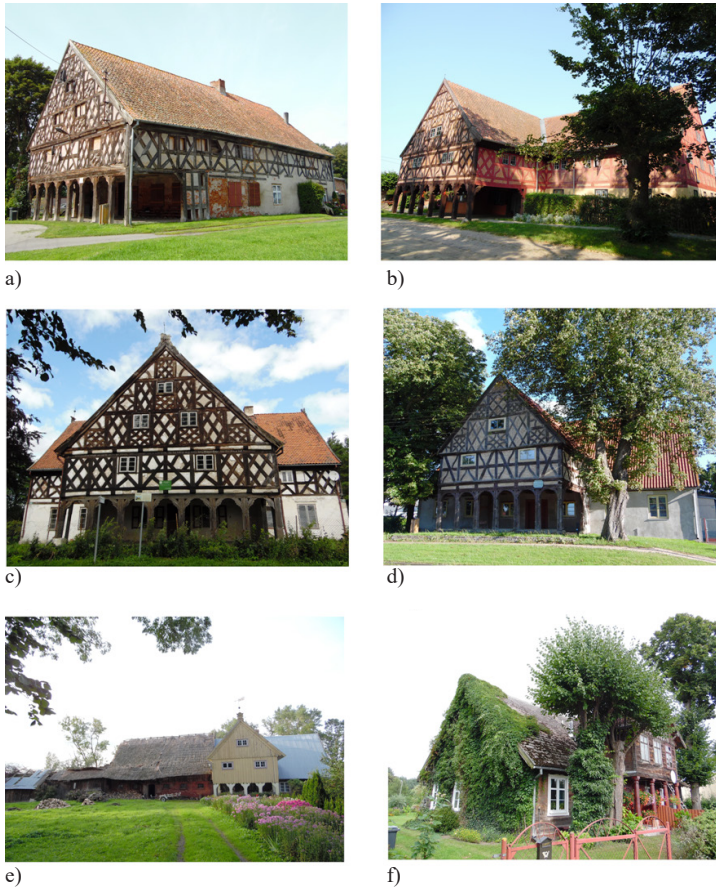
Fig. 1. Types of arcaded houses: a) type I house in Klecie, b) type II house in Trutnowy, c) type II-III house in Stalewo no.14, d) type III house in Koszwały, e) type III house in Markusy, f) type III house in Mikoszewo no. 68 (photo by the author)

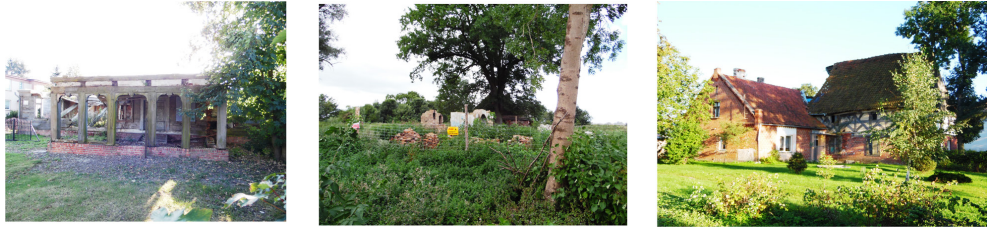
houses in Lasowice Małe (Fig. 2a)<sup>21</sup>, Kławki (Fig. 2b)<sup>22</sup> and Świerki (Fig. 2c)<sup>23</sup>. The list of historical monuments (as of 2015) also includes an arcaded house in Złotów, which burned down in 2014<sup>24</sup>.

Fig. 2. Destruction of arcaded houses: a) Lasowice Małe, b) Kławki, c) Świerki (*photo by the author*)

<sup>21</sup> The house is in ruins. Only part of the ground floor of the building has survived (as of 2016).

<sup>22</sup> The house was demolished, in 2016 there was only a chimney.

<sup>23</sup> The house is partially destroyed (1/3 of the roof collapsed).

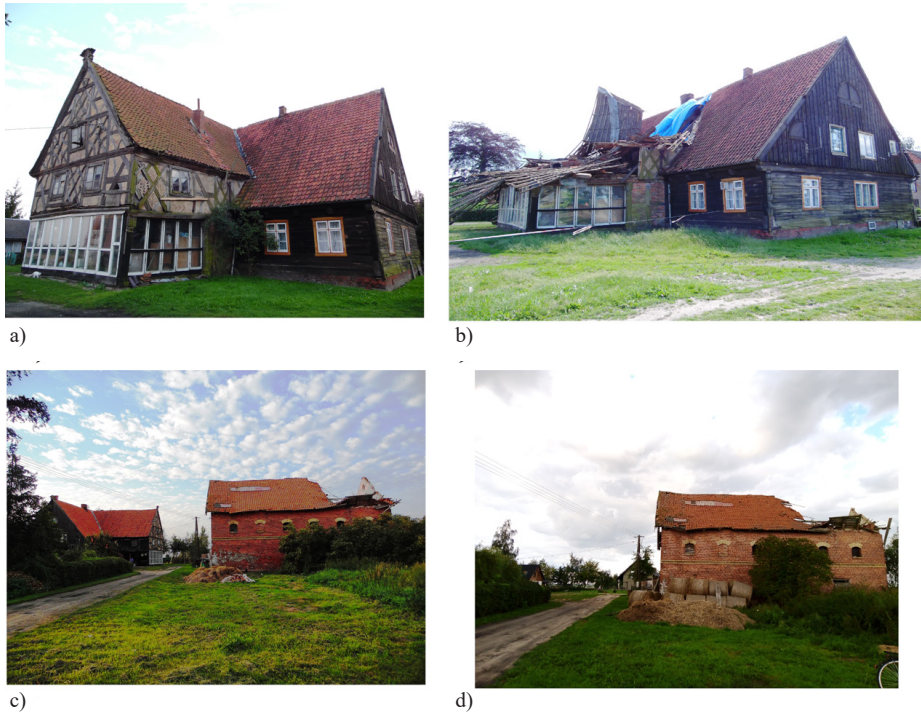
During five years of research, the state of preservation decreased by one monument (Fig. 3a). In 2017, the house in Izbiska from 1778 was completely destroyed<sup>25</sup>. In May 2017, as a result of a strong wind, the arcade collapsed (Fig. 3b), in November 2017 the house burned down. No attempt was made to rebuild it (Fig. 3c, d)<sup>26</sup>.

<sup>25</sup> In 2016, the author measured the geometry of the break as well as the height and cross-sections of the columns.

<sup>26</sup> In 2020, only the foundations of the house and construction rubble from its demolition are left.

Fig. 3. Destruction of the arcaded house in Izbiska: a) August 2016, b) June 2017, c) view of the farm – August 2016, d) view of the farm – September 2020 (*photo by the author*)

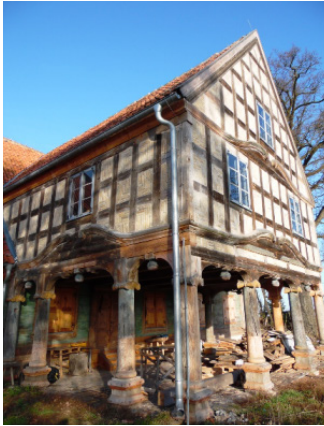
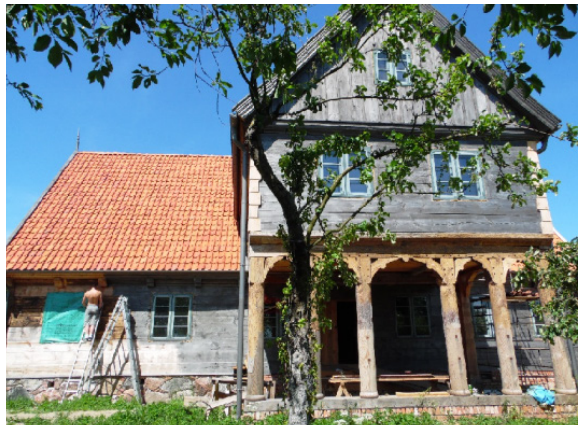
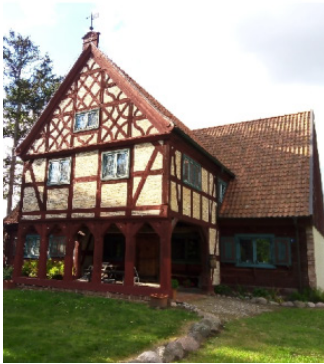
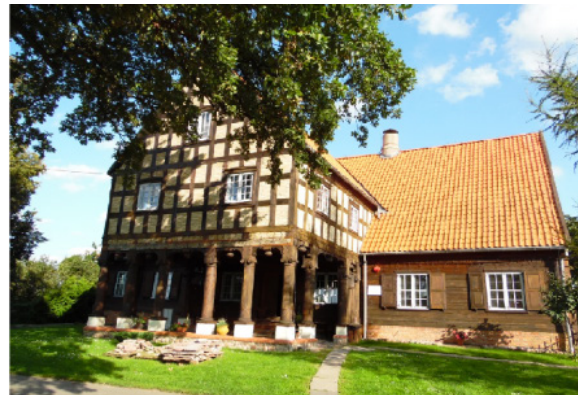
Fig. 5. Arcaded houses in: a) Orłowo no. 66, during construction and conservation works in 2015, b) Miko-szewo no. 55, during construction and conservation works in 2017, c) Przemysław no. 4, d) Marynowy no. 19 / 19a (photo by the author)
