Anisotropy and compaction gradient assessment on rammed earth specimens through sonic tomography approach

J.D. Rodríguez-Mariscal ^a, M. Zielińska ^b, M. Rucka ^c, M. Solís ^{a,*}

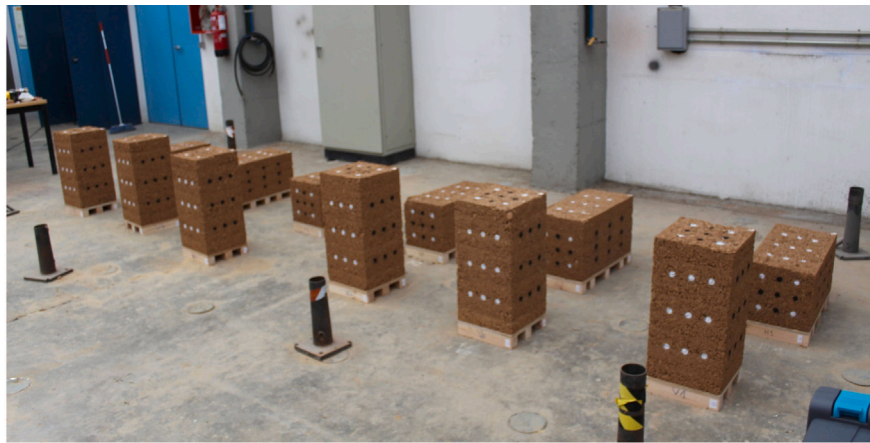
Fig. 2. (a) Specimens on their position after manufacturing. (b,c) Dimensions, sides numbers, and measuring points of vertical (b) and horizontal (c) specimens at their position during the compression and sonic tests. (d) Picture of the experimental set-up.

The sonic tests were performed before any load was applied on each specimen and after the loading–unloading cycles were applied as explained in the compression tests description. Nine measurement points were distributed in a Top row (T1, T2, T3), Middle row (M1, M2, M3) and Bottom row (B1, B2, B3) as illustrated in Fig. 2(b) and

(c). The excitation points were located in front of the receiver points at the opposite side. The SWPV between each point on the excitation face and the 9 reception points on the opposite face were determined. Even though measuring points seem to be located precisely at layer interfaces in Fig. 2(b) and (c), it must be noted that layer heights after manufacturing were not precisely 75 mm, the size of the accelerometers base is relatively big (15 mm diameter) and location of manual impacts have an implicit uncertainty in their precise location. As a result, it
