APPLICATION OF THE CORROSION TESTER IN CORROSION TESTS USING THE ACOUSTIC EMISSION METHOD

Gdansk University of Technology, Poland

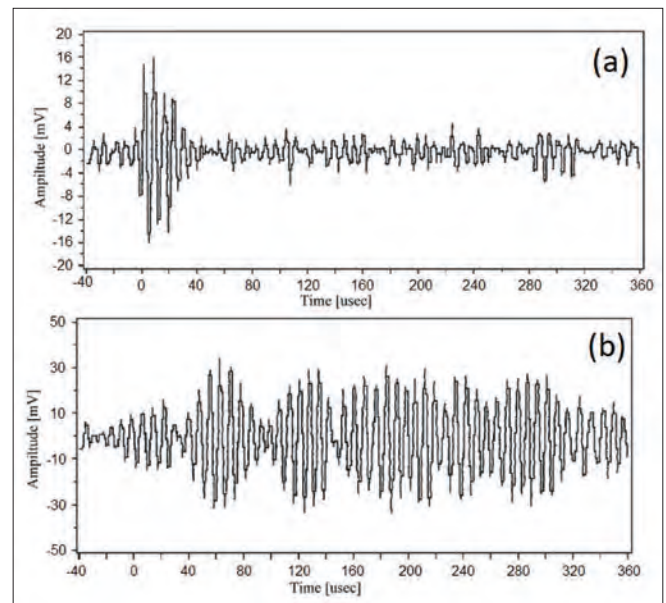
Fig. 1. Run of (a) short wave, (b) reflected wave [26].

of the released internal energy. A wave formed in this way (Fig. 1(a) and Fig. 1(b)) is registered by the acoustic sensor. In the case of pitting corrosion monitoring, events arise from cracks in the passive layer that form on the surface of the corrosive metal. The events that become the source of wave emissions may be low-energy or high-energy events and determine the progress of pitting formation.

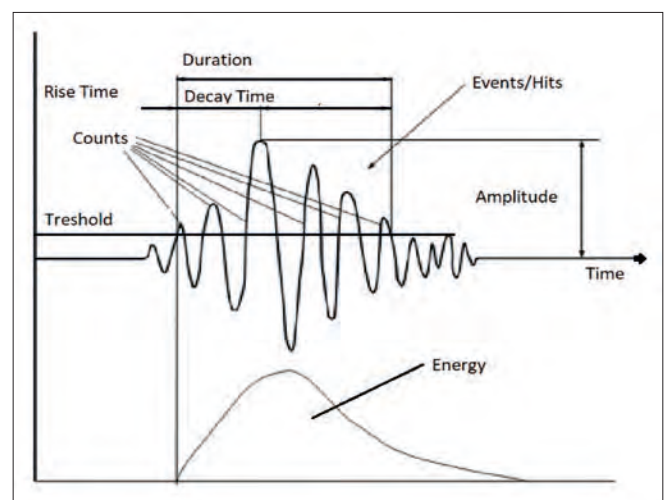
Fig. 2. A single acoustic emission signal [17].

The acoustic emission signal is characterised by such parameters as: energy, amplitude, number of crossings of the discrimination threshold, rise time and duration of the acoustic signal (Fig. 2).

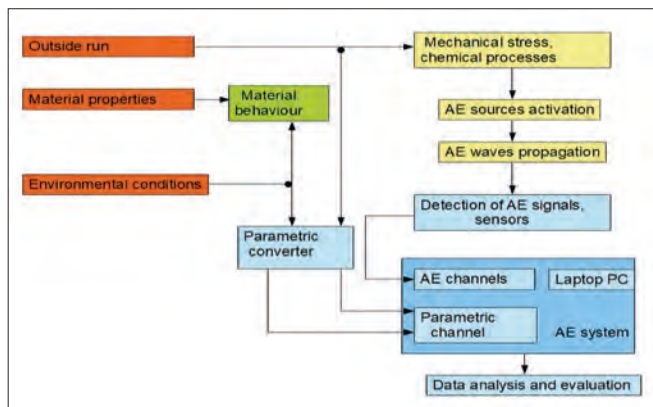
Fig. 3. Diagram showing the acoustic emission system in operation.

The diagram of the acoustic emission test is shown in Fig. 3. Because of the AE system software, it is possible to visualise the registered measurement data in real time. When several sensors are used, with appropriate software algorithms, it is possible to locate the energy source of the acoustic emission

on the basis of the difference in the time the wave reaches individual sensors.

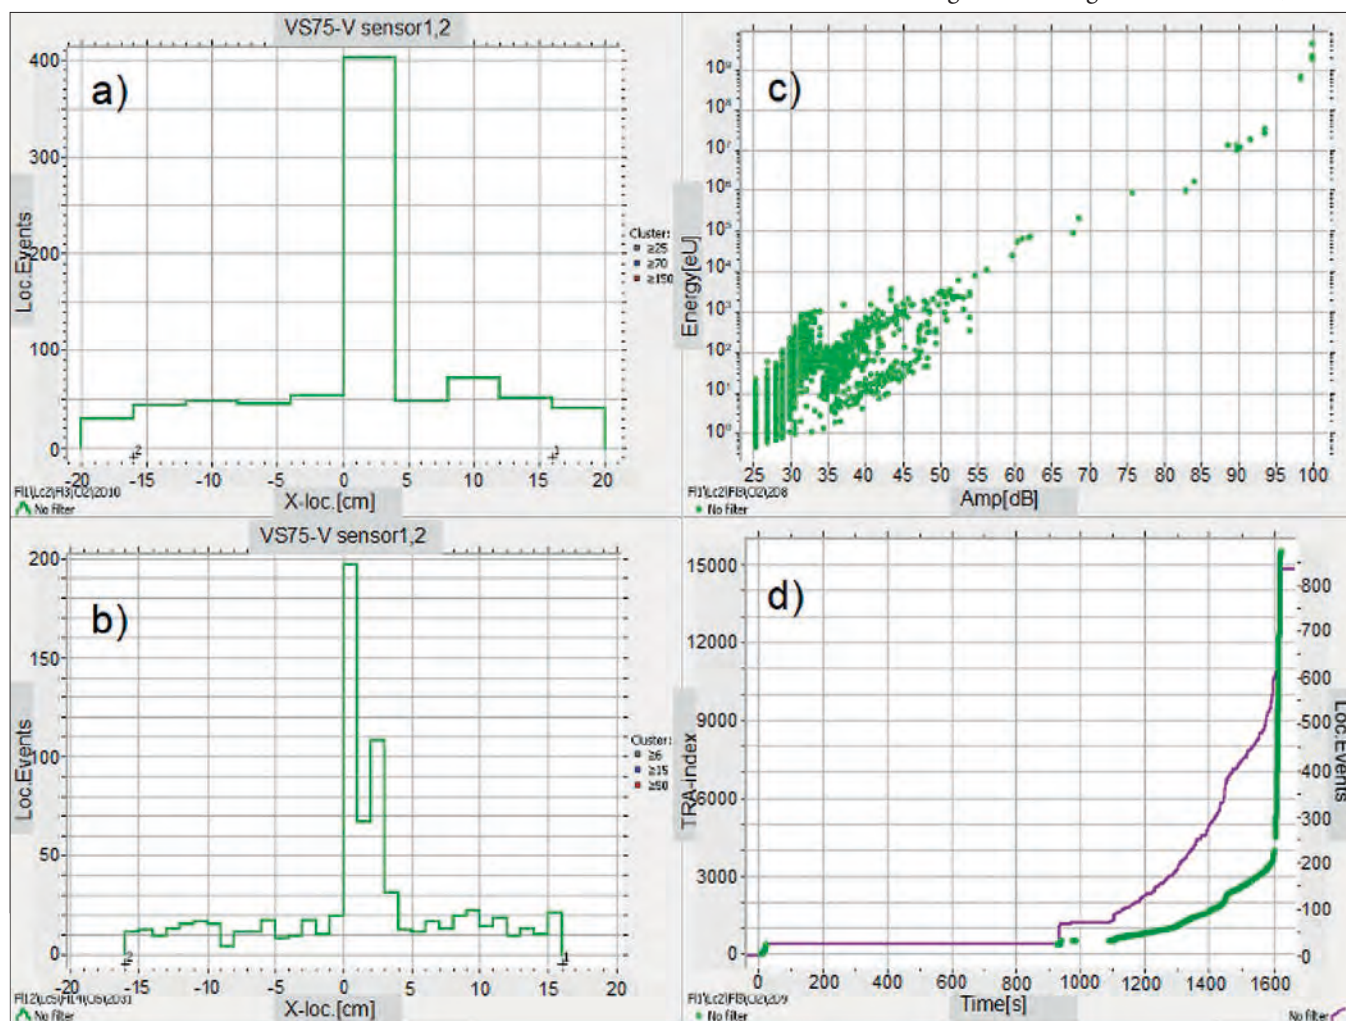
Fig. 7 The KE-2 corrosion tester and its background detectability for VS 75-V sensors, a), b) - the relationship between the location of the tester in relation to the sensors and the number of events recorded by the system, c) the dependence of the signal amplitude given in decibels (dB) to the released energy, d) graph of the measurement time and the number of events.

Before the acoustic test itself, all components of the corrosion tester were well cleaned. After removing all impurities, the reaction cylinder and stopper were degreased with ethyl alcohol. Then, the corrosion processes in the tester were initiated, commencing with flooding the tester reaction tank with the corrosive solution (Table 1) to 1/3 of its volume. After placing and mounting the tester in the tank (Fig. 4) and connecting the VS150 RIC and VS75 sensors with preamplifiers, the AMSY-5 acoustic emission system was activated and the recording of the acoustic signal was started. The signal recording from the moment of flooding to its completion was about 30 minutes. The results of this measurement are presented in Fig. 7 and Fig. 8.

The presented test results prove the possibility of continuous detection of acoustic signals from the corrosion tester. It gives a stable and clear 50 dB signal that stands out clearly from the rest of the acoustic background during the measurement, which

fluctuates around 20-30 dB, as shown in the graphs (Fig. 7c and 8c). This is a similar result to that found by [25], which is characteristic for the amplitude of the signal originating from corrosion occurring in steels in seawater. The corrosion signal obtained in the laboratory during corrosion tests also corresponds to the amplitude of the signal obtained during further tests carried out on real objects [26]. It can be observed that the tester is visible against the background noise coming from the laboratory. A clearly visible increase in energy in the places where the acoustic sensors of both VS75-V and VS150-RIC are attached, can also be observed. This proves not only the possibility of detecting the signal coming from the corrosion tester, but also the possibility of its partial localisation, which is very well illustrated in the graphs in Fig. 7a, 7b, 8a and 8b.

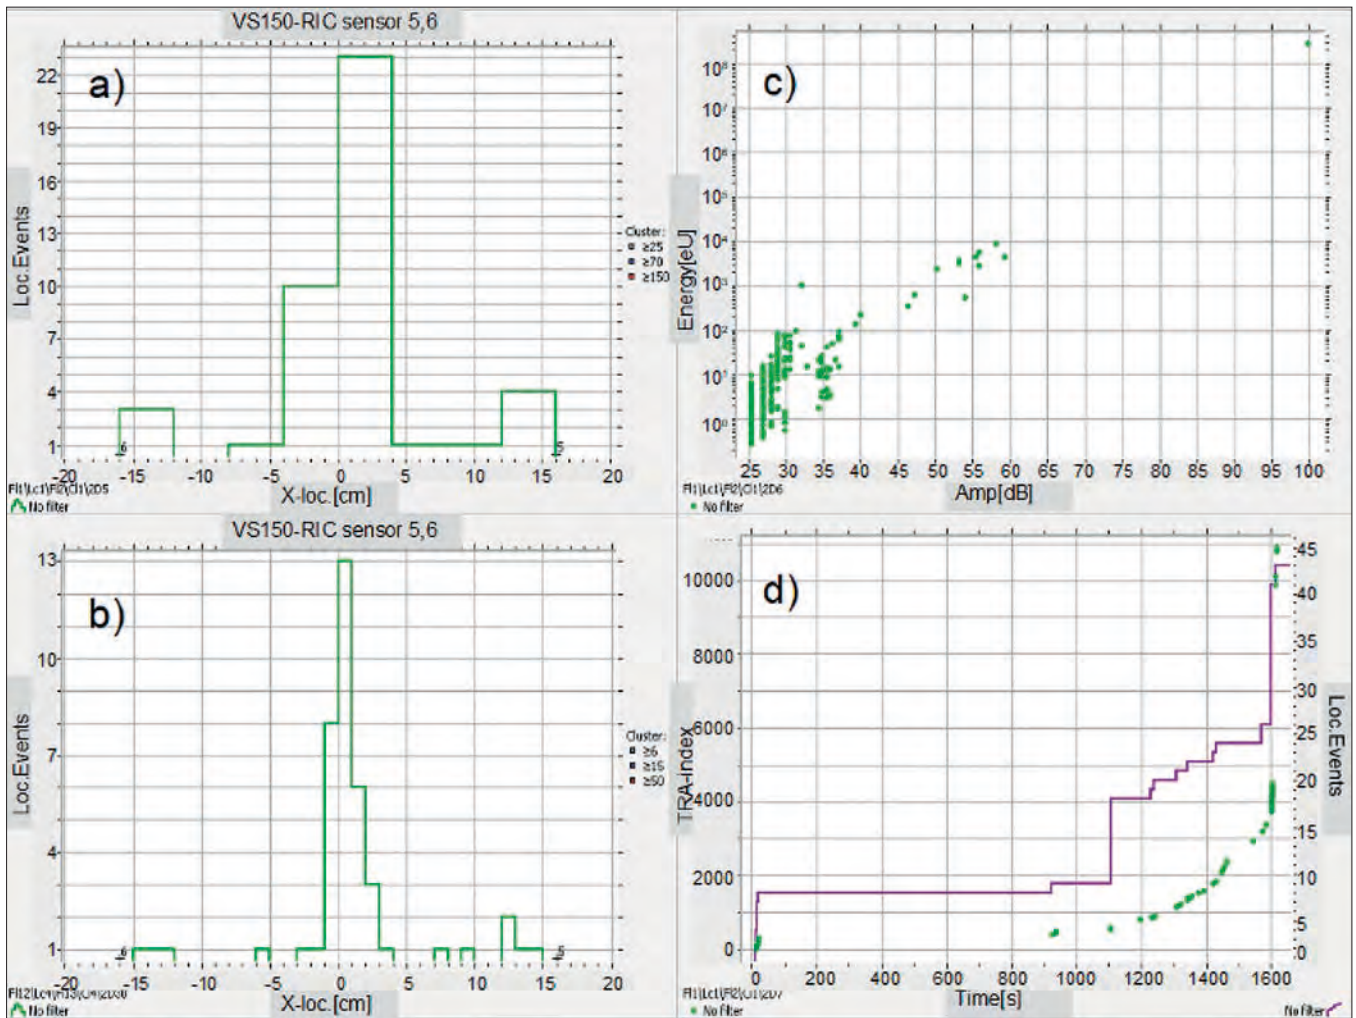
Fig. 8. The KE-2 corrosion tester and its detectability for VS150-RIC sensors. a), b). dependence between the location of the tester in relation to the sensors and the number of events recorded by the system, c) dependence of the signal amplitude in decibels (dB) to the released energy, d) dependence of the measurement time of the number of events

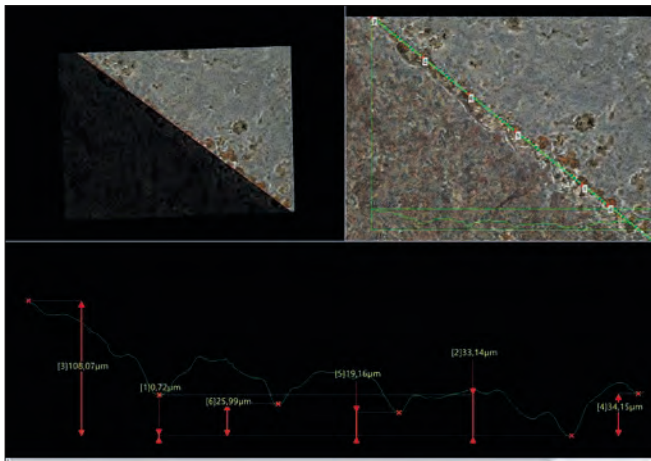
Fig. 10. The surface profile of the greatest corrosion damage observed on the surface of the plug from the reaction cylinder. As you can see in the photograph, the shape of this damage is extensive and consists of many pits connected with both. The deepest corrosion cavity is about 110 μm deep and the smallest is about 0.32 μm .

Figures 9 and 10 present the results of metallographic testing of the plug covering the tester's reaction cylinder. The profile of the plug's surface shows extensive corrosion damage along the cross-section up to a certain point. Once that is exceeded,

the damage that occurs is very small. This is due to the way the corrosion tester is attached to the tank during the test. After careful examination of the photographs, a distinct line can be seen between the corrosive solution and the air trapped in the rest of the tester's reaction cylinder (Fig. 10).
