Review Papers

Can Historic Interiors with Large Cubature
be Turned Acoustically Correct?Tadeusz KAMISIŃSKI⁽¹⁾, Andrzej KULOWSKI⁽²⁾, Roman KINASH⁽³⁾

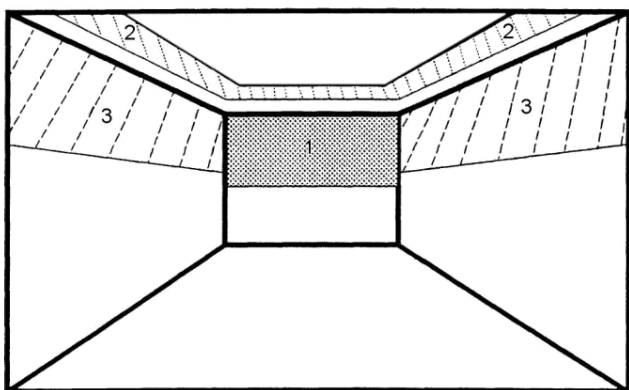
Fig. 3. The recommended sequence in which the sound-absorbing materials should be applied, in the order corresponding to increasing effect on the room acoustics: 1 – rear wall; 2 – ceiling portions bordering to walls, 3 – upper portions of side walls (KULOWSKI, 2011; FASOLD, WINKLER, 1976).

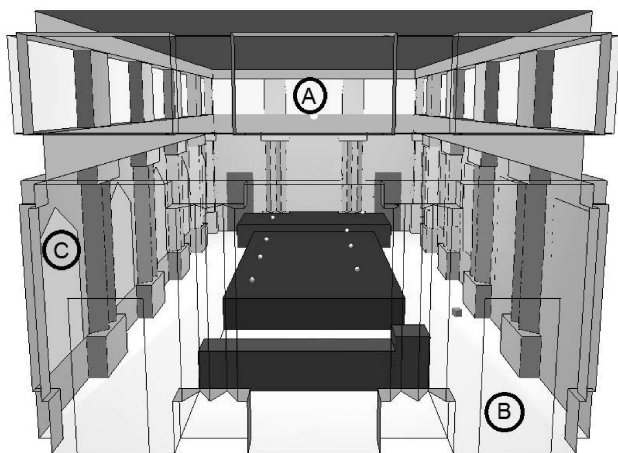
Fig. 4. The Assembly Hall model developed in CATT-Acoustic with arrangement of sound-absorbing materials listed in Table 1.

A graphical representation of the model used to simulate the hall in CATT-Acoustic programming environment is shown in Fig. 4. The model was developed with geometrical dimensions of the hall taken into account together with sound absorption and diffusion coefficients characterizing the existing finishing materials and furniture (4 long tables, a lectern, and 160 upholstered chairs). The model has been calibrated based on the measured reverberation time values.

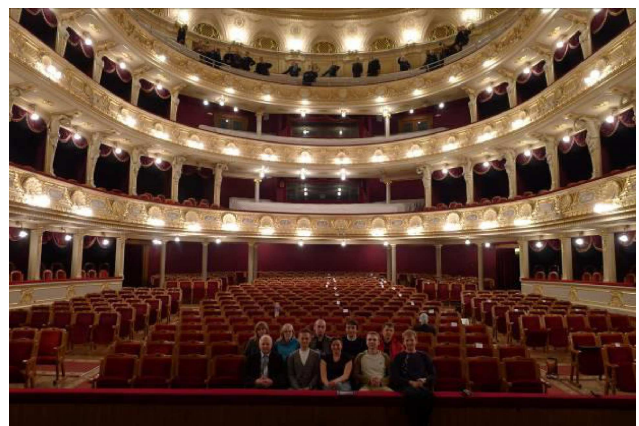
Fig. 7. A view of the Lviv Opera House hall.

The hall has a horseshoe-shaped layout typical for opera houses, with level floor in the stalls and rows of boxes situated on the semicircular wall (Fig. 7). An acoustically difficult element in rooms of this specific shape are concave underbalcony cavities situated along the rear wall in the stalls. In case of walls being finished with hard materials, such as plaster or wallpaper put up on a hard substrate, the sound reflected from the rear wall focuses in the rear part of the audience area which is considered an important acoustic flaw of any room. At some point in time, the user decided to soundproof the rear wall (Fig. 8) which was also unfortunate because of excessive sound damping in the higher frequency range observed in the last two rows of seats.

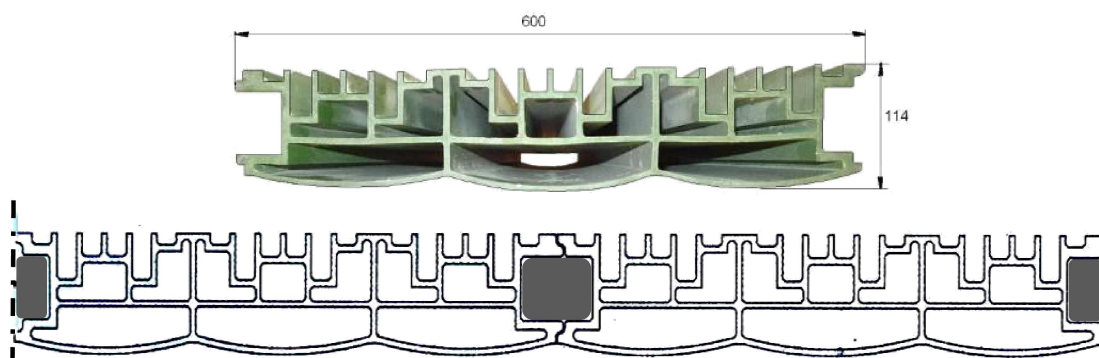
Fig. 9. A cross-section of the sound diffusers (dimensions in mm). The material and manufacturing process is protected as an industrial design (Community Designs Bulletin, 2012).

Schroeder diffusers are usually constructed by craftsmen in the course of interior finishing work or are offered in short series by specialized manufacturers. A solution concerning both the material and technological process used to fabricate the diffuser elements on an industrial scale has been patented in the European Union as an industrial design (Fig. 9). The diffuser has a form of a pressing continuously extruded out of a composite based on epoxy resin (EPD) filled with wood dust. The system is mounted on 60 mm × 60 mm posts inserted into holes provided in the diffuser’s structure.

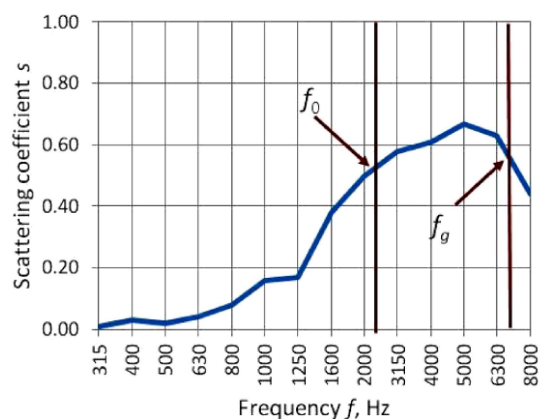
Fig. 10. The sound scattering coefficient s for the diffuser of Fig. 9 obtained from acoustics measurements (third-octave resolution, frequency range 314–8000 Hz). f_0 and f_g are the lower and the higher sound diffusion limiting frequencies, respectively. It is assumed that sound diffusion occurs at frequencies above $0.5 f_0$ (KAMISIŃSKI *et al.*, 2012b).

as the ratio of the sound energy reflected in the diffused way to the total reflected sound energy. Values of the coefficient s depend strongly on the sound frequency (Fig. 10). The frequency range $[f_0, f_g]$ within which the sound diffusion is particularly effective is a derivative of the sequence of wells constituting the structure. The sequence, i.e. the number of wells per cycle, their width, and depth, is determined by an algorithm developed by MANFRED SCHROEDER (1975). The lower limiting frequency f_0 is related to maximum depth of the wells. The value adopted in the present case (2234 Hz) followed from technological limitations and the fact that for deep wells, the diffuser is characterized with high absorption coefficient at low frequencies (KAMISIŃSKI *et al.*, 2012a).

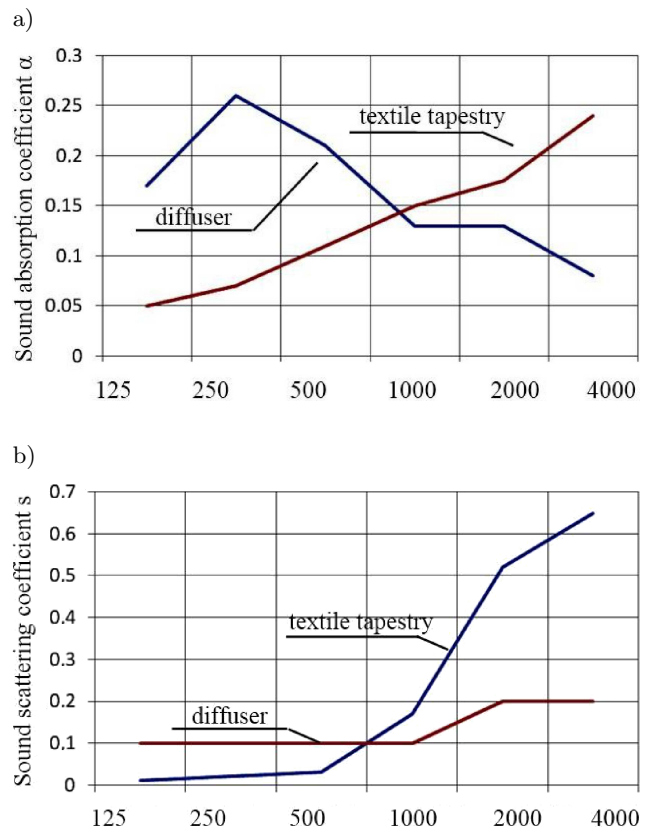
Fig. 11. Acoustic parameters of the textile tapestry and the diffuser of Fig. 9 used in computer simulation (octave resolution, frequency range 125–4000 Hz): a) sound absorption coefficient α , b) sound scattering coefficient s (KAMISIŃSKI *et al.*, 2012b).

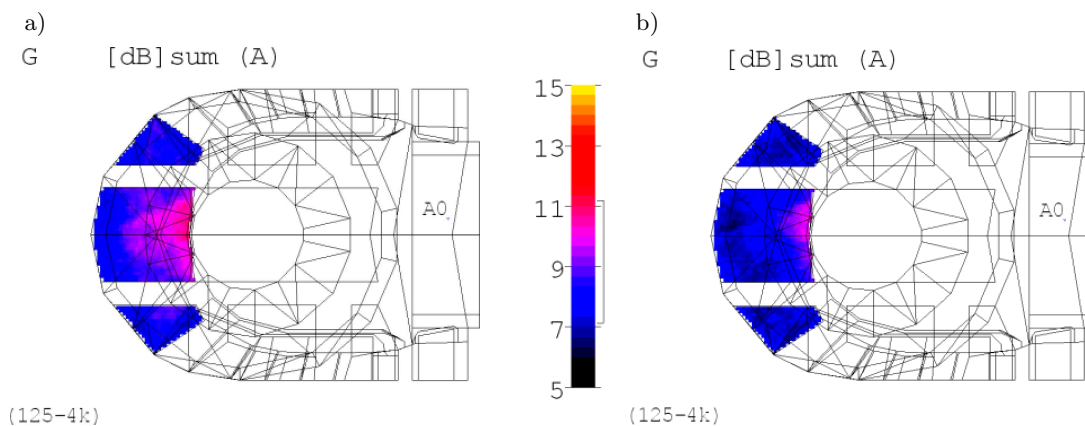
Fig. 12. The forecasted distribution of G values in the underbalcony area for the rear wall covered with: a) textile tapestry, b) sound diffuser.

smooth and hard rear wall with a sound scattering structure, distribution of the parameter became significantly more even (Fig. 12). The effect is particularly prominent for frequencies above 1 kHz, as in this very range, the sound absorption introduced by the diffuser is lower, while the scattering effect is stronger (Fig. 11). Even more favorable is the forecasted change in the clarity factor C_{80} (Fig. 13). This is especially

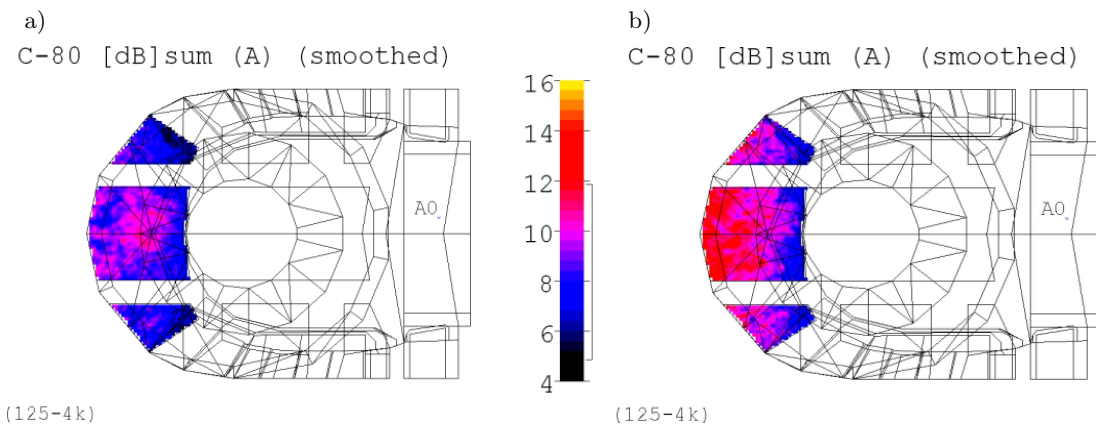
Fig. 13. The forecasted distribution of C_{80} values in the underbalcony area for the rear wall covered with: a) textile tapestry, b) sound diffuser.

true for the last rear rows where acoustic deficiencies were most uncomfortable. In this area, C_{80} increases by as much as 5 dB, and what is more, distribution of this increased value remains even in the whole underbalcony zone. In view of the complex measurement procedure (ISO 17497-1, ISO 17497-2), sound scattering coefficients are rarely published. Graphs shown in Fig. 11 a come from the authors' own measurements (KAMIŃSKI *et al.*, 2012b), while scattering coefficients of other materials have been adopted as suggested in the instructions for the program CATT-Acoustic.

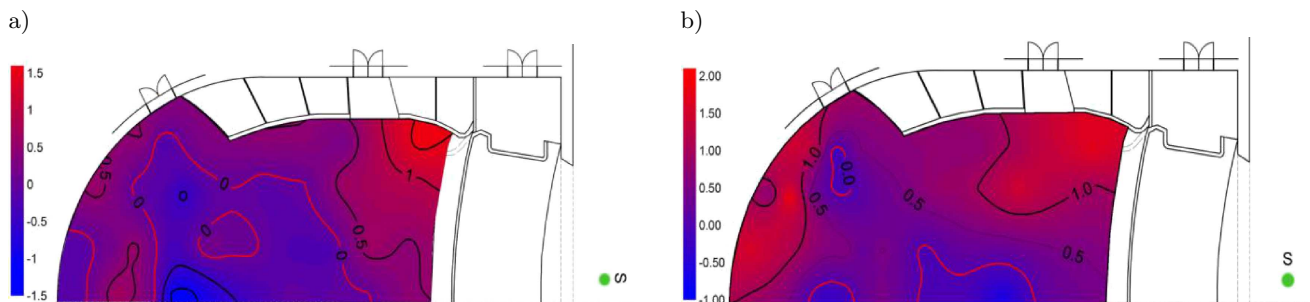
Fig. 14. The effect of mounting the diffusers on the sound strength G in octave bands: (a) 0.5–1 kHz and (b) 4 kHz.

the whole impulse response decay period (cf. Fig. 15a and 14b, respectively). This means that the impression of sound strength in the auditorium and the parameter G corresponding to sensation related to this quantity is created in the initial stage of formation of the impulse response. The observation is consistent with the generally accepted regularity concerning enhanced response of the human ear to early high-energy sound reflections.

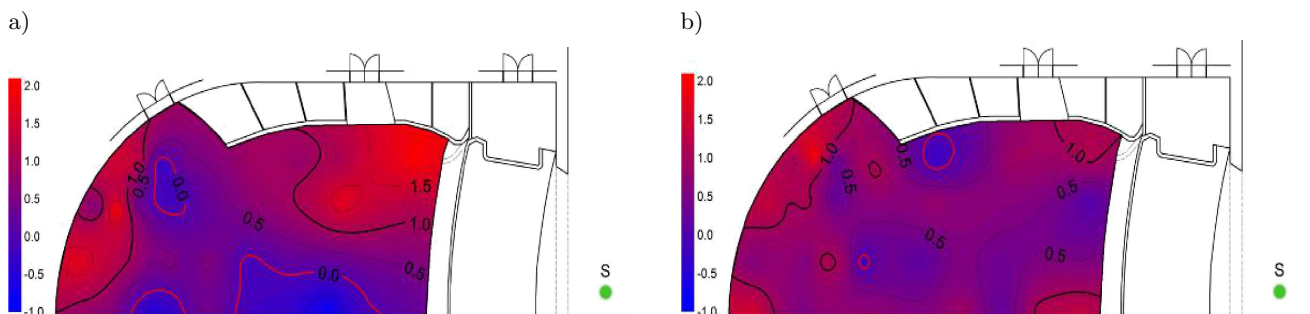
Fig. 15. The effect of mounting the diffusers on the sound strength G : a) $G_{80 \text{ ms}, 4k}$ and b) $G_{\text{Late}, 4k}$.

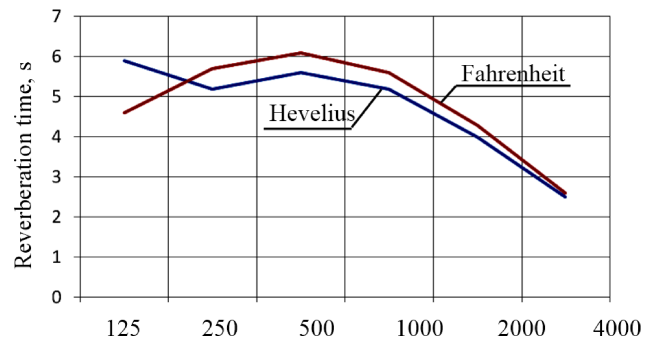
Fig. 21. Reverberation time of the courtyards after textural plaster renovation and face brick cleaning (July 2007).

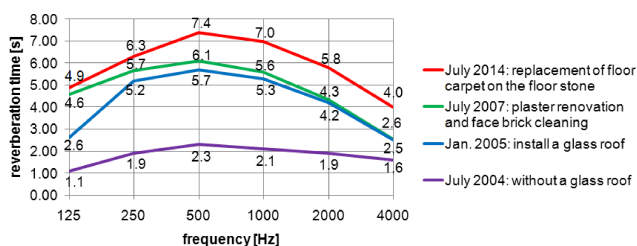
Fig. 23. The Fahrenheit Courtyard reverberation time after successive renovation stages.

The original acoustics of the courtyards was characterized with a short reverberation time (cf. Fig. 23, the lowest curve). The original acoustics of the courtyards was distinguished with a short reverberation time and high degree of sound diffusion. This followed from diversified structure of the brick elevation with significantly resolved stone decorations and resulted in good speech intelligibility. Such characteristics was favorable from the point of view of the functional program of the courtyards despite exposition of the space to the elements.

als are intended mainly for outdoor applications, such repairs result in further deterioration of acoustic conditions prevailing in the courtyards. For instant, the recent stage of renovation included laying a stone floor (Fig. 22) which was the cause of further increase of the reverberation time, as the stone, alike the glass used for the roofing, is a material reflecting virtually the whole of incident acoustic energy. After subsequent work stages, the reverberation time increased gradually and from the initial 2.5 s, it increased up to the current 7.5 s, whereas the value recommended for the official functional program of the interiors should not exceed 2.0–2.5 s (Fig. 23).

where $T_0 \approx 7.0$ s is the currently observed reverberation time (cf. Fig. 23), and ΔA is the acoustic absorptivity increase relating to application of the foil, value of which can be calculated as
