Cavitation behaviour of the SUPERSTON alloy after laser treatment

ABSTRACT

Purpose: Results of laser treatment at cryogenic conditions and its influence on microstructure, microhardness and cavitation resistance of the SUPERSTON alloy are presented in this paper.

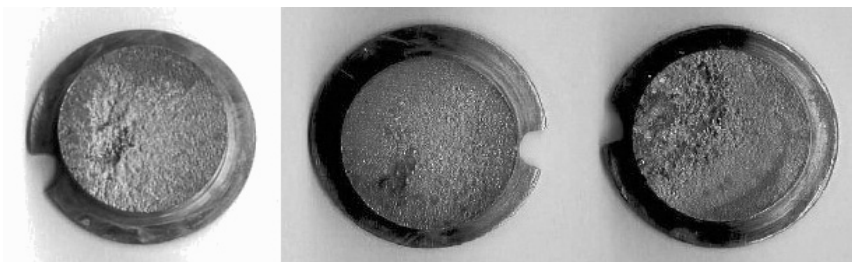
Fig. 9. Surface of the SUPERSTON alloy after cavitation test by 5.25h: a) 4000W, 0.5m/min; b) 4000W, 1.0m/min; c) base material - as casting

View of the base material and laser remelted specimens made of the SUEPRESTON alloy after cavitation test is shown in Fig. 9.
