# Combination of terrestrial laser scanning and UAV photogrammetry for 3D modelling and degradation assessment of heritage building based on a lighting analysis: case study—St. Adalbert Church in Gdansk, Poland

The construction of the St. Adalbert Church in Gdansk dates to 1310. It is a church of rich history and great historical value, and its care is challenging. In this study, the combination of unmanned aerial vehicle (UAV) photogrammetry and terrestrial laser scanning (TLS) was used to accurately build a 3D model of the church. Together with the collected historical inventory documentation, the historic building information model (HBIM) was generated. The Autodesk-Revit<sup>®</sup> tool was used for this purpose. On the basis of the generated model, the reflection properties of the laser scanner beam and red–green–blue (RGB) images, a methodology was proposed for analysing the degradation of the church's components. The main hypothesis of this study is based on the analysis of sunlight outside the church. In addition to the importance of the method for determining the risks of church degradation, a high-quality method for model visualization combining two photogrammetric tech

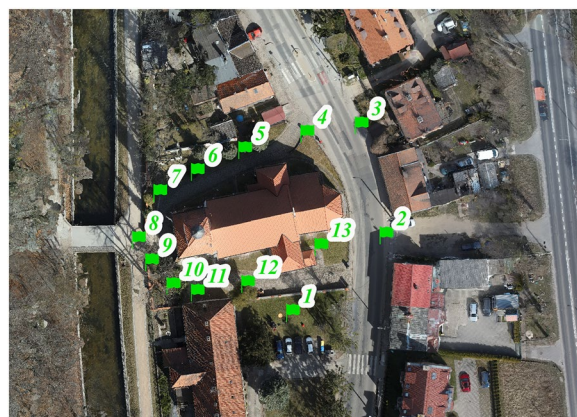
**Fig. 4** Scan positions location

In order to present the possibilities of using the laser scanner more broadly, we have presented the location of the scanner positions during the measurements in Fig. 4. According to the Fig. 4, scan positions around the church are numbered from 1 to 13. Additional scan positions from 14 to 20 were located inside the church. Denser distribution of scanner positions around the tower was

because the scanner was located in close proximity to the church. This was for two reasons: first, to combine the scans recorded outside and inside the church, we needed to have as many common elements as possible to minimize an alignment error. Second, we used the beam reflection intensity for our analyses. Due to the fact that its value also depends on the angle, the type of material, its colour and humidity, we didn't want the angle of a laser beam to be perpendicular to the church (which has the effect of too high intensity value saturation) or too large (where the laser beam won't be able to return to the scanner).

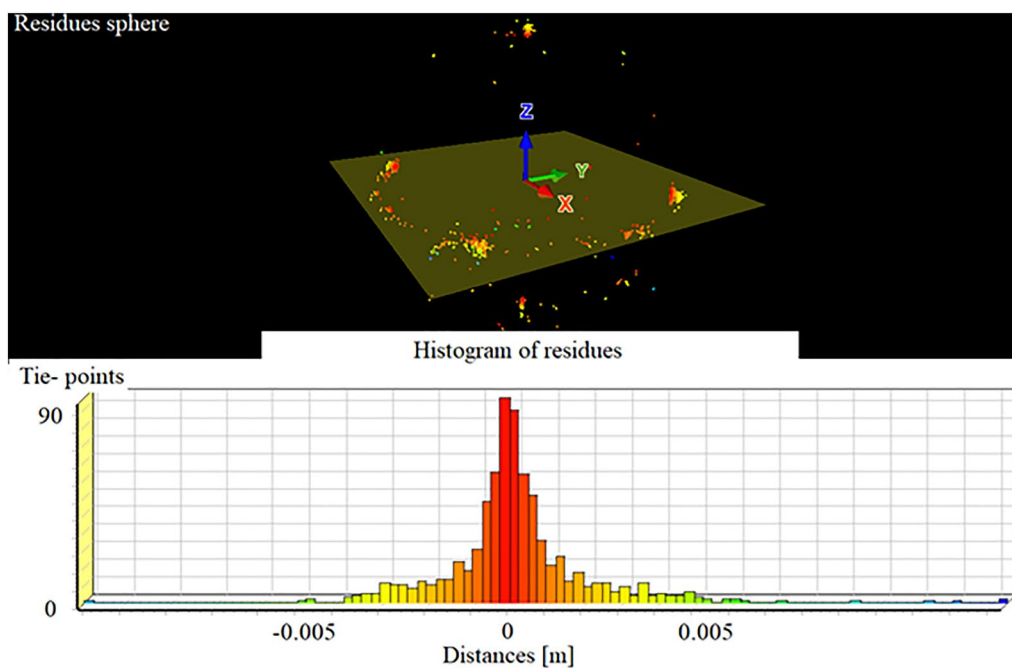
**Fig. 5** TLS Alignment results as a histogram of residues between tie-points

individual scanner positions to each other) as accurately as possible. Moreover, as in the case of UAV oblique photogrammetry, manual and automatic filtered tie-points were used to align the data to the same coordinate system (ETRS89/Poland CS2000 zone 6 (EPSG: 2177) and the EGM2008Geoid model). In this way, we obtained two photogrammetric models in relatively close proximity. The registration process was performed in RiSCAN PRO<sup>®</sup> software. This process was based on corresponding tie-points (created automatically or indicated manually). To minimize alignment errors, RiSCAN PRO<sup>®</sup> has a plugin function called "Multi-Station Adjustment" (MSA). The main functionality of MSA is to improve the registration of scan positions. For that purpose, the external position of each scan position was modified to calculate the best overall fit for them. The alignment results are shown in Fig. 5 as a histogram of the residues of the tie-points and an error sphere.
