Effect of Thermal Treatment and Erosion Aggressiveness on Resistance of S235JR Steel to Cavitation and Slurry

Alicja K. Krella ^{1,*}, Dominika E. Zakrzewska ¹, Marta H. Buszko ¹ and Artur Marchewicz ¹

Institute of Fluid Flow Machinery PAS, Fiszerka 14, Gdańsk, Poland; dzakrzewska@imp.gda.pl (D.E.Z.); mbuszko@imp.gda.pl (M.H.B.); artur.marchewicz@imp.gda.pl (A.M.)

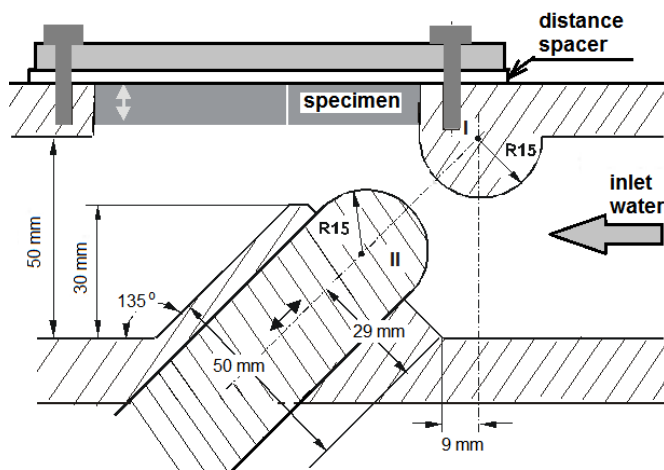
Figure 1. Scheme of the cavitation tunnel.

In order to investigate the effect of cavitation intensity on the erosion process, four tests were carried out using a cavitation tunnel equipped with a system of barricades. The scheme of the cavitation tunnel is shown in Figure 1 and it has been described by Krella et al. [18]. As a working fluid tap water with a temperature of 20 ± 2 °C was used. The intensity of cavitation is governed by the fluid flow rate, which is controlled by the inlet and outlet pressures, which in turn are regulated by the inlet and outlet valves. Flow speed was measured using a portable ultrasonic flowmeter Fluxus® model ADM 6725 (FLEXIM, Edgewood, NY, US) with a measurement accuracy of $\pm 0.5\%$ of the measured value. In the presented investigations, the water flow velocities were 35 m/s, 37.9 m/s, 40.5 m/s, and 43 m/s in the slot between the barricades. The total duration of the test was 600 min.

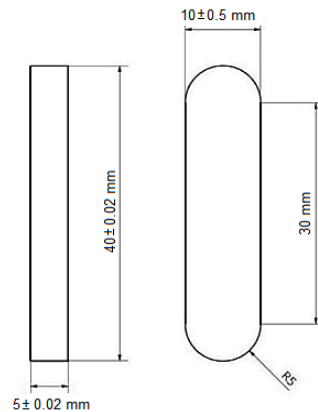
Figure 4. The shape and dimensions of a specimen for slurry erosion tests.

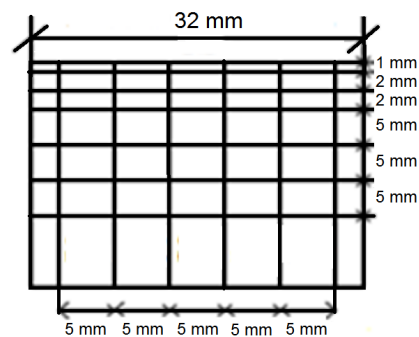
Figure 5. The scheme of the network for surface roughness measurements.

The distributions of surface roughness along the network shown in Figure 5 that developed during the entire cavitation erosion tests are shown in Figures 12 and 13, respectively for S235JR-AR and S235JR-TT steel. In order to show the effect of flow conditions on the roughness, the same maximum Ra value was used in the color bar despite the different maximum Ra values. During the slurry test, the entire surface of the specimens was uniformly eroded, so five measurements of the Ra parameter were taken after each exposure. The development of the Ra surface roughness parameter is shown in Figure 14.

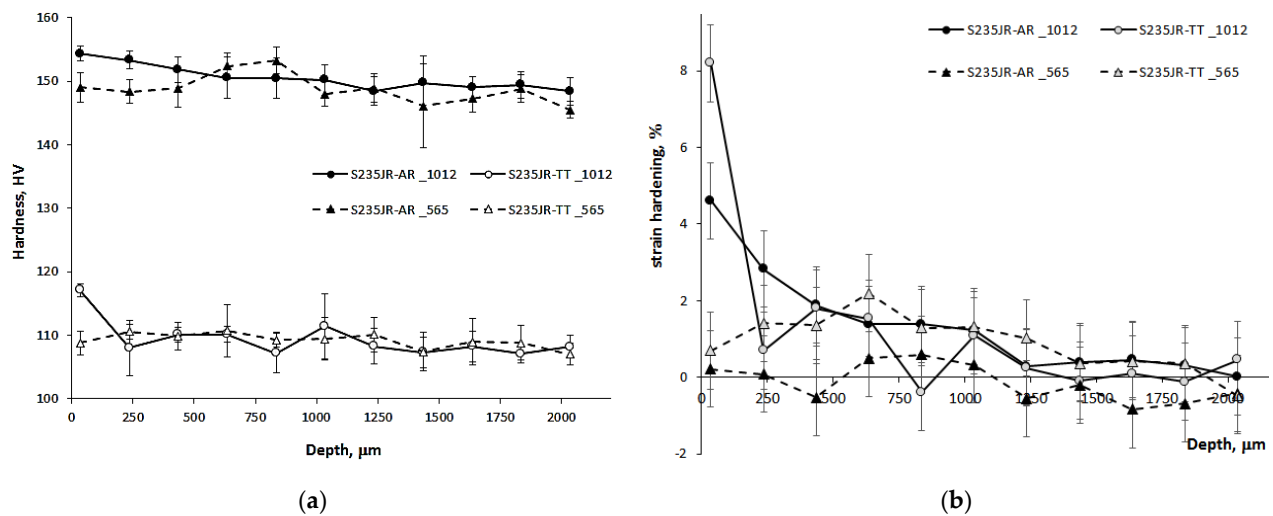
Figure 11. Hardness (a) and strain hardening effect (b) along the specimen depth caused by slurry

In the case of the slurry erosion tests performed at the highest rotational speed of 1012 rpm, the hardness of the as-received steel and the thermally treated steel increased to about 159 HV and 120 HV at a depth of 35 μm (Figure 11a). Thus, the strain hardening effect was about 5% and 8%, respectively (Figure 11b). This indicates that a higher strain hardening effect was obtained for the thermally treated steel, which had lower initial hardness. This effect was in opposition to that obtained during cavitation erosion tests at the flow velocity of 43 m/s. Moreover, the strain hardening of the as-received steel was much lower than that obtained in cavitation erosion tests, while the thermally treated steel was comparable to that obtained in cavitation erosion tests (Figure 10b). The depth of strain hardening was about 1800 μm and 1400 μm , respectively. However, the biggest decrease in strain hardening occurred at a distance of about 200 μm (from 8.2% at 35 μm to 0.7% at 235 μm). These depths are much smaller than those obtained in cavitation tests (about 4 mm). This indicates the different degradation mechanism. In cavitation erosion, cavitation pulses impact the surface with a wide range of amplitudes, from a few kPa to GPa. In slurry erosion, all erodents impact with comparable energy, so the dispersion of impact energy is small. Due to the high rotational speed, which influenced the high impact velocity, the impact energy is used mainly on the initiation and development of cracks, resulting in a significant mass loss and less strain hardening than in the case of cavitation erosion, where low energy impacts also occurred.

In the case of tests carried out at the lowest slurry erosion intensity, i.e., at a rotational speed of 565 rpm, the hardness of the S235JR-AR steel at a depth of 35 μm was about 152 HV. It means that the hardness increase did not occur. All changes in hardness oscillated around the initial value. In the case of S235JR-TT steel, the impacts of solid

particles caused a slight increase in hardness to about 112 HV at a depth of 35 μm . The strain hardening effect was about 1%. The highest hardness (113.4 HV) was obtained at a depth of 635 μm . This makes that strain hardening increased to 2.2%. Then, hardness decreased to an initial value that was reached at a depth of about 1800 μm . Thus, the depth of strain hardening was bigger than in the tests performed at the highest rotational speed. The likely reason for this was the lower impact energy supplied by erodents to the steel surface that caused significant less mass loss and much less removal of the hardened layer.

speed increases, this interaction is likely to increase. A low depth of strain hardening at the highest rotational speeds (Figure 11) is consistent with the assumption that the particles interact with each other.

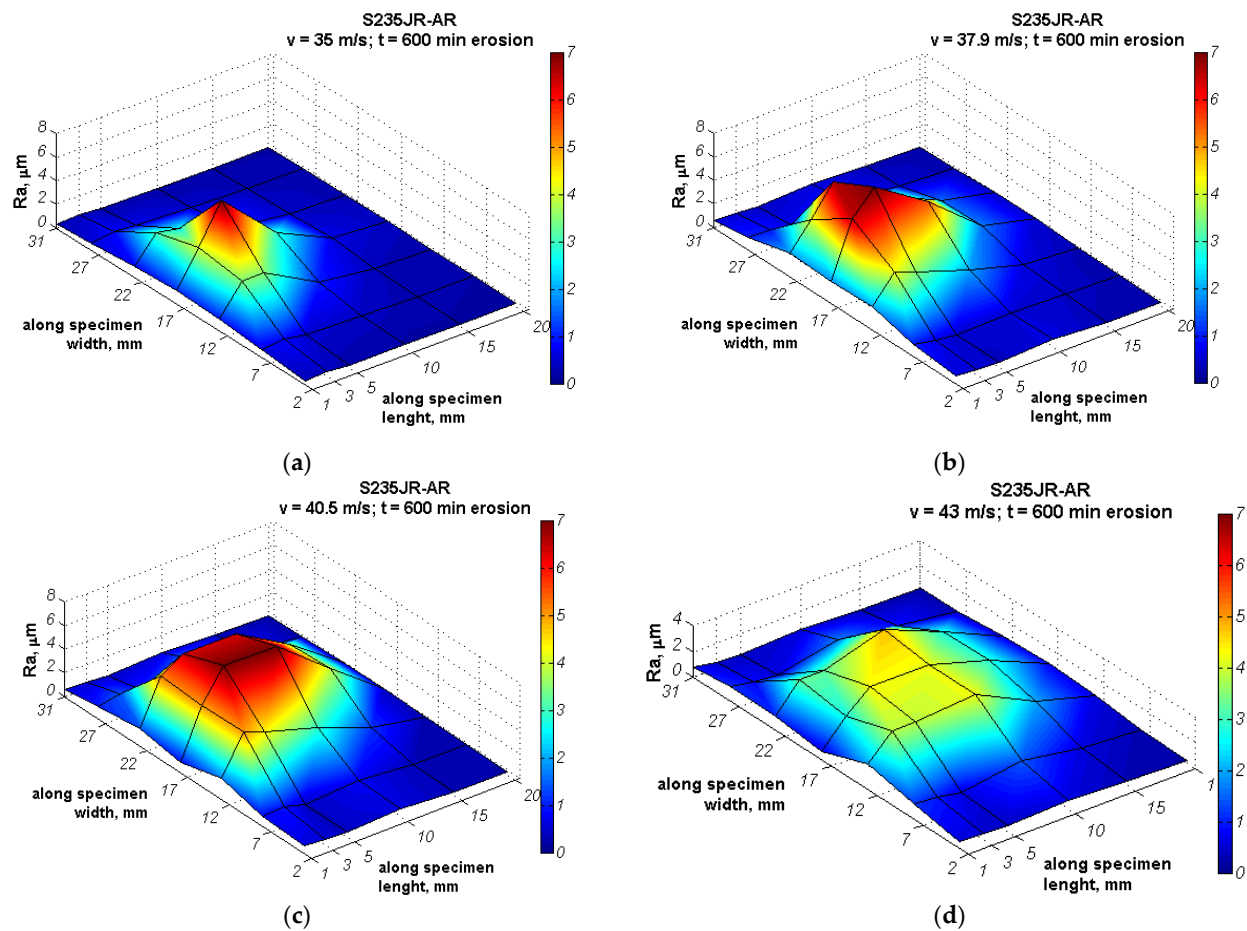
Figure 12. Distribution of the Ra parameter on the surface of the S235JR-AR steel tested for resistance to cavitation erosion at a flow velocity of (a) 35 m/s, (b) 37.9 m/s, (c) 40.5 m/s and (d) 43 m/s.

Roughness measurements of specimens tested in cavitation erosion tests revealed areas of high roughness $Ra > 5 \mu\text{m}$ that are at approximately half the width of the

specimens close to the upper barricade (Figures 12 and 13), regardless of the hardness of the tested steel (steel state) and the flow velocity. With increasing flow velocity, the area with $R_a > 1 \mu\text{m}$ also increases, but it is not followed by the increase in the maximum roughness value. Also, the distribution of R_a parameters changed its character depending on the flow velocity. In the case of tests conducted at a flow velocity of 35 m/s, the maximum R_a value was $7.38 \pm 0.16 \mu\text{m}$ and $8.71 \pm 0.21 \mu\text{m}$, respectively for S235JR-AR and S235JR-TT steel. Thus, higher roughness was obtained on softer steel. The surface roughness increased rapidly to a maximum value, which was reached 5 mm from the specimen edge nearest to the upper barricade, and then decreased, regardless of the steel state. However, the rate of decrease in roughness was related to the hardness of the steel. In the case of softer steel after thermal treatment, this rate was lower. Although the maximum surface roughness had higher values, the roughness (R_a parameter) of less than $1 \mu\text{m}$ was only recorded at a distance of 20 mm from the upper barricade. Nevertheless, in both steel states, the roughness distribution formed a sharp peak.

For the tests carried out at a flow velocity of 37.9 m/s, the maximum R_a value was $8.47 \pm 0.15 \mu\text{m}$ and $11.60 \pm 0.27 \mu\text{m}$, respectively (Figures 12b and 13b). Thus, the maximum R_a value increased $1 \mu\text{m}$ and nearly $3 \mu\text{m}$, respectively. Moreover, the area with $R_a > 2 \mu\text{m}$ increased significantly. The roughness peak was still obtained and located 5 mm from the upper barricade. The roughness peak was sharp in S235JR-TT steel (Figure 13b), while slight in S235JR-AR steel (Figure 12b). Moreover, the eroded surface with $R_a > 6 \mu\text{m}$ formed a large area indicating a zone of high erosion level.

In the case of tests carried out at a flow velocity of 43 m/s, surface roughness decreased even more (Figures 12d and 13d). The maximum Ra values were $4.31 \pm 0.11 \mu\text{m}$ and $5.48 \pm 0.12 \mu\text{m}$, respectively. Thus, the Ra parameter decreased by nearly $3.5 \mu\text{m}$ and $4 \mu\text{m}$, respectively. Besides, the Ra parameters were lower than those obtained in the tests carried out at the lowest flow velocity. This decrease was caused by the effect of overlapping damages. The surface with the highest surface roughness formed a large, flattened area with a comparable erosion level. The conducted tests showed that the steel of lower hardness was characterized by higher roughness regardless of the flow velocity. This is in agreement with the mass losses and erosion rates.

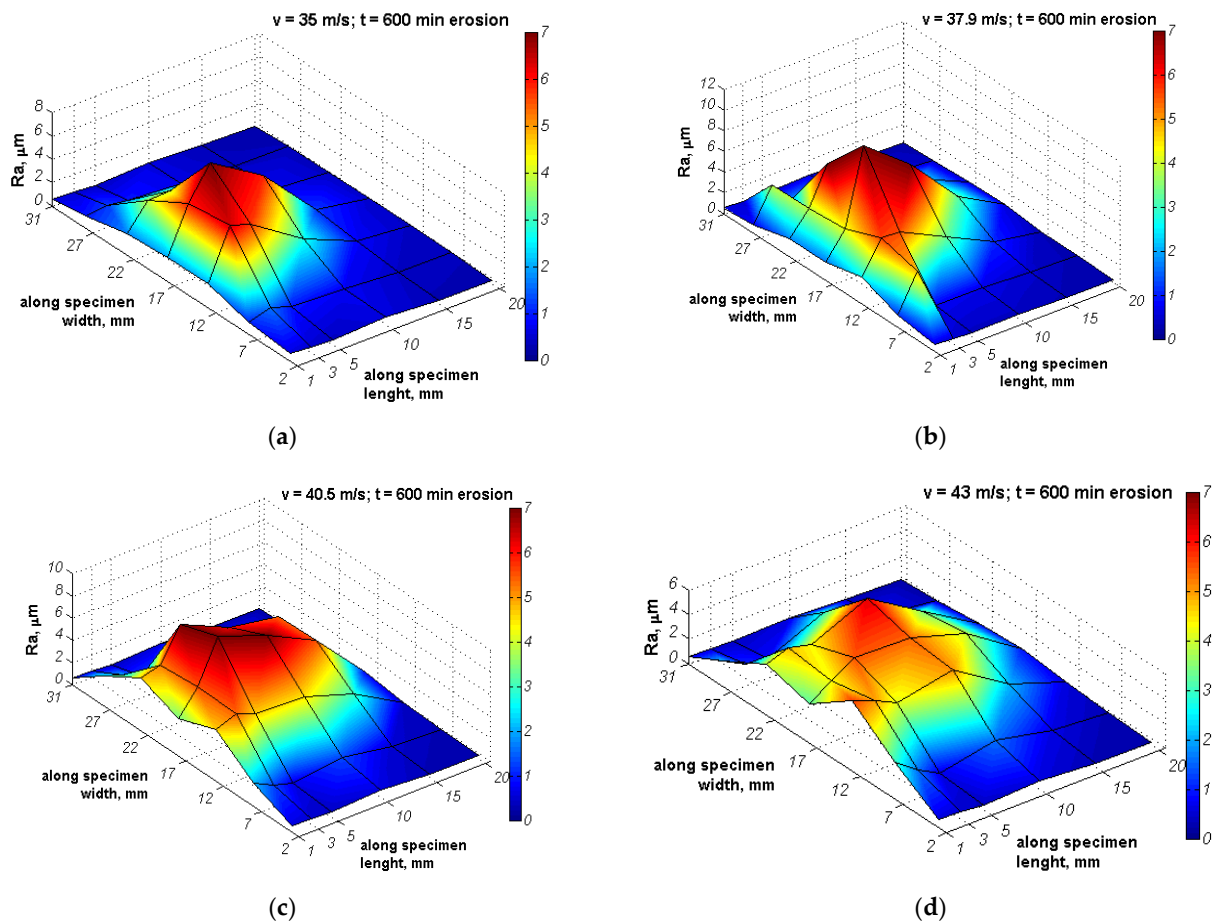
Figure 13. Distribution of the R_a parameter on the surface of the S235JR-TT steel tested for resistance to cavitation erosion at a flow velocity of (a) 35 m/s, (b) 37.9 m/s, (c) 40.5 m/s and (d) 43 m/s.

A further increase in a flow velocity to 40.5 m/s caused an increase in the area with $Ra > 2 \mu\text{m}$. However, the roughness values lowered concerning those obtained at a flow velocity of 37.9 m/s. The maximum Ra values of S235JR-AR and S235JR-TT steel were $7.71 \pm 0.19 \mu\text{m}$ and $9.38 \pm 0.28 \mu\text{m}$, respectively. Thus, the maximum Ra value decreased by nearly $0.8 \mu\text{m}$ and over $2 \mu\text{m}$, respectively. Considering that with increasing flow velocity the mass loss also increased (Figure 6), a decrease in surface roughness was caused likely by overlapping damages. However, the surface with $Ra > 6 \mu\text{m}$ increased without any roughness peaks indicating a comparable erosion level.

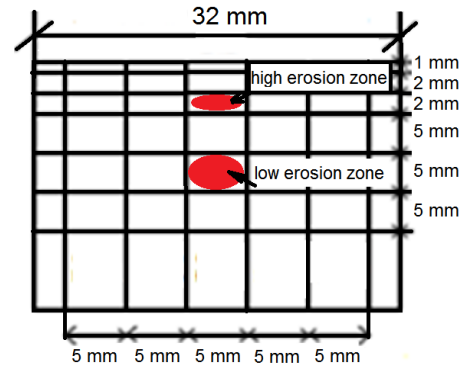
Figure 15. The observation areas of damage developed on the surface of S235JR steel during cavitation erosion tests.

Based on the roughness measurements, the zones of low and high erosion in cavitation tests were determined and showed in Figure 15. The surface damages of the S235JR-AR and S235JR-TT steels developed during tests performed at the lowest (35 m/s) and highest (43 m/s) flow velocity in these zones are shown in Figures 16 and 17, respectively.

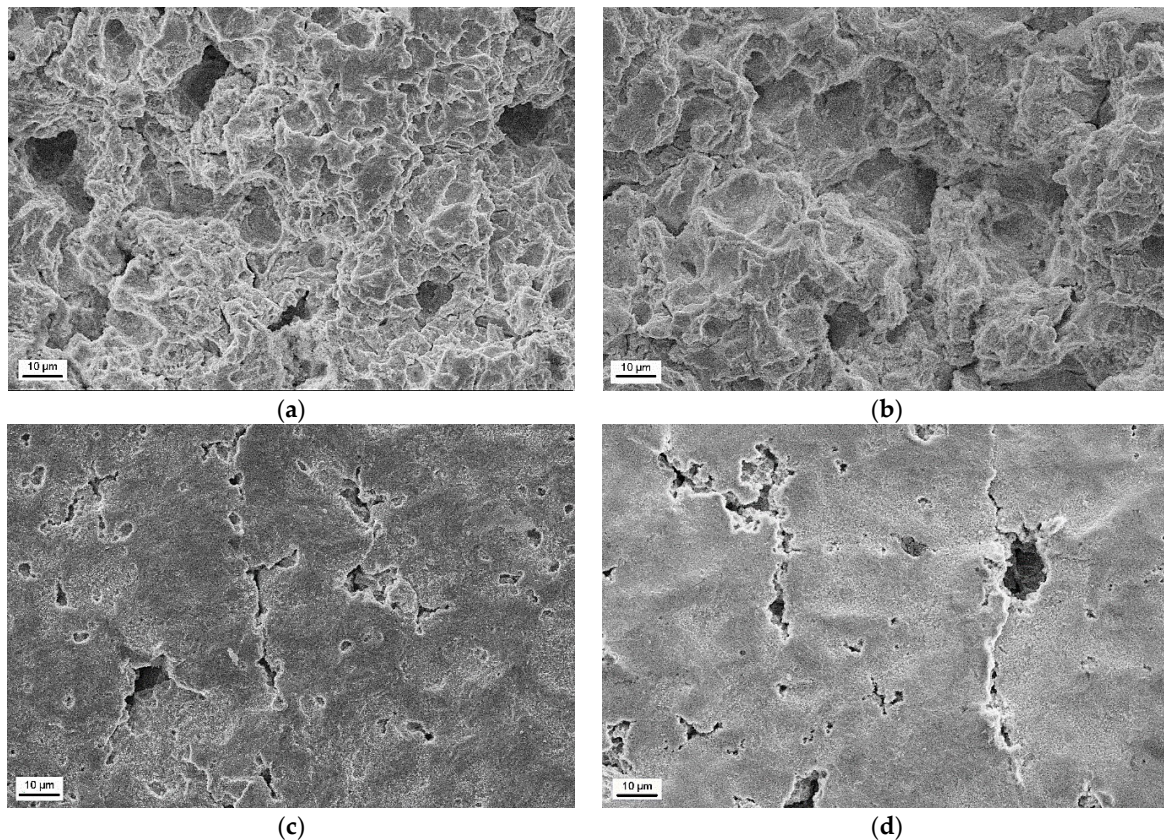
Figure 17. Surface damages developed during cavitation erosion tests carried out at a flow velocity of 43 m/s in the high erosion zone of (a) S235JR-AR steel and (b) S235JR-TT steel, and in the low erosion zone of (c) S235JR-AR steel and (d) S235JR-TT steel.

Damages on the surface of S235JR-AR and S235JR-TT steel in the strongly eroded zone and tested at a flow velocity of 43 m/s also have the form of ductile cracks, cavitation pits/tunnels and voids (Figure 17a,b). Thus, all these failures are typical of this steel and this erosion process. Nevertheless, the intensity of cavitation affected the number and width of the cracks, which are much narrower than those observed at a flow rate of 35 m/s. The diameter of some pits/cavitation tunnels in hard S235JR-AR steel ranges from about $10 \mu\text{m}$ to $20 \mu\text{m}$ (Figure 17a), but such pits are not seen in soft

S235JR-TT steel (Figure 17b). It is related to the hardness of the steel and the mass losses. Taking into account the greater loss of mass on the S235JR-TT steel in the cavitation test, the most likely reason for the lack of such pitting is the removal of such a heavily damaged surface layer. On the other hand, the damage size of the steel as received is smaller than that of thermal-treated steel, which is consistent with the hardness measurements (Figure 10). Also, more severe damage developed during tests with a flow velocity of 35 m/s is consistent with the hardness measurements. Moreover, the observation of the degree of destruction of S235JR steel in both states is consistent with the roughness measurements (Figures 12 and 13).

In the case of the low erosion zone (Figure 17c,d), the damage is mainly in the form of pitting, but several cracks and surface undulation are also observed. The cracks are likely developed along the grain boundaries. The length and width of cracks, as well as the size of pits, are much bigger for the thermal-treated steel. The pits were caused by shearing due to the impacts of high-velocity micro-jets. The bigger size of pits indicates that this steel is more susceptible to such impacts. However, damage density is much bigger for steel in the as-received state. The lower size of pits and cracks length are connected with a higher hardness of this steel.

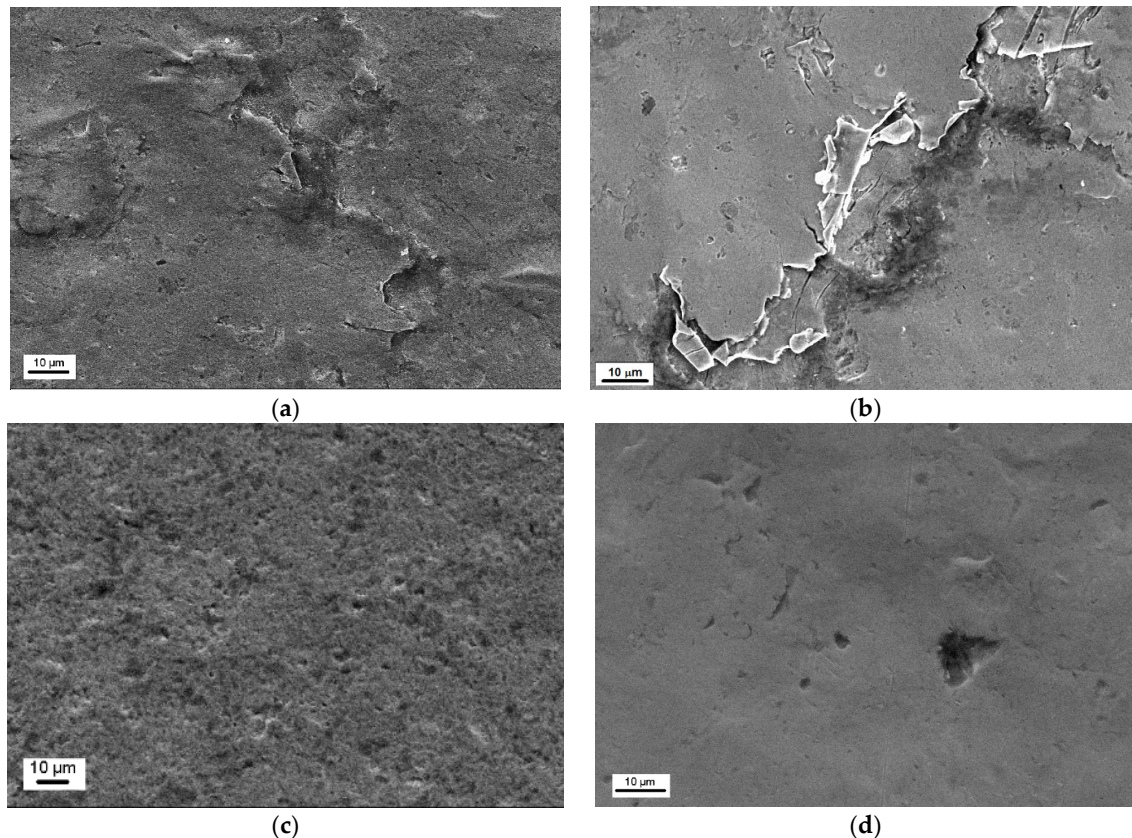
Figure 18. Surface damages developed during slurry erosion tests carried out at a rotational speed of 1012 rpm in (a) S235JR-AR steel and (b) S235JR-TT steel, and at a rotational speed of 565 rpm in (c) S235JR-AR steel and (d) S235JR-TT steel.

The damage from slurry erosion testing is completely different (Figure 18). In the case of tests carried out at a rotational speed of 1012 rpm (Figure 18a,b), flaking and undulation of the surface are visible, regardless of the steel state. There are also some tiny and shallow pits. The surface is much less degraded concerning that developed in cavitation tests (Figures 16 and 17). The level of surface degradation is consistent with the roughness results (Figure 14). Also, damage developed at a rotational speed of 565 rpm

degradation is consistent with the roughness results (Figure 14). As shown in Figure 18c,d, the surface of S235JR-AR steel is slightly undulated, similar to the surface of the thermal-treated steel. However, the undulation of the latter (Figure 18d) seems to be bigger. Yet, the surface looks much smoother. There is no flaking, but pits and short cracks. The number and size of pits depend on the steel state. In the case of the as-received state, pits are much smaller, but their number is much bigger than on the surface of S235JR-TT steel (Figure 18c,d). The pit seen in Figure 18d was likely due to steel removal and not shearing as with cavitation erosion.

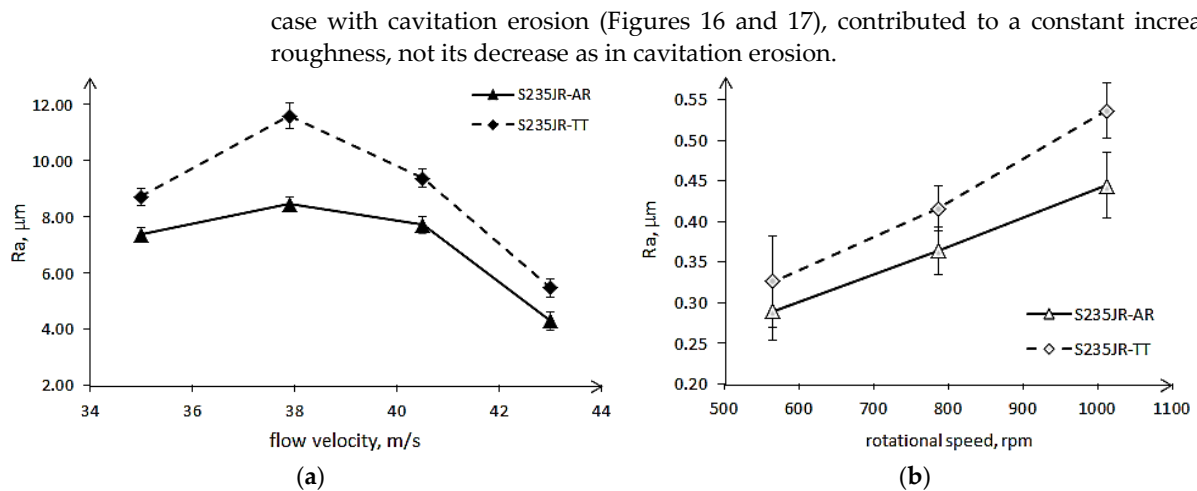
Figure 21. Correlation between (a) the maximum Ra parameter and a flow velocity in cavitation erosion tests, and (b) the mean Ra parameter and a rotational speed in slurry erosion tests.

Although erosion processes concern mainly the degradation of the material surface layer, the investigations of surface roughness development in relation to erosion intensity are not so extensive. According to Chiu et al. [38], in cavitation erosion, surface roughness (Ra parameter) increases up to limit value that is related to the steel grade with increasing testing time and then remains unchanged. However, Dojcinovic et al. [39] showed that the mean surface roughness Ra of ductile cast iron exposed to cavitation increases with testing time, although the rate of roughness change decreases. In the presented results, in cavitation erosion, surface roughness depends also on the cavitation intensity, i.e., flow velocity (Figures 12 and 13). Taking into account the maximum Ra parameter obtained on the exposed surface after 600 min of testing and flow velocity, the correlations shown in Figure 21 a are obtained. As shown in Figure 21a, the Ra parameter increases with increasing flow velocity from 35 m/s to 38 m/s, but for flow velocities greater than 38 m/s, a decrease in surface roughness with increasing flow velocity was obtained. This decrease was probably due to the strain hardening (Figure 10b), the intensive development of surface damage and an increase in overlapping damage (Figures 16 and 17). Regardless of the flow rate, higher roughness values were obtained for thermally treated steel, probably due to its lower hardness. Taking into account the strain hardening, the greater the increase in hardness the lower Ra parameter is observed only for cavitation erosion tests conducted at 43 m/s, but not at 35 m/s. Intense overlapping damage and intensive mass loss may cause a decrease in surface roughness. As a result, the surface roughness obtained at 43 m/s was lower than that obtained at 35 m/s.

In the case of slurry erosion tests, a linear increase in surface roughness with increasing rotational speed was obtained (Figure 21b). This correlation was independent of the steel hardness. A similar correlation was obtained by Abedini et al. [40]. As in the case of cavitation erosion, higher Ra values were obtained for thermally treated steel that had lower hardness. Besides, the difference between Ra values increased with increasing rotational speed. Taking into account the changes in hardness (Figure 11b), the steel after thermal treatment underwent greater strain hardening than the steel in the as-received state. However, the surface roughness did not follow it. This was likely caused by more intensive mass loss (Figure 8). The lack of overlapping damage (Figure 18), as was the
