## GUIDED WAVES IN SHIP STRUCTURAL HEALTH MONITORING – A FEASIBILITY STUDY

### ABSTRACT

**Keywords:** Corrosion, Guided Waves, Non-destructive Testing, Ship Structures

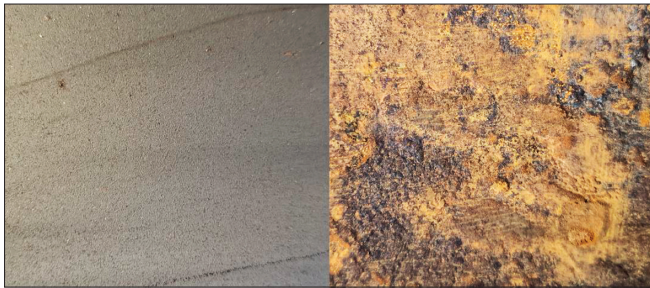
Fig. 3. Plate surface close-up. Left: intact plate. Right: c24 plate corroded and cleaned from corrosion products

Figures 3 and 4 present photos of selected specimens. Figure 3 shows a close-up view of the intact and corroded plate surface. On the intact plate, the surface was as it arrived from the steel mill. The corroded surface was dried out and so the authors removed loose corrosion products and dusted up the surface. Figure 4 presents a stiffener side view on the c12 sample, with magnifications on given parts of the plate. Apart from specimen markings, there are visible white dots on the sample, indicating places where UT gauging was performed.

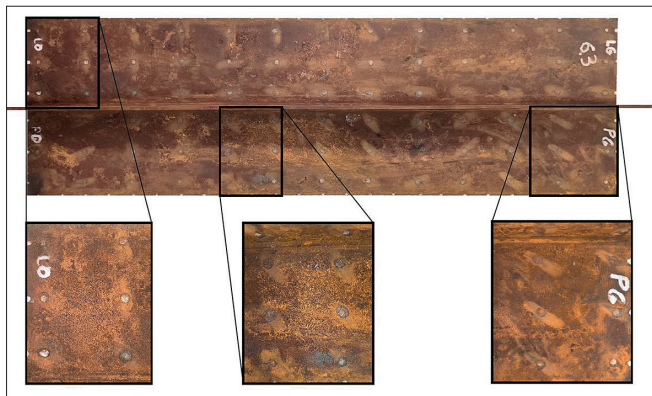
Fig. 4. Sample c12 (12% DoD): stiffener side view with close-ups of surface.

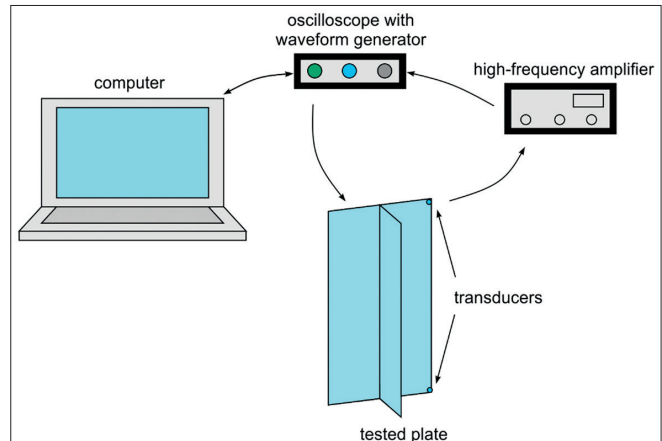
Fig. 10. Guided wave experimental set-up.

Transducers were connected to a wave generator, amplifier, and oscilloscope, as presented in Fig. 10. The signal measured from a series of the same signals was then averaged at an oscilloscope, filtered using an oscilloscope-integrated low pass filter (with double base cut-off frequency), and stored as a voltage-time relationship.

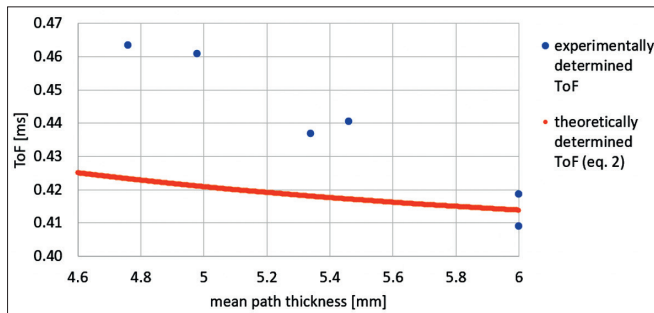
Fig. 21. ToF to thickness curve from equations in front of ToF measured in the experiment

As previously mentioned, the relationship between ToF and the plate thickness is strongly nonlinear and requires the solving of dispersion equations. Based on the experimentally determined material parameters, the theoretical curve representing the thickness-ToF relationship was calculated for an incorporated frequency of 140 kHz and compared with experimental results (Fig. 21).
