Identification of Risk Factors for Collisions Involving Cyclists Based on Gdansk Example

Abstract. The role of pedestrian and bicycle traffic in Poland has growing trend. The comprehensive traffic study, conducted in Gdansk in 2016, has confirmed the increase in the number of cyclists and their share in the modal split. Therefore, it is particularly important to ensure the safety of this group of unprotected road users. Only in 2015 on the roads of Gdansk occurred 93 accidents (excluding collisions) involving cyclists. As a result, 101 people were injured, including nine seriously and 3 people killed. The study aim was to identify risk factors for collisions involving cyclists based on data of accidents reported to the police. The following factors were analysed: the conditions for the drivers on the road (speed limits of, surface conditions), conditions for cyclists (cycling infrastructure, traffic management), external conditions (time of the year, time of the day, weather conditions), conditions organizational (type of intersection, traffic light) as well as the social aspects – the behaviour of all users.

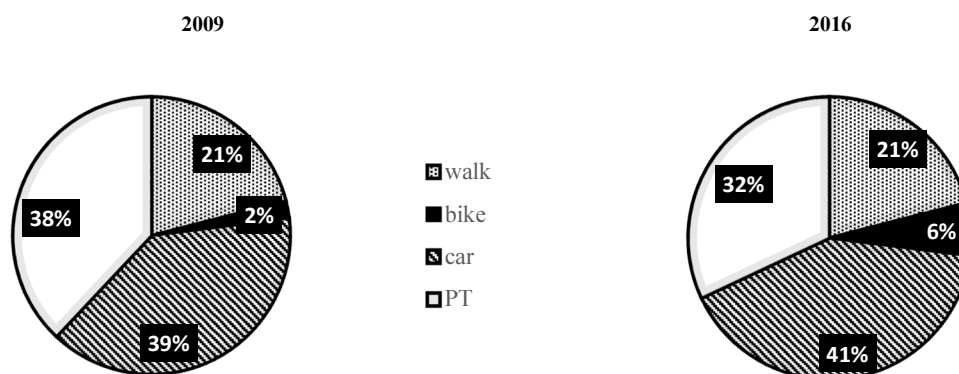
Fig. 4. Changes in Modal Split in Gdansk in years 2009–2016
Source: own study based on VIA VISTULA 2016; Gdansk Development Office 2009

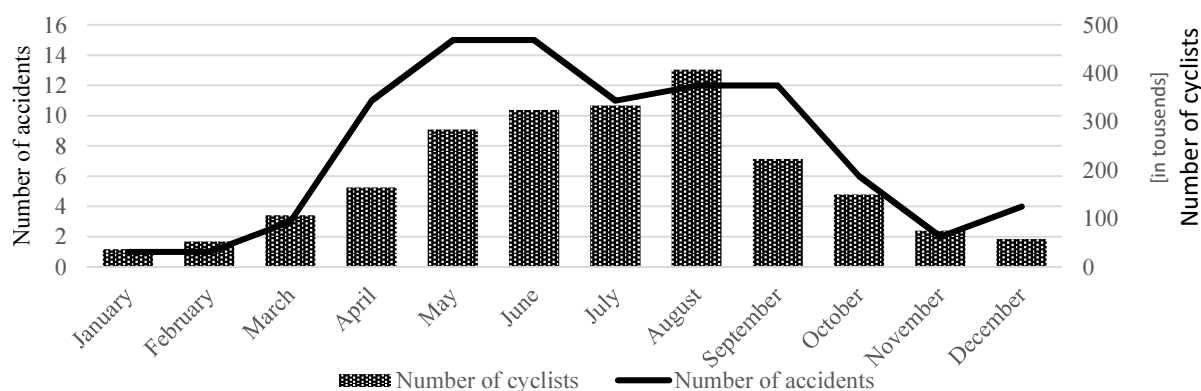
Fig. 8. Comparison between the trend of changes in individual months of 2015 in terms of the number of cyclists on three most important road sections (Zwycięstwa Avenue, Coastal belt and Grunwaldzka Avenue) and the number accidents involving a cyclist

Analysis of the relationship between the number of cyclists reported by automatic measurements and the number of accidents involving cyclists can relate to a time period of year, week or day. The use of bikes in bicycles trips is strongly correlated to the season (Fig. 8). The greatest cycling intensity occurs from April to October and in the remaining months it is much lower. The plot of annual distribution of the number of accidents involving cyclists is also variable during the year. Figure 8 summarizes a trend in the change of the magnitude of traffic intensity with the number of accidents. Moreover, analyzing the relationship between the intensity of bicycle traffic and the number of accidents per week, mutual correlation can be observed. Along the main transport axis of Gdansk, the intensity of cycling is higher on weekdays in comparison to weekend.
