# Imaging of Increasing Damage in Steel Plates Using Lamb Waves and Ultrasound Computed Tomography

**Abstract:** This paper concerns the inspection of steel plates, with particular emphasis on the assessment of increasing damage. Non-destructive tests were performed on four plates, one of which was undamaged, while the remaining three had defects in the form of circular holes with diameters of 2, 5 and 10 cm. Guided Lamb waves were used in the research, and the image reconstruction was performed using ultrasound computed tomography. The damage size was estimated by tracking the real course of rays and densifying the pixel grid into which the object was divided. The results showed the great potential of ultrasound tomography in detecting defects in steel elements, together with the possibility of estimating damage size.

**Citation:** Zielińska, M.; Rucka, M. Imaging of Increasing Damage in Steel Plates Using Lamb Waves and Ultrasound Computed Tomography. *Materials* **2021**, *14*, 5114. <https://doi.org/10.3390/ma14175114>

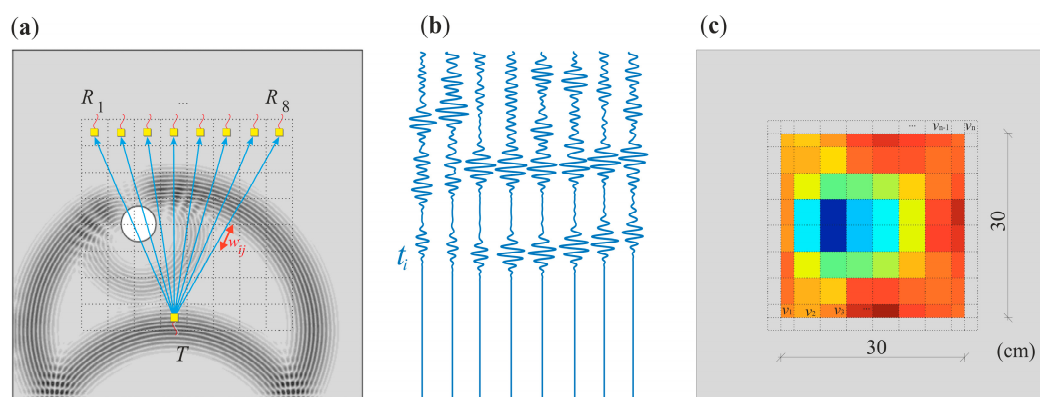
**Figure 1.** Schematic diagram of velocity reconstruction using ultrasound tomography: (a) plate with indicated receivers ( $R$ ), transmission ( $T$ ) points and simulated wave field; (b) guided wave propagation time signals; (c) ultrasound tomography map.

Ultrasound tomography imaging allows recreating the internal structure of an examined object using the properties of elastic waves. A schematic process of performing ultrasound tomography is shown in Figure 1. The first step is to divide the test sample into cells called pixels. Each one of them constitutes a discrete area in the tested element. Such a division is shown with a dashed line in Figure 1a. Then, after applying appropriate algorithms, each pixel takes a value representing the speed of the ultrasonic wave propagated through this area.

Image reconstruction is based on information from ultrasound wave signals propagating from transmitting points ( $T$ ) to receiving points ( $R$ ). This information may be, for example, the time of flight (TOF), measured along with the multiple ray paths, determined after appropriate signal processing [34–36]. Each obstacle in the path of the travelling wave changes the propagation time. Among them, we can distinguish defects that delay the wave reaching the receiver, such as air voids or cracks, and those that decreased total velocity along all rays passing through these inclusions. The latter include inclusions made of materials whose propagation velocity is higher than in the surrounding medium. Based on the time of flight of the wave, with the known geometry of the tested object, it is possible to determine wave propagation speed, correlated with the mass density, modulus of elasticity, and Poisson's ratio characteristic for a given material.

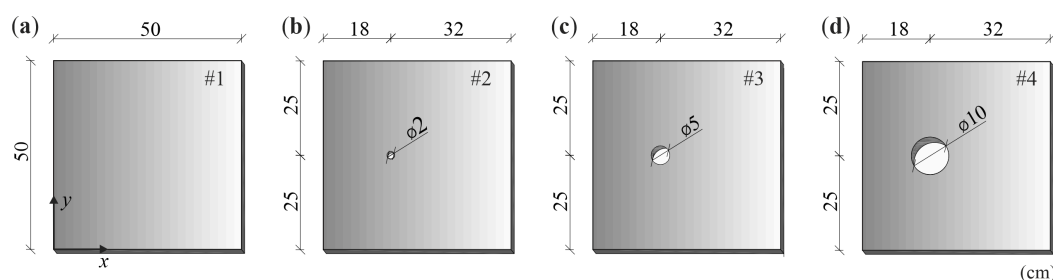
**Figure 2.** The geometry of the tested plates: (a) plate without damage (#1); (b–d) plates with surface damage (#2–#4).

The tests were carried out on four steel plates with dimensions of 50 cm  $\times$  50 cm and 3 mm thickness. A reference model was the first element without damage (plate #1). The other three plates contained a circular hole of variable diameter: 2 cm (plate #2), 5 cm (plate #3) and 10 cm (plate #4), which represented damage of a surface type. Holes were made through the entire thickness of the plate. The centres of all holes were placed symmetrically in the  $y$ -axis direction and at a distance of 18 cm from the outer edge of the plate in the  $x$ -axis direction. The geometry of the test models is shown in Figure 2. Photographs of the plates used for the experimental tests are presented in Figure 3.

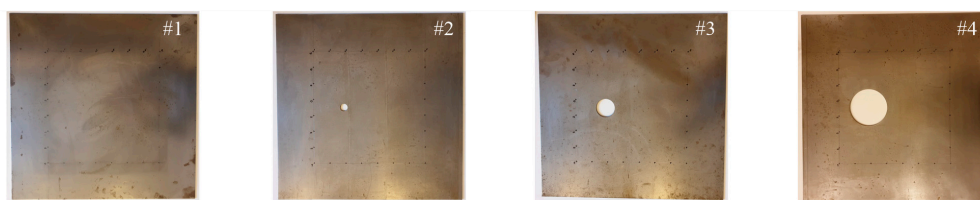
**Figure 3.** Photographs of tested plates (models #1–#4).

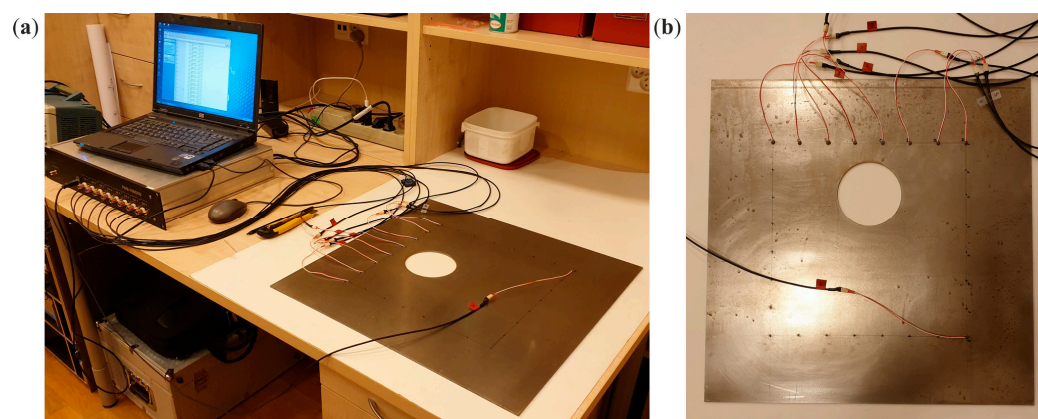
**Figure 4.** Experimental setup (a) and view on the steel plate with piezoelectric transducers (b).

Experimental tests of the propagation of Lamb waves in the steel plates were performed using a system for generation and registration of ultrasonic waves, the PAQ-16000D system (EC Electronics, Krakow, Poland). The experimental setup is shown in Figure 4. For both transmitting and receiving Lamb wave signals, plate piezoelectric transducers, NAC2024 (Noliac, Kvistgaard, Denmark), were applied. The excitation was a wave packet with a central frequency of 150 kHz, consisting of five sinusoid cycles modulated with the Hann window.

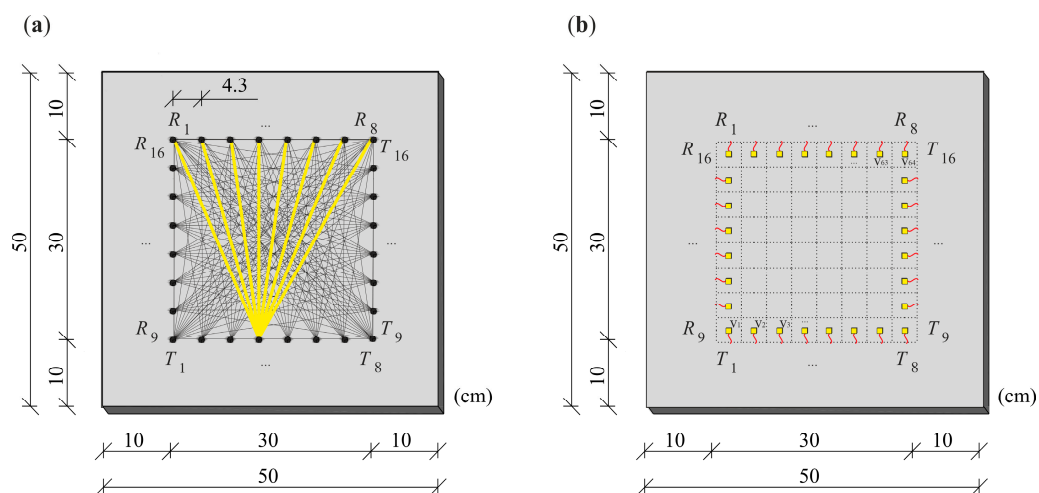
**Figure 5.** The plate with the marked inspected area: (a) location of transmitters  $T_1$ – $T_{16}$  and receivers  $R_1$ – $R_{16}$ , (b) division of the area into pixels.

The inspected region of the plate was a square with dimensions of 30 cm  $\times$  30 cm, with a margin of 10 cm from each of the outer edges of the plate. The excitation was applied at 16 points (8 points on two perpendicular edges), and wave propagation signals were also sensed at 16 points. The transmitting points are marked in Figure 5a as  $T_1$ – $T_{16}$ , and the receiving points as  $R_1$ – $R_{16}$ . During measurements, the transmitter was placed at a specific point, and the output signals were registered at 8 points located on the opposite edge. The transmitter was then moved to the next point, and the measurement was repeated. Altogether, 128 wave propagation time signals were collected.

The image reconstruction process started by dividing the inspected region of the plate into 64 pixels. The number of pixels was derived from the number of measurement points located on each edge of the plate (8  $\times$  8 points). Each pixel had a dimension of 4.3 cm  $\times$  4.3 cm. Pixels are marked with dashed lines in Figure 5b. Image reconstruction was made according to the collected signals of the wave transition from transmitters to receivers. The time of flight (TOF) of the ultrasonic wave for each of the  $T$ – $R$  paths was determined. The tomography velocity image was created in MATLAB<sup>®</sup> (9.3.0.713597, The MathWorks, Inc., Natick, MA, USA), based on the ART method. In the first step, it was assumed that the wave paths propagating from the transmitters to the receivers are straight. In the next step, the actual course of the rays was traced.

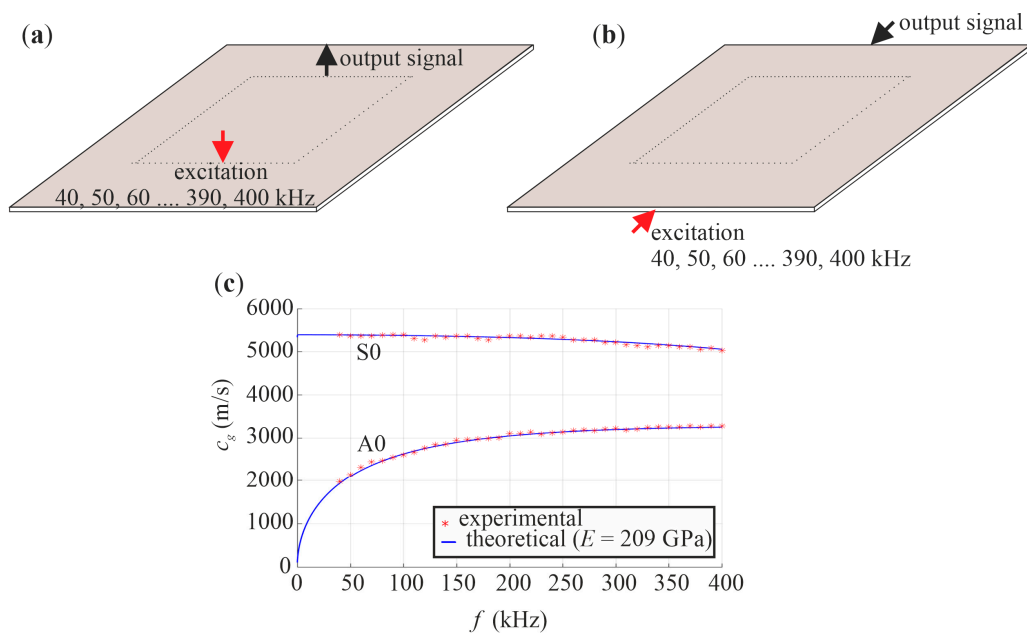
**Figure 6.** The scheme of experimental tests for determination of dispersion curves for (a) A0 mode and (b) S0 mode and (c) obtained dispersion curves.

Identification of material parameters was carried out for an intact plate #1. The experimentally determined mass density was  $\rho = 7893 \text{ kg/m}^3$ . Poisson’s ratio was set as 0.3. The dynamic elastic modulus was also determined experimentally based on a comparison of experimental and numerical dispersion curves. At first, dispersion curves of Lamb waves of two basic modes, i.e., symmetric S0 and antisymmetric A0 were determined. For this purpose, guided waves of frequencies ranging from 40 kHz to 400 kHz with a step of 10 kHz were excited and measured in two configurations, shown in Figure 6a,b. Theoretical dispersion curves were then calculated for different values of elastic modulus. Finally, the dynamic elastic modulus was determined by the method of least squares to give the best fit experimental and numerical modes, and its value was found to be 209 GPa (Figure 6c). The obtained values of the material parameters were then used for numerical simulations.

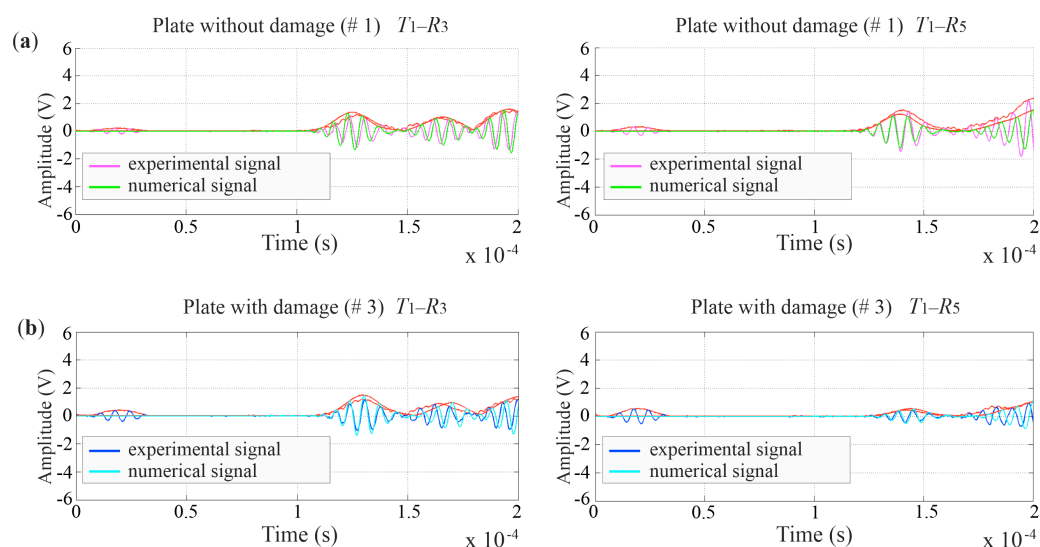
**Figure 7.** Comparison of selected Lamb wave signals for experimental and numerical tests in a plate without damage (a) and with damage (b).

Numerical and experimental signals transmitted and registered at selected points were the basis of tomographic maps. The comparison of selected Lamb wave signals for the experimental and numerical models is presented in Figure 7. The graphs show a high convergence between the results from both models.

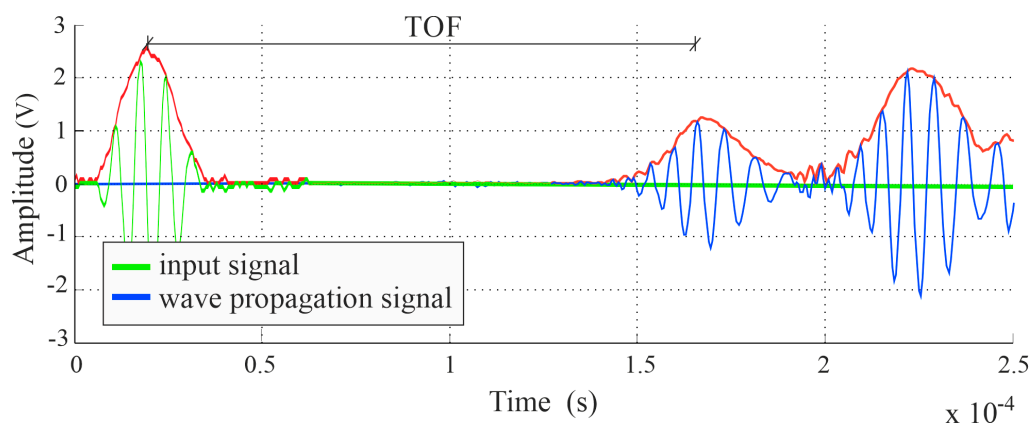
**Figure 8.** Determination of the time of flight (TOF) between transmitters and receivers.

The scheme of determining the time of flight (TOF) is shown in Figure 8. The estimation of this value is based on the first wave packet. The wave propagation time was established through the peak-to-peak method and was the difference between the peak value of the first wave pack of the output signal and the peak value of the input signal. The Hilbert transform was employed to create the signal envelope, which enabled the identification of peaks.

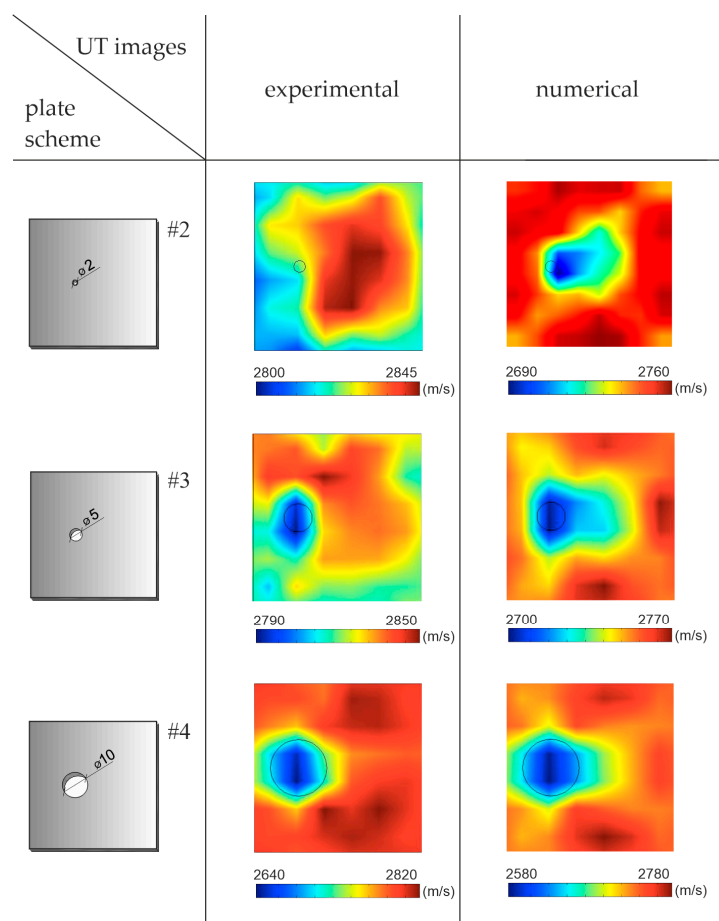
**Figure 9.** Ultrasonic tomography (UT) velocity maps using direct wave transition in plates with surface damage.

The ultrasonic tomography maps are illustrated in Figure 9. The first column shows the plate scheme; the next two present the tomographic maps based on experimental and numerical signals, respectively. The tomograms are constructed, based on the direct measurement of the wave travel time, which means that the results were not compared with the results obtained for the undamaged plate. Each of the performed tomograms is presented separately, ranging from the minimum to the maximum speed. The maps present results for all considered plates, with the increasing surface damage in the form of holes with a diameter of 2, 5 and 10 cm. The defect with a diameter of 2 cm was properly imagined only for data obtained from numerical tests. On the other hand, the holes with a diameter of 5 and 10 cm were successfully detected in both experimental and numerical results. The locations of this damage are marked as areas with a reduced speed in relation to the surrounding material. However, the size of the holes was difficult to estimate accurately.

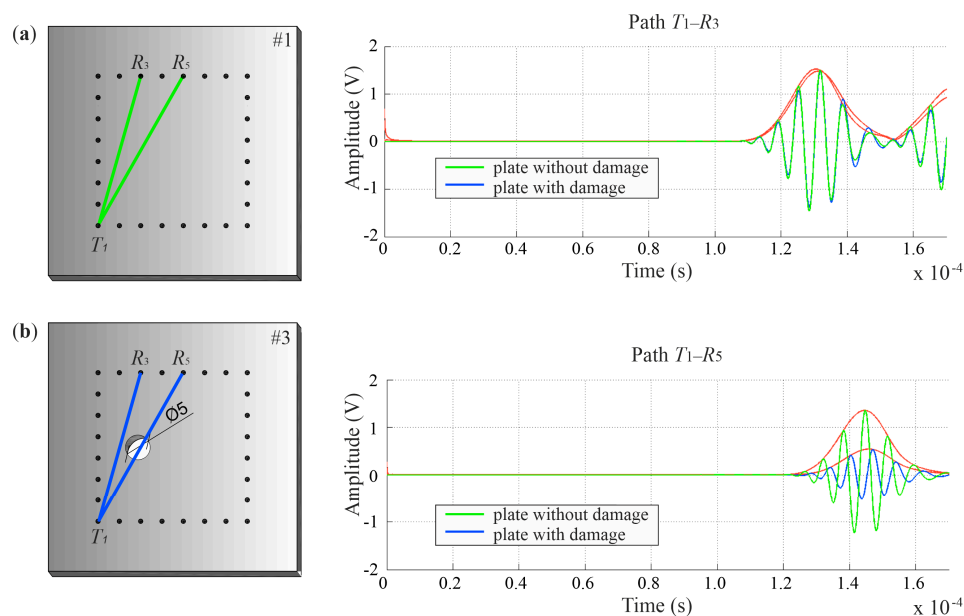
**Figure 10.** Comparison of wave signals propagated in intact plate (a) and plate with a 5 cm hole (b) along traces  $T_1-R_3$  and  $T_1-R_5$ .

ble to indicate a difference in the TOF, especially if there is a defect along the inspected path. In the case of damage to the entire thickness of the element, the recorded signals travel along the path around the damage [39] so the paths are curved. Examples of Lamb wave signals propagated in an intact plate and a plate with a 5 cm hole along paths  $T_1-R_3$  and  $T_1-R_5$  are compared in Figure 10. When the wave passes through the hole (path  $T_1-R_5$ ), its amplitude and shape change. Moreover, the wave arrives at the receiver with a delay. On the path propagating beyond the damaged area (path  $T_1-R_3$ ), the first wave packet registered by the receiver is the same for the damaged plate and the plate without damage.

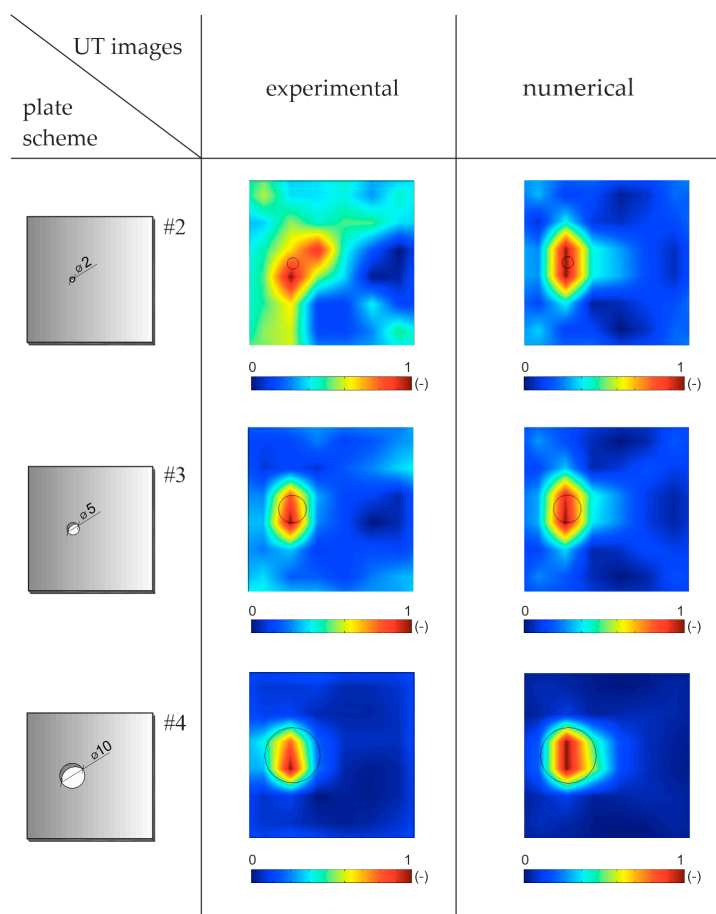
Figure 11. Ultrasonic tomography (UT) maps in plates with surface damage with the reference to the undamaged plate using TOF differences.

Figure 11 shows the tomographic velocity maps obtained based on differences in wave propagation TOF between the reference plate and the plate with growing damage. Each map was made on a scale from 0 to 1, where 1 indicates the highest difference between reference and current state, and 0 indicates their full compatibility. The location of the circular hole (Figure 11) was detected on the numerical images as regions with a reduced speed of wave propagation. These maps clearly indicate the location of the holes; however, it is not possible to precisely determine their size. This is due to the number of pixels into which the element was divided, as they define the image resolution. Regardless of the hole diameter, each defect lies on a combination of at least two pixels (see Figure 12). This area is indicated on tomography maps as a place with a reduced propagation velocity of ultrasonic waves. In the case of the UT images reconstructed for experimental signals, it can be noticed that they made it possible to determine the location of defects, regardless of their size. At the same time, it was not possible to assess the damage size, as in the case of the numerical results.

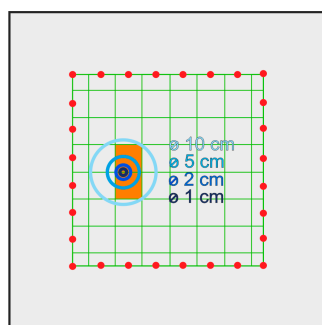
Figure 12. Location of damage with respect to the division of the element into pixels.

The existence and position of the surface growing damage in steel plates were determined based on the time of flight and UT reconstruction for both experimental and numerical data (see Figures 9, 11, 13 and 14). However, the damage size assessment using the indicated methods did not reflect the actual dimensions of the hole. This was due to the size of the pixels into which the tested structure was divided. Such a division resulted from the number of transmitters and receivers used in the study. On two perpendicular edges, eight transmitters and eight receivers on opposite edges were used, which determined the division of the element into 64 pixels. The number of pixels affected the resolution of the obtained tomography image (cf. Figure 12).

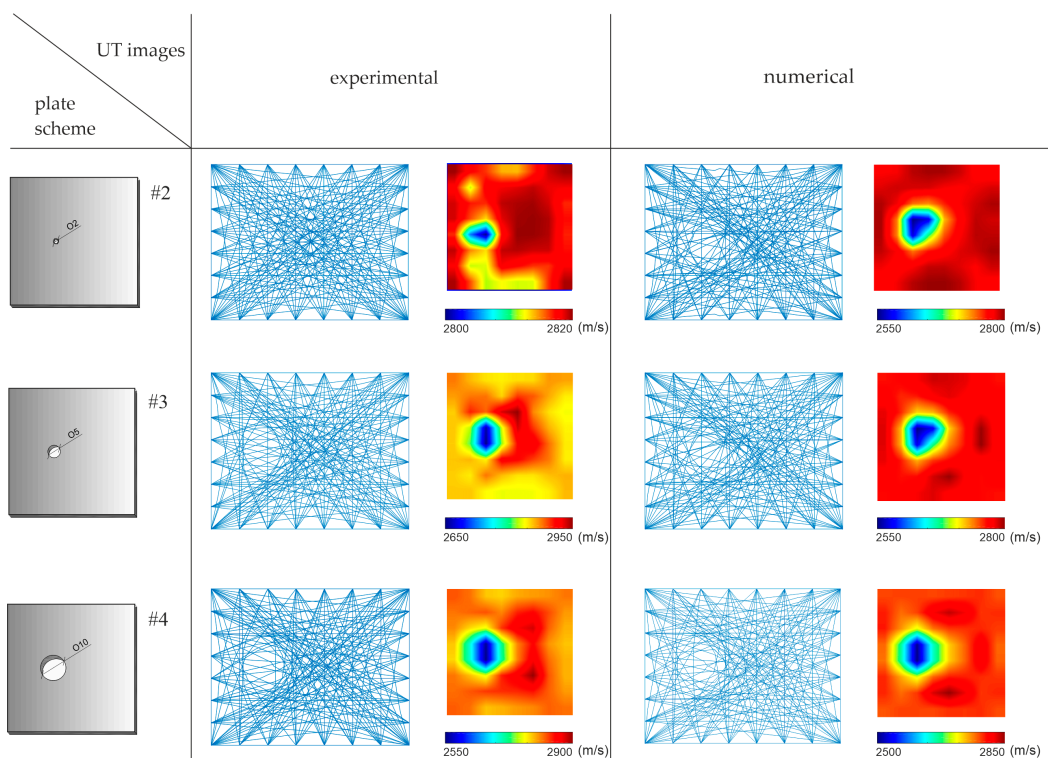
Figure 13. Ultrasonic tomography (UT) maps using direct travel time measurements with curved paths.

Figures 13 and 14 present experimental and numerical tomography maps created using the curved rays determined by the hybrid method. The analysis was carried out for the time of flight measured directly from transmitters to receivers (Figure 13) and by comparing the results between the current and reference state (Figure 14). The first step of the hybrid method is the preparation of a tomographic map for straight rays from transmitters to receivers. These maps are prepared both for the time of flight measured directly and for the differences in signals between the current and reference model. It is the starting point for which further ray bending iterations are carried out [52].

The tomographic velocity maps made on the basis of direct measurements (Figure 13) clearly indicate the location of the defects. They are visible as areas with smaller values of wave propagation velocity. Each of the tomographic images has its own individual scale, with values ranging from minimum to maximum velocity. Maps made for straight paths give satisfactory results. Simultaneously, the use of a hybrid method, combining the network method and the ray bending method, improved the results. In this case, the defect area was more concentrated. However, it was difficult to assess the extent of the damage based on these maps. Analysis of traced rays showed that the paths determined by the hybrid method bypassed the area of the defects.

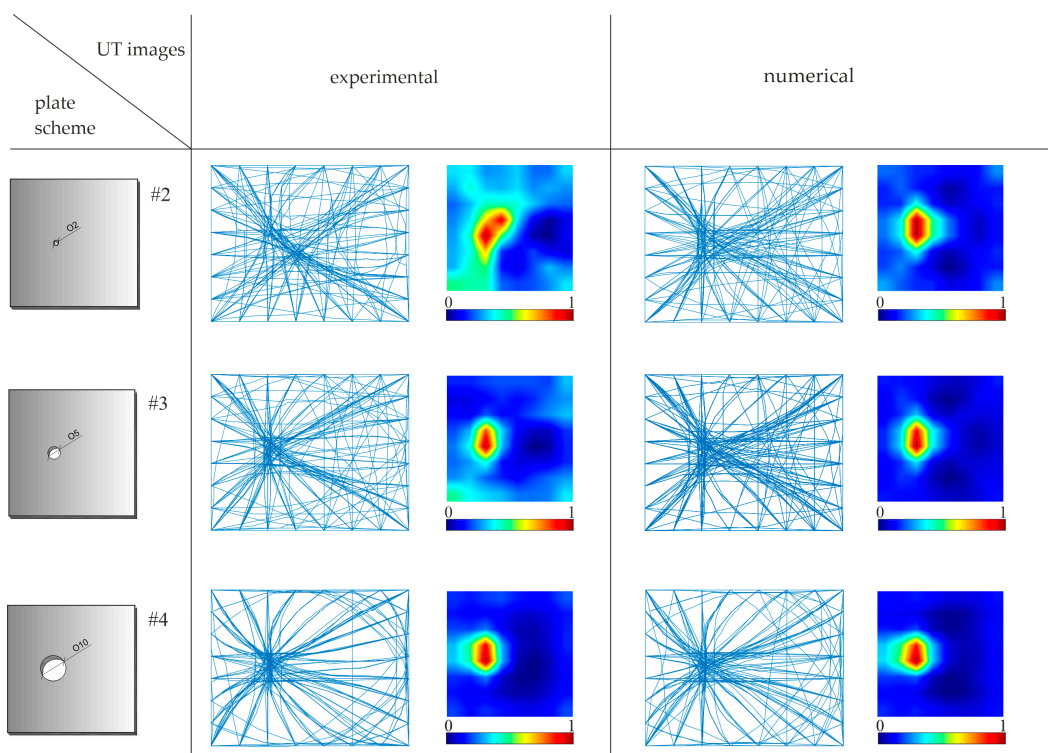
Figure 14. Ultrasonic tomography (UT) maps using the method of signal differences with curved paths.

Figure 14 shows tomographic velocity maps based on the comparison of the TOF between the undamaged plate and plates with growing defects. Values in the map cover the range from 0 to 1, where 1 indicates the highest measured difference between the map for undamaged and defective pieces, and 0 indicates their full compatibility. The circular

hole in each plate is shown as an increased value, which means a significant difference in wave propagation velocity in this area. Curved rays are concentrated within the defect. In this case, the maps are similar to those prepared with the use of straight rays. However, the damaged area is only a little more concentrated. In this case, it was also impossible to estimate the damage size as in the case of straight rays.

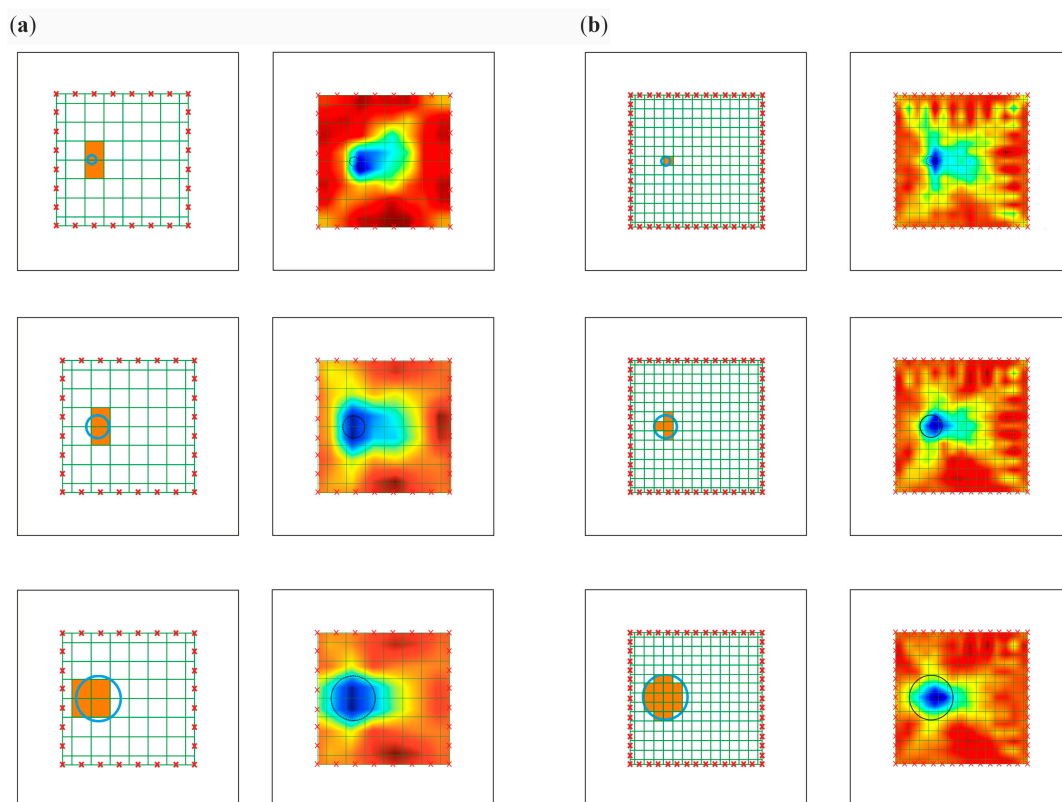
**Figure 15.** Pixel grid for the direct travel time measurement method: (a) division into 64 pixels; (b) division into 225 pixels.

In order to improve the identification of the size of damage, the pixel mesh was refined. The split of each edge was increased from 8 to 15 elements, which gave a total number of 225 pixels. The dimension of a single pixel was  $2.15\text{ cm} \times 2.15\text{ cm}$ . The impact of the density grid was assessed for data obtained from numerical simulations. Figures 15 and 16 show the tomography maps prepared for the elements divided into 64 and 225 pixels, respectively, using direct measurement of time of flight and difference in the TOF between the current state and the reference state. Orange colour marks the pixels for which the damage covers more than half of the area. In the case of a 64-cell mesh, the damage was concentrated within two pixels. The exception was damage with a diameter of 10 cm, which occupied 4 pixels. More significant differences in the number of pixels occupied by the damage are visible when the mesh was densified to 225 pixels.

The maps in Figures 15a and 16a concern models divided into 64 pixels. The tomograms are very similar to each other, regardless of the damage size. The images were enhanced significantly by densifying the pixel grid (Figures 15b and 16b). It was possible to estimate the damage size for such prepared tomograms. The size of the area with a lower velocities of wave propagation on these maps increased with the size of the defect.

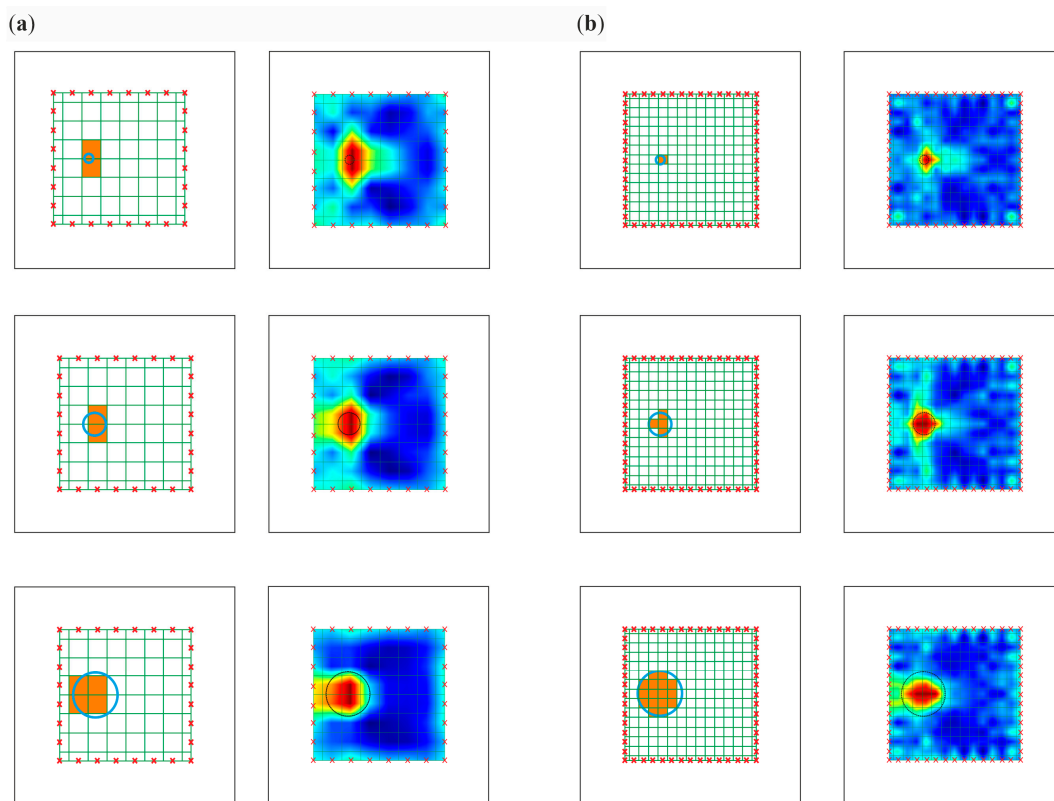
**Figure 16.** Pixel grid for travel time difference method (a) division into 64 pixels; (b) division into 225 pixels.

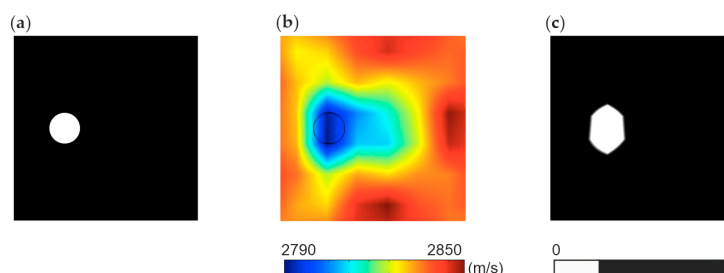
**Figure 17.** Error coefficient values for maps with reduced spectrum based on direct travel time measurement method: (a) reference model with a reduced spectrum, (b) topographic map with a full spectrum, (c) tomographic map with a reduced spectrum.

The accuracy of the tomographic reconstruction was quantified by using an error coefficient comparing the reference image with the obtained tomographic maps. Each of the prepared tomographic maps was replaced by a simplified model with a reduced spectrum, indicating high and low velocities as well as large and small differences. In the case of direct measurement, pixels with velocities below the 25th percentile of the maximum scale value are considered to be low-velocity indications and are assigned a value of 0, while others are assigned a value of 1. An example of spectrum reduction for direct measurement is shown in Figure 17. In the case of maps based on signal differences for an undamaged structure and a damaged structure, pixels with a difference above the 75th percentile of differences in a scale are assigned a value of 0, and the remaining pixels are assigned a value of 1.
