# Indoor accelerated controlled corrosion degradation test of small- and large-scale specimens

**Abstract:** The work presented here is a part of a long-term project analysing the structural behaviour of ageing marine structures. An accelerated corrosion degradation set-up was developed to reproduce specimens of corroded marine structural specimens of different degrees of degradation, controlling various natural factors, *i.e.*, temperature, oxygen content, salinity, and flow velocity. The nine stiffened plates of 1.2 m length and 30 small scale specimens made of mild steel of three different thicknesses have been corroded. The mean corrosion depth and rate have been controlled during the degradation process for all specimens. The corrosion degradation characteristics have been measured and analysed. In the case of small-scale specimens, microscope scanning, and for the stiffened plates, ultrasonic thickness measurements were performed. The obtained corrosion surfaces are highly non-uniform. During the corrosion degradation, a number of measurements were performed to satisfy a confidence level of 95% and an error of 10%. The developed corrosion degradation is compared with a real

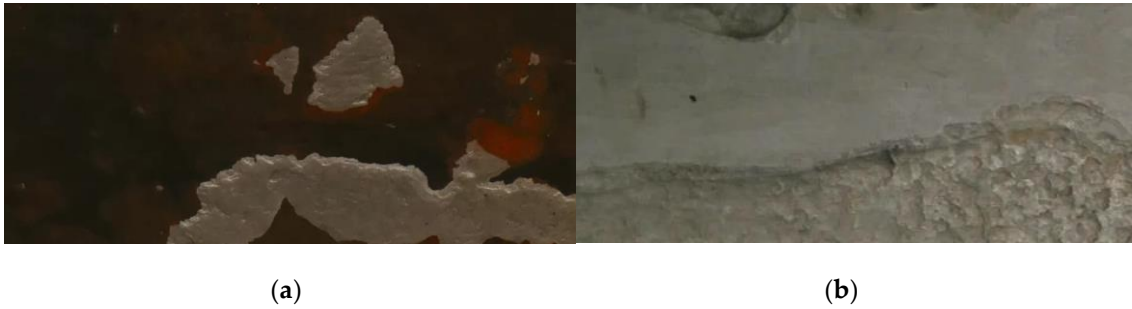
**Figure 8.** The example of specimen: (a) before cleaning; (b) after cleaning.

Corrosion products need to be removed to analyse the surfaces of corroded specimens. Thus, cleaning with the use of a chemical solution has been applied (see Figure 8). The cleaning was performed using water, hydrochloric acid, which dissolved the corrosion products and corrosion inhibitor, preventing dissolution of steel by acid. To avoid further atmospheric corrosion, the specimens were cleaned and dried. The final mass of the specimen has been measured after the corrosion process, revealing that the corrosion products could disturb the measurement of the degradation level up to 1.5 %.

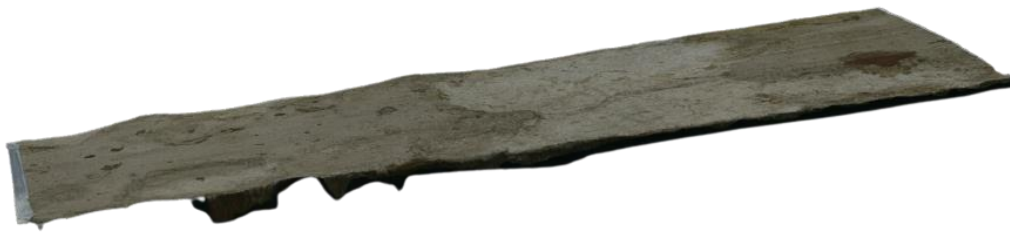
**Figure 9.** An example of a scan of the corroded surface (specimen 6.3).

The detailed 3D reproduction of the corroded surfaces has been obtained with the mesh size of  $2\ \mu\text{m} \times 2\ \mu\text{m}$ . An example of such a scanned corroded surface could be seen in Figure 9. It is noted that only the gauge length of the specimen has been scanned because this part is relevant during tensile testing, whereas mounting parts are not important. Additionally, the range of the possible area that could be captured via a microscope has been limited.

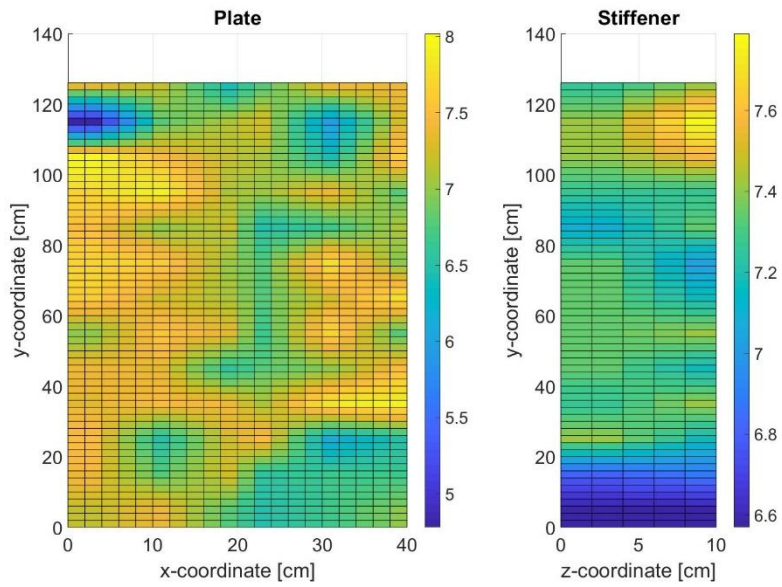
**Figure 19.** Thickness distribution in 1.8 specimen (14% of DoD) [mm].

The thickness distributions for initially 8 mm stiffened plates are presented in Figures 18 – 20. The distribution of thickness for 2.8 specimen is shown in Figure 18. It is noted that the higher corrosion diminutions for both plates and the stiffener are near the bottom and top of the specimen. In the specimen with a 14% degradation level (see Figure 19), high corrosion diminutions are observed near the plate's welding zone and right side. High corrosion depths are kept in the lower part of the stiffener, which is relatively uniformly corroded. In the most strongly corroded specimen (see Figure 20), the severely corroded regions in the plate are the bottom, top and left side. In the case of the stiffener, there is an irregular field; however, near the bottom are the highest corrosion deteriorations observed.

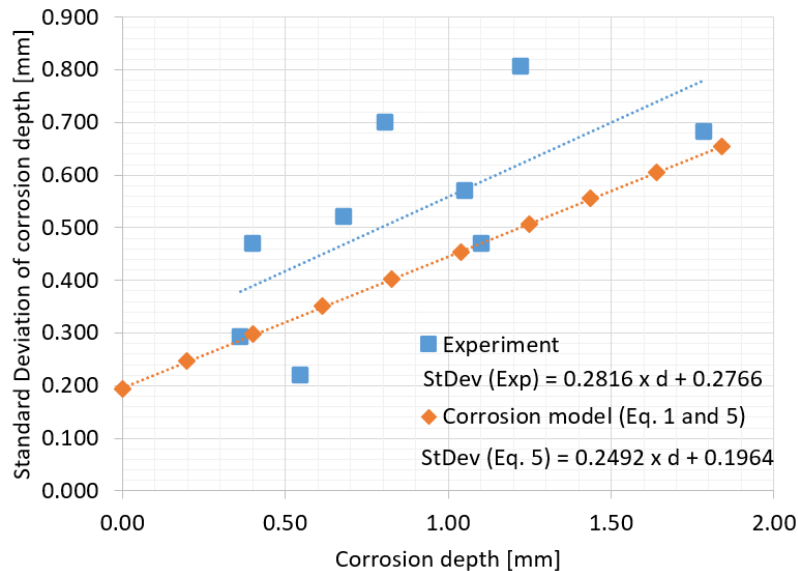
Figure 21. Standard deviation of corrosion depth vs corrosion depth.

The standard deviations from Table 9 can be fitted to Eqn 5. Since the tested plates are exposed to seawater, their corrosion degradation will be like the corrosion degradation of deck plates of ballast tanks. The transition time is about 17.5 years, and the long-term corrosion depth is calibrated to obtain the same mean corrosion rate for non-accelerated conditions (0.0787 mm/year). The long-term corrosion depth is estimated at 2.36 mm. Based on Equations 1 and 5, the dependency between corrosion depth and standard deviation of plate thickness is derived, presented in Figure 21. Based on Eqn 5, the standard deviation is shown as a function of the corrosion depth and not as a function of time; thus, the relationship is linear instead of logarithmic.

It is noted that the standard deviation obtained from measurements is higher in comparison to the corrosion model. This could result from more detailed measurements in the current work, whereas the model is based on the in-situ measurements performed in real operating ships. In the latter case, not so many measuring points are captured. Nevertheless, the inclination of both curves is very similar, and there can be used for the estimation of standard deviation with corrosion development.
