# Jumping Wave Characteristic during Low Plasticity Burnishing Process

**Abstract:** During the low plasticity burnishing process of soft materials such as carbon steel with a hardness of up to 40 HRC (Rockwell grade) a raised structure of the material known as the Jumping Wave forms in front of the tool roll. This phenomenon significantly disturbs the burnishing process, but is very poorly described in the literature. This article presents studies of this phenomenon on the example of burnished 1.0562 steel. The research concerns the changes in the surface structure of the processed material as well as changes in the structure of the material during this process. The research shows changes in the geometric structure of the surface made in the 3D system and their parametric description. Moreover, the work presents an analysis of the metallographic structure in the tool zone. The research showed occurrence of material slippages in the wave in front of the tool, which creates an additional structure on the surface. These tests make it possible to better understand the process of changes that take place in the surface layer of the processed element in the low plasticity burnishing pro

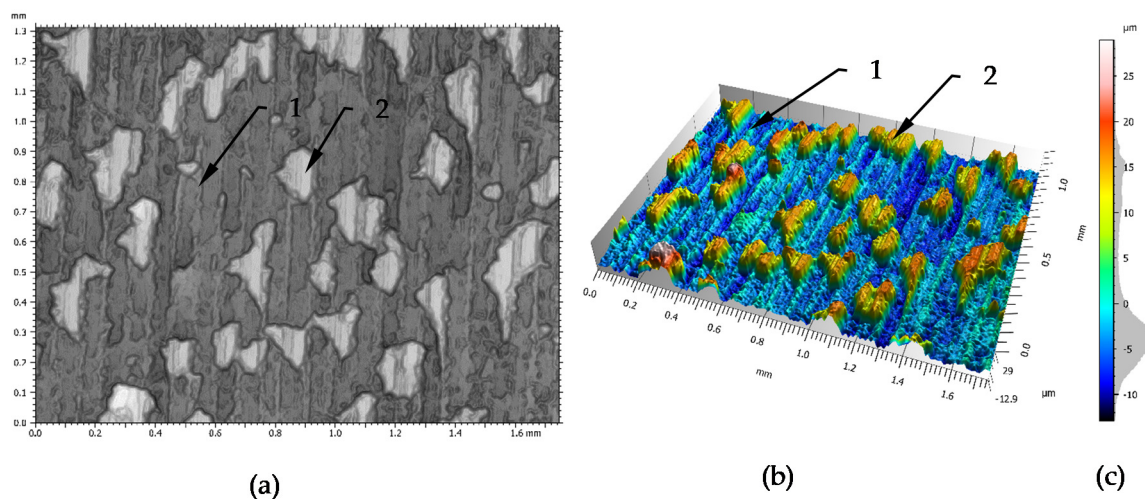
**Figure 2.** Surface structure after turning: (a)—photograph of surface, (b)—3-D surface scanning, (c)—scale of height and the ordinate histogram, 1—turning tool trace, 2—hard material grains on the surface. The surface topography measurements were made with objective 10× EPI and Z-Scan step of 2 μm.

Research of the wave formation process in front of the burnishing tool were performed on steel specimens (material data—Table 1) that had been turned before burnishing (processing data—Table 2). Figure 2 shows the surface structure of the samples after turning, which was measured by a confocal microscope. In this Figure are visible traces (1) of the cutting tool and particles of protruding above the surface (2) of the processed material.

The surface structure seen in Figure 2 was measured and described by the roughness surface parameters. The results of this geometric structure made according to ISO 25178 [47] are presented in Table 3. Based on the 3-D view (Figure 2) and a proportion of  $S_p$  to  $S_v$  parameter (Table 3) it can be confirmed the occurrence of single hills of the geometric structure of the surface. The maximum height ( $S_z$ ) value was 41.8 μm and the plateaus were predominant and maximum peak height ( $S_p$ ) represented it to almost 70% of maximum height ( $S_z$ ). Presented skewness parameter ( $S_{sk}$ ) was used to evaluate deviations in the height distribution. Positive skewness ( $S_{sk} = 1.12$ ) indicates the presence of high plateaus above a smoother valley. The kurtosis ( $S_{ku} = 3.09$ ) value was slightly higher than 3, which indicates the presence of some sharp valleys in the texture. The root mean square height ( $S_q$ ) value was about 25% higher than arithmetical mean height ( $S_a$ ) value. Such differences are characteristic for irregular random profile, where individual maximum and minimum height values, observed in the profile, have greater effect on  $S_q$  than on  $S_a$ .

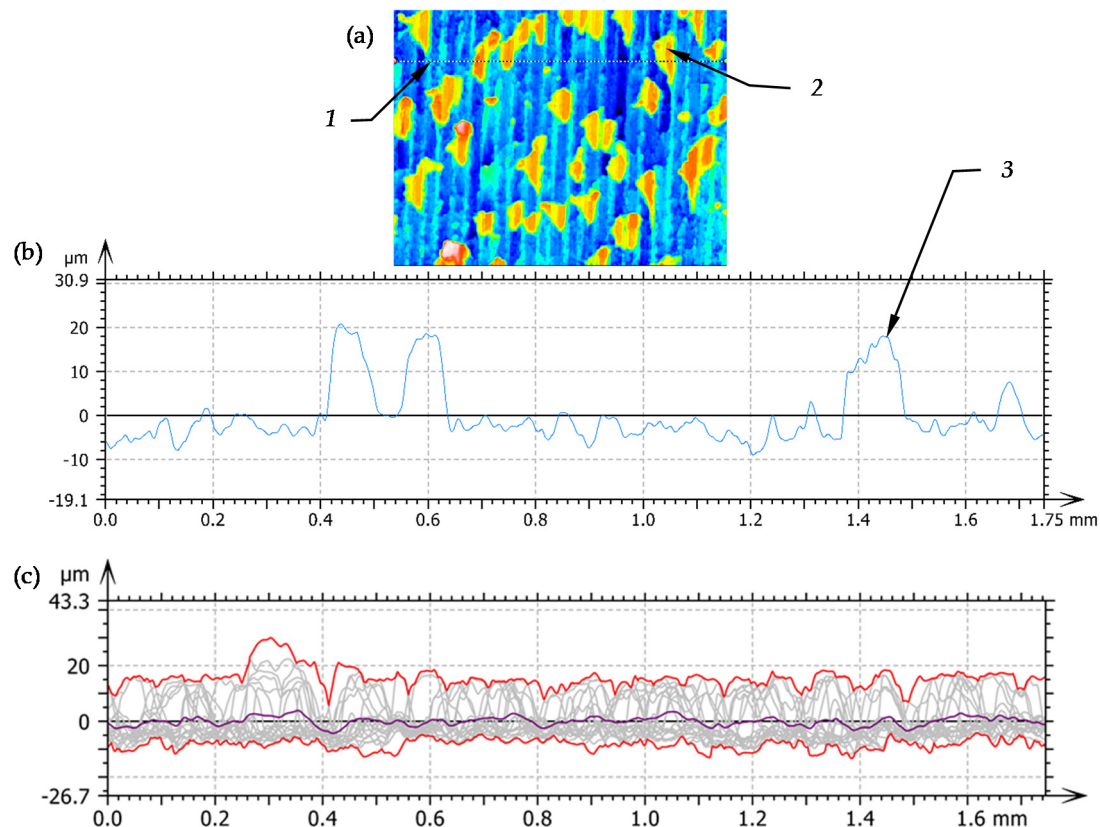
**Figure 5.** Extracted profile of surface after turning: (a) front view of turned surface, (b) profile of turned surface, 1—line of surface cross section, 2—surface peak, 3—profile surface peak, (c) the series of 19 west-east profiles extracted from the surface with upper/lower envelope and mean profile.

In order to compare the grain size to the substrate structure, a profile analysis was performed, where the surface profile was carried out by selected structure grains. Figure 5a,b shows the location of the profile in relation to the existing grains and the obtained profile. Additionally the series of 19 west-east profiles were extracted from the surface with upper/lower envelope and mean profile (Figure 5c) and statistical values of selected parameters of P-profile were included in Table 7.

On the presented profile you can see the structure of unevenness of the floor, the height of which does not exceed 10  $\mu\text{m}$ . The harder grains of the structure create hills with an additional height of 20  $\mu\text{m}$  protruding above the basic structure profile. The obtained profile was characterized by the parameters for the unfiltered profile, of which values are shown in Table 7. Analysing the parameters, it is possible to notice that single grains do not significantly affect the value of the average parameter, which is parameter Pa.

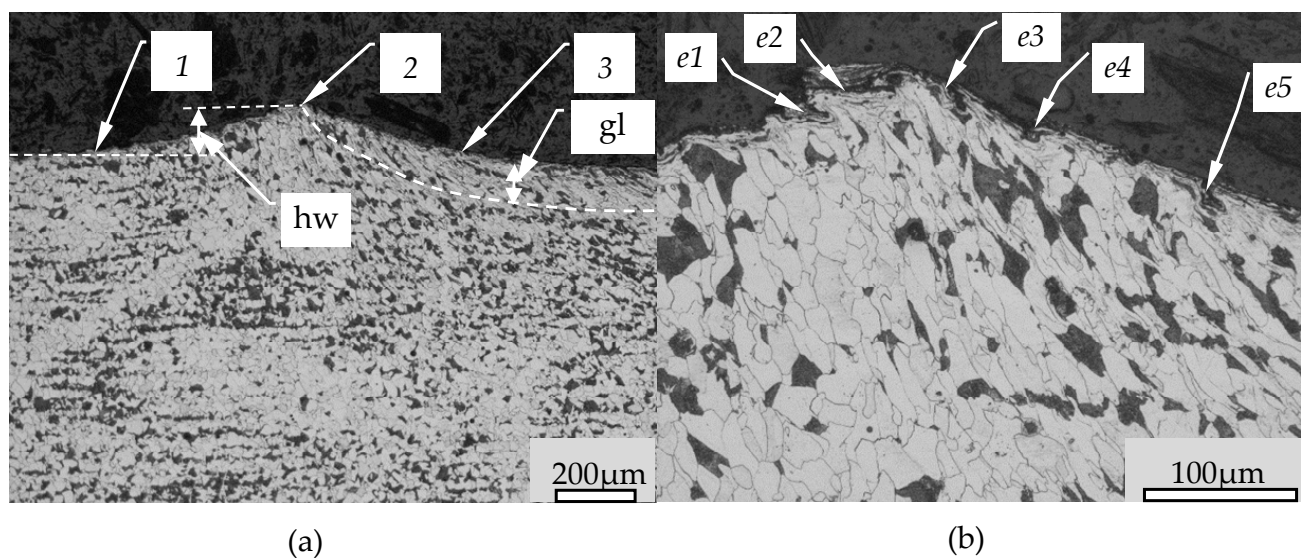
**Figure 7.** Jumping wave zone cross section: (a)—cross section from the jumping wave area (magnification 50×), (b)—top of jumping wave (magnification 200×), 1—surface structure after turning, 2—Top of Jumping wave, 3—structure under burnishing tool, e1–e5—subsequent changes in the structure of the surface flaws, *g1*—thickness of deformed layer, *hw*—height of jumping wave.

The Figure 7 presents the cross section of the “Jumping wave” before burnishing tool. In this Figure, the item 1 shows the surface before pressing, the item 2 crest of the wave and the item 3 presents the surface of influence of the burnishing tool. The pressure of the burnishing tool raises the processing material on the height indicated in Figure 7 by the item *hw*. Underneath the surface of the burnishing tool there is also a deformed zone marked *gl*. Significant deformation of the material structure can be seen in this zone. The wave in front of the tool is formed by the material rising in front of the tool. Even though in this structure material is pushed in over surface, however, the grains structure in the jumping wave does show slight differences from the core while the slight orientation of the grains towards the flow of the material can be observed. In the wave the rising is

differentiated, which causes shear stress to occur between the different material zones. Shear stress causes slippages between zones in the generated wave. The displacement of the material layers in the wave causes creating additional surface irregularities in front of the burnishing tool. In Figure 7b are seen irregularities which occur when the layers of material slip in the wave and then move underneath the kneading tool where they are further deformed. Such a deformation scheme introduced additional defects (flaws) to the surface. The subsequent elements of the process of flaws creation is marked in Figure 7b as items e1–e5. In this Figure it can also be seen that the stresses that causes the wave of material creation also induced a change in the dominant direction of the grain arrangement in the plastic deformation zone. In this process, the workpiece material first flows upwards creating a wave and then is compressed by the burnishing tool, creating a zone of directional grain orientation. The movement of the material at different depths below the surface varies slightly.

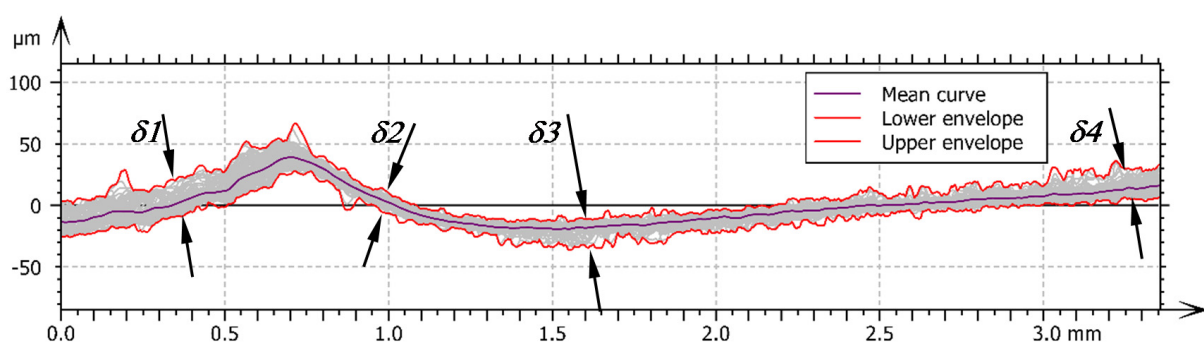
**Figure 9.** The sum of profiles of jumping wave structure:  $\delta 1$ —the thickness of the roughness structure after turning,  $\delta 2$ —the thickness of the roughness structure in front of the burnishing tool,  $\delta 3$ —the thickness of the roughness structure in bottom of the burnishing tool,  $\delta 4$ —the thickness of the roughness structure after burnishing.

Figure 9 shows a set of the profiles of the working section of the burnishing process. The thicknesses of the roughness zone are different in each segment of the burnishing process section. In the first segment is the wave which increases the initial roughness by the phenomena which occurs in the wave. In this segment the single irregularities are visible which were created by the slipping of burnishing material in the wave. The structure thickness in this segment is marked  $\delta 1$ . In the second segment of the burnishing process may be observed the roughness zone under the tool. This is the zone of direct action of the tool which the tool presses raised material against the surface of the workpiece. The roughness zone is smallest in this segment and is marked  $\delta 2$ . In segment three, the map surface is outside of the working area of the tool but is still in the suppress of waviness zone by the tool. The small range of reverse flow of material occurrence in this place causes the roughness zone to increase which is marked  $\delta 3$ . In the fourth zone, the surface is outside the tool; it is marked  $\delta 4$ . The mainly difference from zone 3 is the change in the roughness structure, i.e., from a predominantly valleys structure to a predominantly peaks structure, which may be due to the reverse flow of material described above.

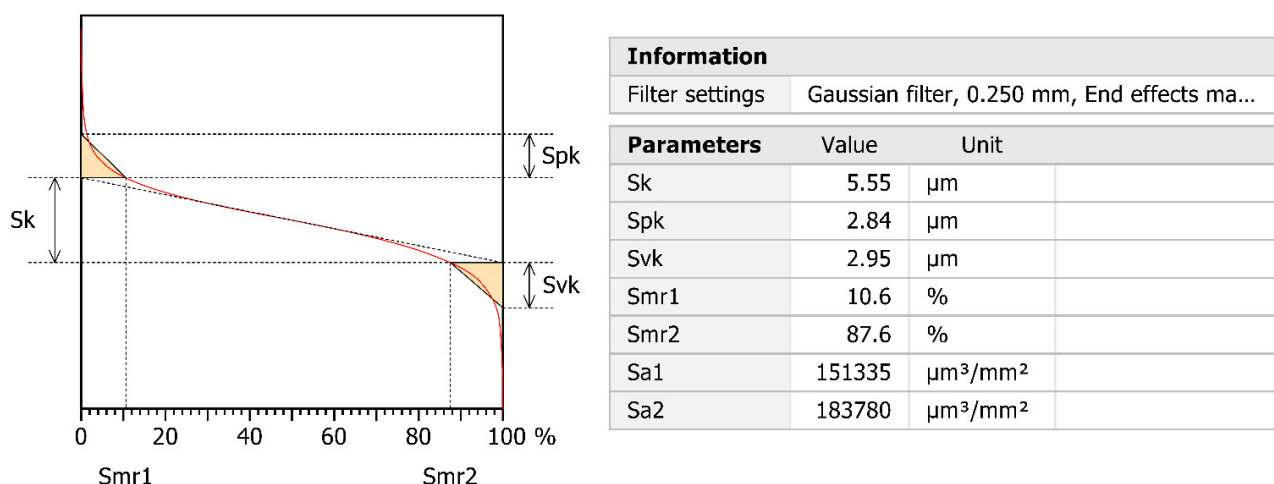
**Figure 11.** 3D material ratio curve and its parameters for the extracted area surface.

From the point of view of utility of the surface, the parameters of material ratio curve are also important, which are presented in Figure 11. The curve presented is symmetrical where the values of reduced peaks and valleys have levelled values. Its relevant parameters are listed in the Table in Figure 11.

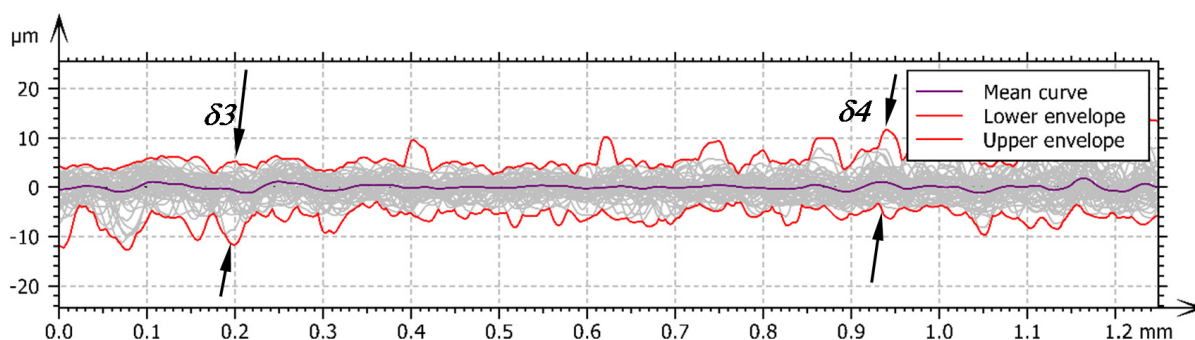
**Figure 12.** The sum of profiles of finishing segment of the burnishing zone:  $\delta 3$ —the thickness of the roughness structure in bottom of the burnishing tool,  $\delta 4$ —the thickness of the roughness structure after burnishing.

Figure 12 shows the assembly of profiles of the separated area. What may be seen is that in the zone of  $\delta 3$  markings, the surface is dominated by pits, while in the zone  $\delta 4$  additional peaks appear. This phenomenon may be caused by a slight flow of materials in the surface layer in the direction opposite to the feed vector in the burnishing process. Table 11 shows the statistical approach of the parameters of the surface profiles which are composed in the roughness zone visible in the Figure 12.
