PROTECTION AND RENOVATION OF PUBLIC AREAS IN A MODERNIST CITY: THE CASE OF THREE STREETS IN THE HISTORIC CITY CENTRE OF GDYNIA

HIRSCH Robert ¹ ŁOZOWSKA Celina ²

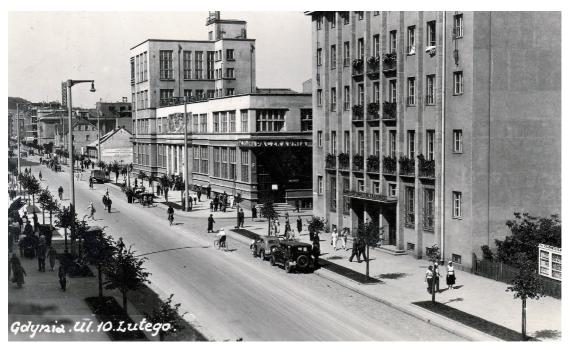
Fig. 1. Gdynia, 10 Lutego Street, the arrangement of the street in the second half of the 1930s; photo from private archives.

10 Lutego Street was arranged in place of Aleja Kuracyjna, which was planned at the beginning of the twentieth century to link the railway station and the beach. In the 1930s, 10 Lutego Street became one of the main compositional axes of the early modernist city centre (fig. 1). The width of the former avenue was then increased to 28 m. The street was laid out using a combination of modern bituminous surface and side lanes of cobblestones with curbs made of longitudinal basalt bricks. Cobblestone lanes were intended for the traffic of vehicles without tires, and as parking lanes (fig. 2). Rows of linden trees were introduced on both sides of the street. Encased in concrete enclosures, the trees were planted in twos, in regular square lawns.

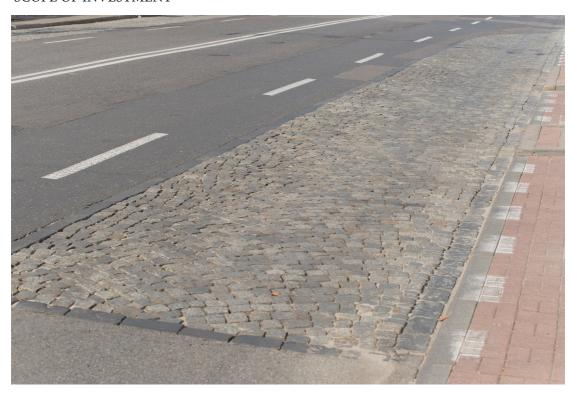
Fig. 2. Gdynia, 10 Lutego Street, historic road surface at the turn of the 1920s and 1930s, where asphalt was combined with cobbled side lanes; photo by B. Ponikiewski.

Apart from the main cobblestone lanes, which testify to the unique character of the street, no original pavement surface or other elements of the arrangement have been preserved.8 No historic reinforced concrete lampposts have survived as these have been successively replaced throughout the city since the 1980s. At the beginning of the twenty-first century most of the trees were cut down to create parking bays.

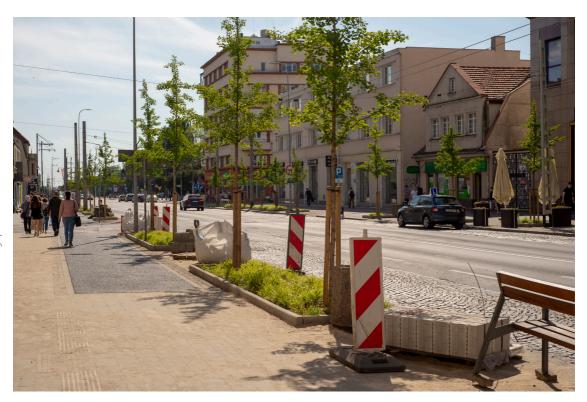
Fig. 3. Gdynia, 10 Lutego Street, after renovation works, which included the conversion of parking bays as well as the reintroduction of the historic width of pavements and the replanting of trees; photo by B. Ponikiewski.

out, including the elimination of a significant number of parking bays, and the restoration of the original width of pavements. Owing to the above, comprehensive reconstruction of the old arrangement of trees was made possible. Since the conditions for the growth of trees were unfavourable due to dense traffic and chemical measures against icing, it was decided in consultation with the conservator of monuments to introduce a foreign species of greater resilience (gingko tree) yet with features similar to the historical one (linden tree). Pavements were given a new surface made of concrete blocks of smaller format than in the original design, supplemented with textured slabs and directional markings for people with disabilities. A bicycle path was marked out in the northern part along the pedestrian lane (fig. 3).

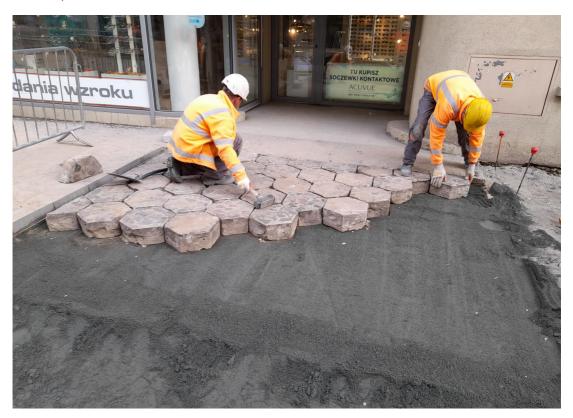
Fig. 4. Gdynia, Starowiejska Street during renovation works in 2022, which involved relocating the historic surface made of hexagonal blocks; photo by R. Hirsch.

of the existing width of the roadway with separate pavements, preservation of the historic road surface and stone curbs with local repairs, preservation of the historic surfaces of access roads to inner yards or former gates (fig. 4), and preservation of original materials, dimensions of stone elements, colours, types of joints as well as the brickwork of reused items. As for the degraded surface of pavements, it was decided to replace them on the provision that references be made to historical solutions, specifically concerning the square concrete slabs. Due to the varied style and time of construction of buildings along the street, some liberty was allowed for the newly designed street furniture, including street lamps, designed in a non-historical maroon colour to add diversity. Efforts to increase the area for pedestrians resulted in the creation of pedestrian zones with parklets, i.e. places to rest with seats and greenery, installed in a non-invasive and reversible way. At the degraded intersections, where asphalt had been reapplied, polished stoneblock speed bumps were introduced to slow down the traffic. Finally, decisions were made to preserve existing trees and add seventy new ones owing to their value for both the entire city and the region, including rows of hawthorns that have lent Starowiejska Street a unique character. RESULTS OF INVESTMENT

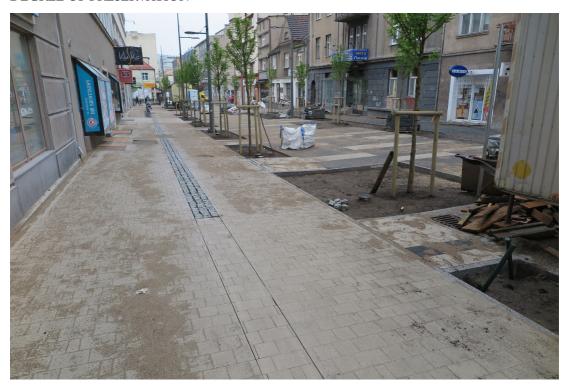
Fig. 5. Gdynia, Abrahama Street, the section between Batorego Street and 10 Lutego Street, during the redevelopment into a so-called woonerf; photo from the archives of the Municipal Conservator's Office.

city authorities to cover, among others, the reconstruction of underground installations.¹³ The project intended to create a so-called *woonerf*, i.e. the first shared space in Gdynia where priority would be given to pedestrians and cyclists. A new surface with geometric patterns, made of two-coloured concrete slabs of various size (fig. 6), replaced the separation of the roadway and pavements (fig. 5). Car traffic was limited to a narrow lane in the middle of the street, and the speed limit was reduced to 20 km/h. Such reorganization of space facilitated the introduction of much greenery and many outdoor catering facilities. Additional street furniture was installed, including benches, bicycle racks and modern lamps. The project had to meet the accessibility standards of the city of Gdynia (Wysocki, 2013). Accordingly, directional guiding and warning systems were added to the pavements, and either they were adjusted to the level of house thresholds or ramps were built allowing unrestricted use of commercial premises located on the ground floor.¹⁴ The investment was commissioned in June 2019.

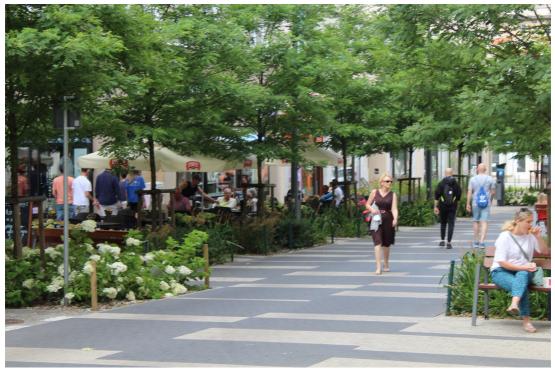
Fig.6. Gdynia, Abrahama Street, the section between Batorego Street and 10 Lutego Street after conversion into a so-called woonerf; photo by B. Ponikiewski.

The reconstruction of the section of Abrahama Street into the contemporary form of a woonerf is an example of current trends concerning utility and social expectations in modern European cities, where the idea of the so-called "shared space" has been implemented since the 1980s (Karlikowska & Kimic, 2017). However, not all such concepts may be compatible
