REDUCTION OF DERIVATIVE PIPELINE EFFORT IN WATER TURBINE

Abstract: The article presents an approach to evaluate and reduce the effort of the derivative pipeline in a water turbine of a hydroelectric power station in its vulnerable spots. Potential places of the biggest effort of the structure, as well as the coefficient of displacement and safety factor related to them were identified using FEM numerical method. Pipeline reinforcement was designed and made based on FEM analysis and non-destructive tests.

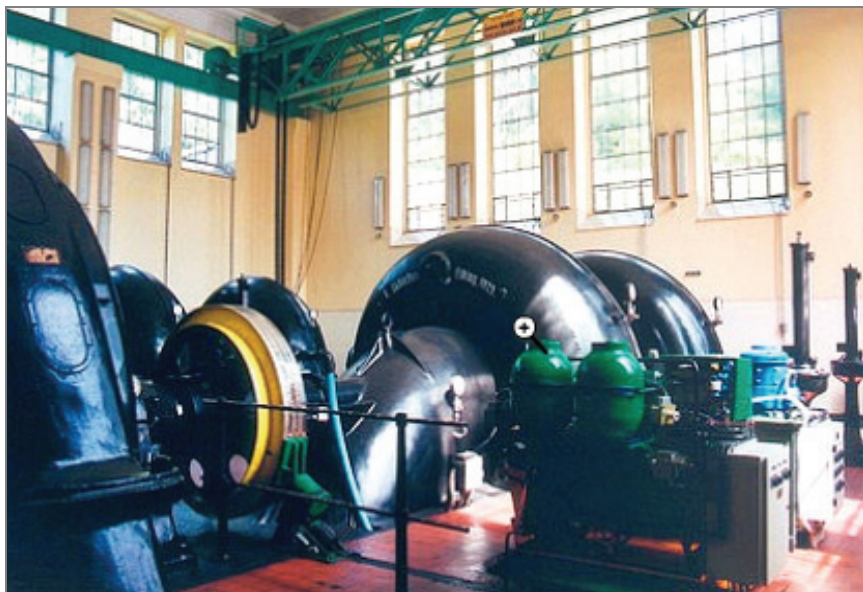
Fig. 1. View of water turbine generators in Łapino.
Source: <http://energia-hydro.pl/2,26,0,Galeria-Lapino.html>

A general view of the water turbine generators of the hydroelectric station discussed is presented in Fig. 1. Figure 2 shows the view of water inlet pipelines between the turbo generators. A draft with selected dimensions is shown in Fig. 3.
