# Results of acoustic emission tests of corrosion protection degree of ship steel tanks covered by means of protective coatings (Phase I)

Henryk Bugłacki  
Piotr Eichert  
Gdańsk University of Technology

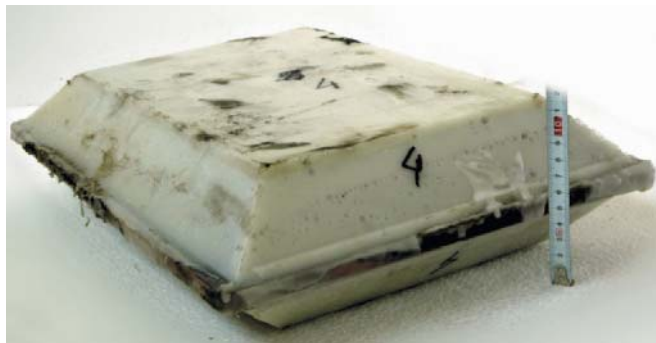
Fig. 2. The specimen covered with the polyurethane layer - concrete filler protective system

In Fig. 2 the specimen covered with the polyurethane layer - concrete filler protective system is shown.
