Research paper

Risk assessment for tram traffic on tramway bridges

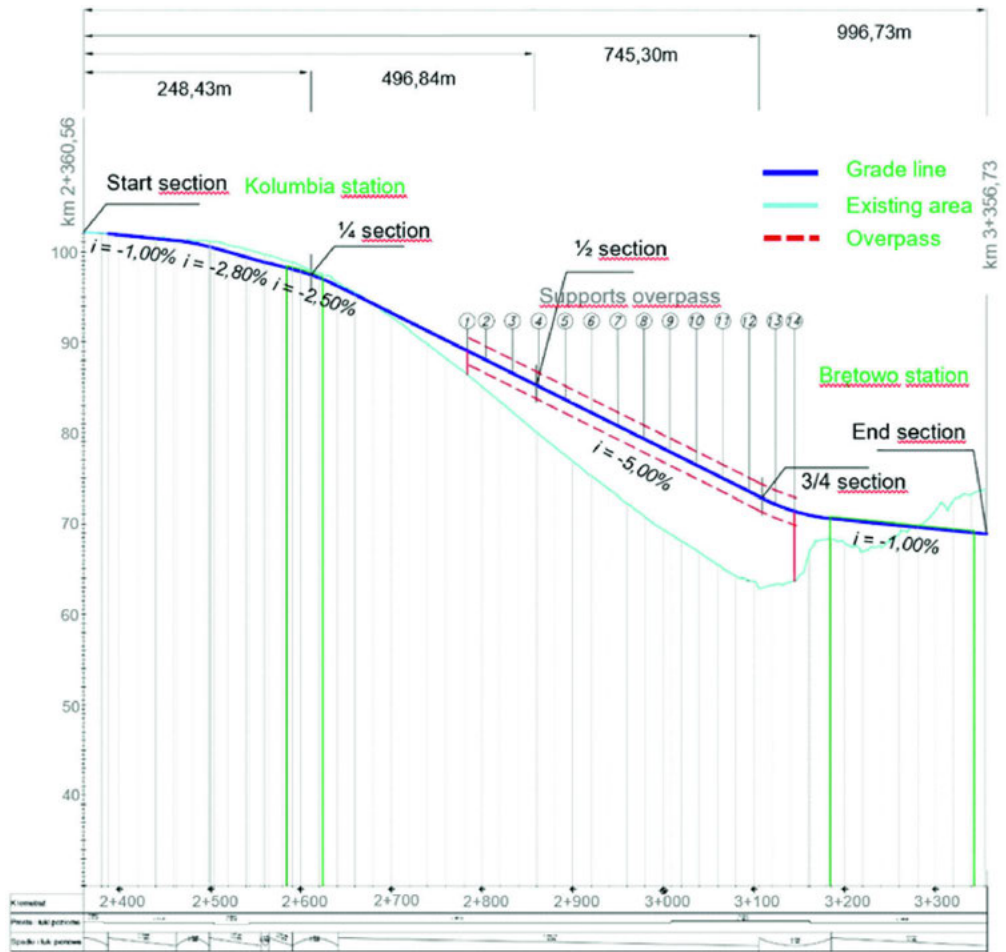
Fig. 3. Diagram of the vertical alignment of the analysed section of the tramway road in Rakoczego St., Gdansk [10]

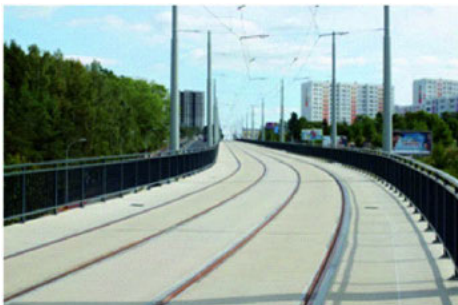
Fig. 4. View of the tramway bridge in Rakoczego St., Gdansk. Source: press materials, trójmiasto.pl

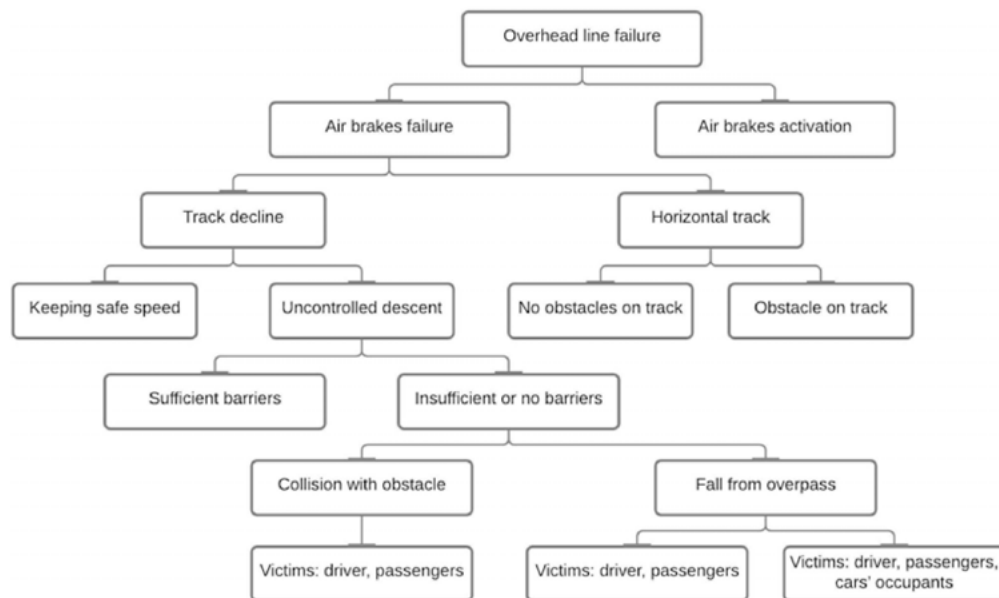
Fig. 5. The cause and effect event sequence during the failure of an overhead contact line – event tree [10]

The cause and effect sequence of events presented in the diagram shows that a failure of the overhead contact line may be the initiating dangerous event on the analysed section of tram tracks located on the overpass. Failure of a tram overhead contact line may cause the vehicle to come to a stop slowly when it is on a flat section of the track. However, where a tram is on a section of the track located on a longitudinal decline (during a power failure), the tram car may start to roll (unable to start in-service braking) in a controlled manner (with the possibility of safety or emergency braking) or uncontrolled manner (unable to engage any braking, e.g. failure or deactivation of the braking system).

Three methods were used to identify the risk of hazards: the event tree method, fault tree method and Bow–Tie method [6, 9, 14, 15, 21]. Fig. 5 shows a diagram of the cause and effect event sequence during the failure of an overhead line.

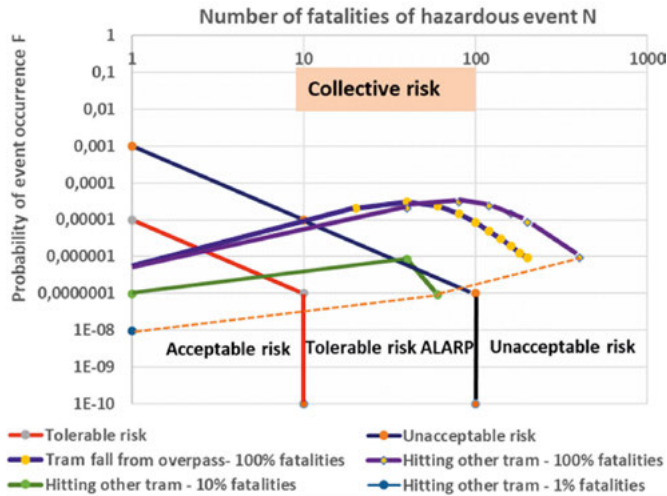
Fig. 9. Distribution of the daily tram passenger load on the analysed section of the line – forecast for 2030 [10]

In the case of collective risk, the EU recommendation [25] was used and a classification dedicated for the needs of tram traffic safety assessment was proposed. Its boundaries are shown in Figure 9. Group risk assessment involves the following steps:

Figure 8 presents graphs of changes in the probability of the potential number of fatalities depending on the number of passengers in the tram (the forecasted passenger load for 2030 was assumed) and the type of a possible hazardous event as a result of an uncontrolled tram descent (falling from an overpass or hitting another tram) [16] against the assumed acceptability limits of group risk.

Using the risk accessibility limits shown in Fig. 9, the level of risk acceptability of a certain number of fatalities in a tram accident was determined. The presented results indicate that the effects of one hazardous event occurring in 30 years, involving an uncontrolled descent of a tram on a steep tramway and falling from an overpass or hitting another tram, poses a very high risk to passengers even at a moderate tram load. In these cases, the **collective risk** of a tram safety hazard on the analysed section of the tramway will be **at an unacceptable level**.
