# Safety assessment of a concrete viaduct damaged by vehicle impact and an evaluation of the repair

**Abstract.** Damage to lower parts of viaducts caused by impact from under-passing high vehicles is relatively frequent. One such incident, in which a viaduct was damaged by the impact from a truck with an improperly assembled hydraulic crane, is considered in this work. The analysis is based on a detailed object damage evaluation, 3D laser scanning, and numerical simulations. The aim of the study is to accurately model the vehicle impact into the viaduct's span. The objective is to diagnose internal damage and to assess the proposed repair concept. No other method will allow discovery of the internal damage, including whether the pre-stressing tendons have been damaged or not. The computational model considers non-linear system dynamics including advanced material definition and the technology of tendon pre-stressing. All complex stages of structural assembly are included in the simulations and the extent of bridge damage is diagnosed. This approach makes it possible to reliably restore the collision event and to assess the safety of internal structural parts. The results from the

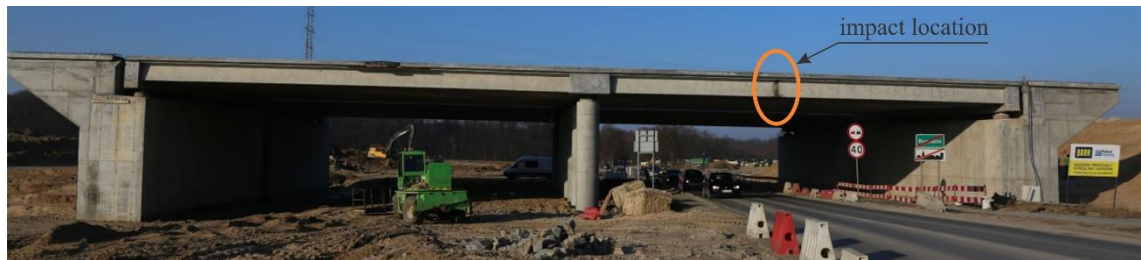
**Fig. 1** General view of the bridge and the location of the impacts.

## 2 Description of the viaduct and the impacts

The WD-113P structure has been damaged due to two impacts. The first, on 10.11.2017, was an impact from a hydraulic lift crane mounted on a truck. This accident damaged the structure substantially. The incident was caused by excessive velocity combined with an inappropriately secured crane. The impact location is shown in Fig. 1 and as a result of this event, the outermost girder was significantly damaged. The second impact took place on 01.12.2017, the consequences of which were scratches to the girder bottoms. The localization of the second impact is near the point of the first impact. The damaged area is shown in Fig. 2 and Fig. 3. Local inspection showed neither unveiling nor damage to the pre-stressing tendons of the girders.

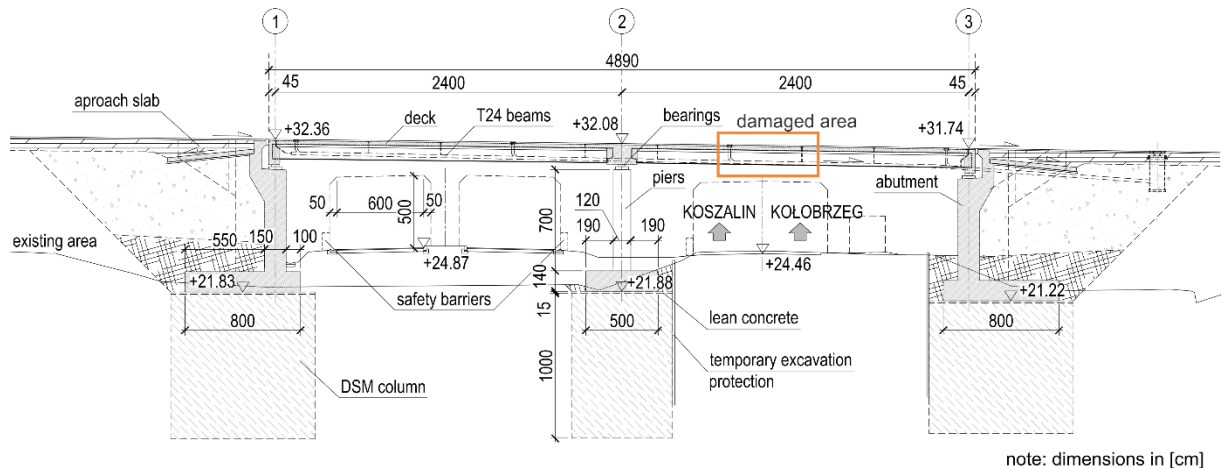
Fig. 3 Side view of the WD-113 viaduct.

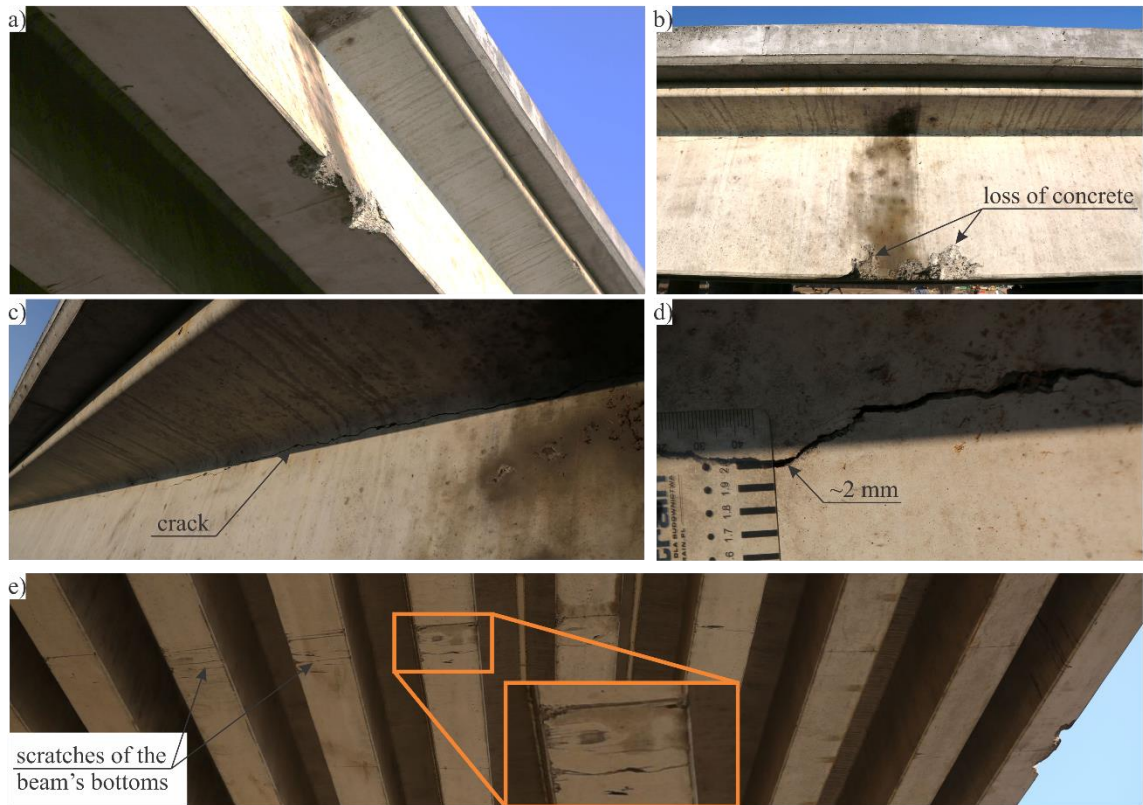
**Fig. 5** The damage to the viaduct, a, b) loss of concrete (first impact), c, d) crack under flange (first impact), e) web scratches (second impact).

The magnitude of viaduct damage measured during the on-site visit is shown in Fig. 4. The following impact damage effects were observed: loss of concrete in the impact location, significant cracks under the girder flange on both sides, diagonal cracks on both sides of the impact location and a hairline crack on the upper side of the slab, between the two outer T-beams. Cracks were also recorded between the web and the flange in the girder interior (Fig. 4, cross section 3-3, bottom view). During the local inspection, the discrepancies of pre-stressing tendons were not observed. Fig. 5 presents the damage overview. As a result of the second impact, the first 13 beams of the object were scratched. The view of the scratches for the first 5 girders is presented in Fig. 4, section 3-3, while the damage photo is included in Fig. 5e.

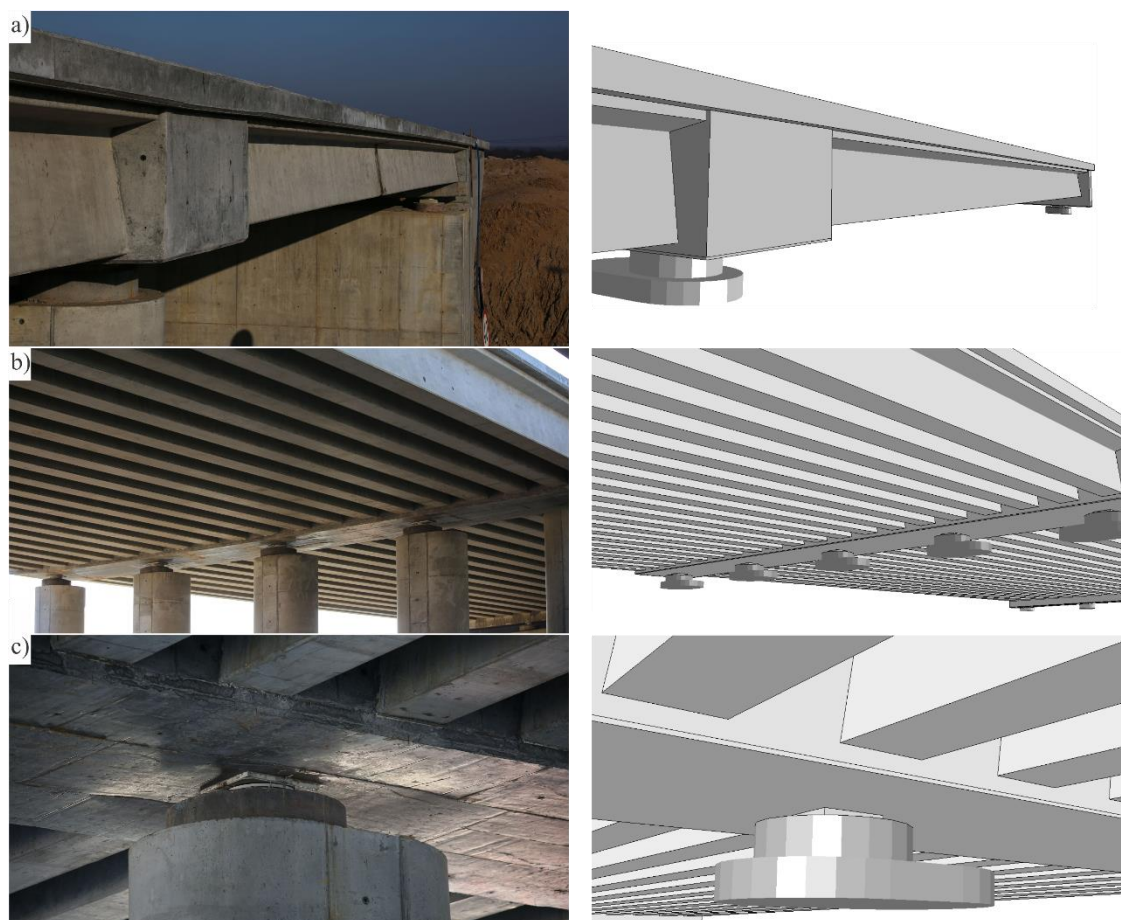
The structure features 20 pre-stressed T-shaped concrete beams assembled with an RC slab. The beams are supported on RC cross girders – two outer, 0.75 m wide and 1.4 m deep, and one intermediate, 2.1 m wide and 1.1 m deep. In the numerical model, the real structure is simplified by means of horizontal, planar geometry modelling, neglecting structural slopes. The outer cross girders are supported on the bridge abutment, while the intermediate cross girder is supported on the columns. The upper part of the columns are modelled only. The supporting of the superstructure on the columns and the abutments is conducted by means of the pot bearings. The connections between the concrete elements are realized by friction forces and by reinforcement that connects these concrete parts. The viaduct modelling procedure made it essential to discretize the system as the efficiency and speed of the central difference method computation is highly affected by finite element dimensions. Fig. 8 compares the numerical model with the real bridge structure.

**Fig. 8** Comparative views of the viaduct, a) side view, b) bottom view, c) detail of the structural support.

displacements and rotations are constrained. This action assumes the overall supporting conditions of the structure. The upper column parts are shown in the right-hand part of Fig. 8. The pot bearings are described in section 5.2.2.

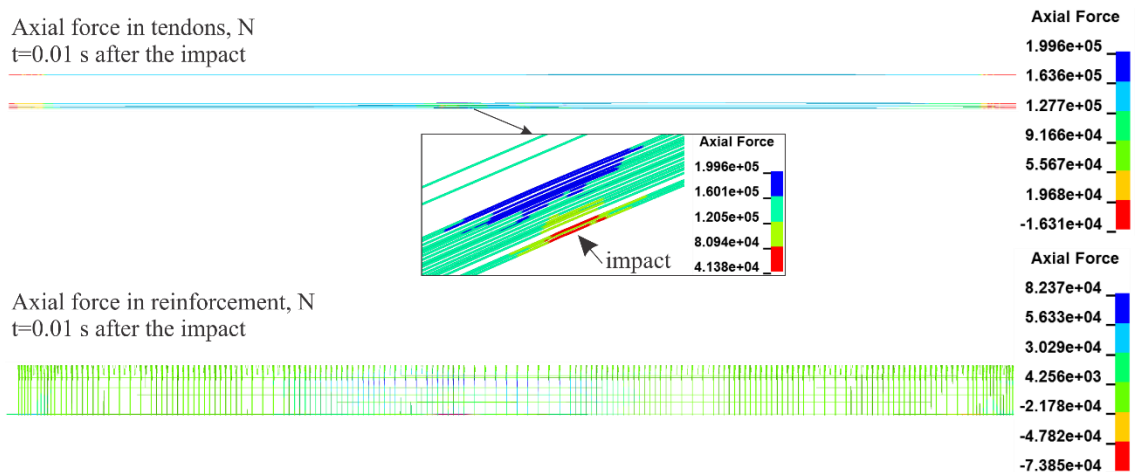
Phase 3 included vehicle entrance and its impact with the girder. The time step was equal to  $3.45E-06$  s. It was decided that the cracking and damage structural pattern would be represented by the maximum of brittle and ductile damage (NPLOTEQ.1). Fig. 16 and Fig. 17 compare the damage of the real structure with a damage pattern based on numerical simulation. In order to make diagonal cracks more visible in the real structure, Fig. 16a is supplemented by thin black lines coinciding with the cracks. The damage from simulation reflects the damage character from the real structure (Fig. 4), featuring concrete loss on the lower edge, a high-dimension crack under the beam's web, diagonal cracks on both sides of the impact spot, a crack on the upper slab surface between the two outer girders, and a flange-web crack at the internal beam section. The highest forces in the tendons were observed on the internal non-impact side of the web. The maximum axial force in the tendon was equal to 199.6 kN and occurred 0.01 s after the collision. The computations reveal that the forces acting on the tendons during the impact did not exceed the tendon axial load-carrying capacity, i.e. 279 kN. On the basis of these results, it can be concluded that, during the impact, the tendon material performed linearly, thus failure did not occur.

**Fig. 18** Axial forces in [N] in the tendons (top) and in the reinforcement and stirrups (bottom).

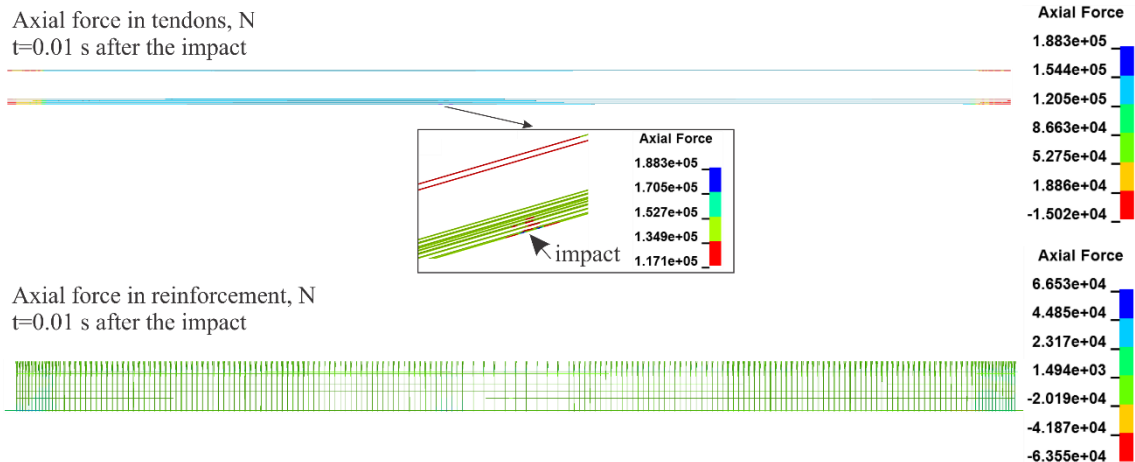
The vehicle impact causes damage to the outer lower T-beam section, causing cracks around the impact location. A crack emerges under the girder flange; however, much smaller than in the case of the non-strengthened structure. Cracks are also detected on the upper surface of the bridge RC slab, between the two outer beams. No significant cracks resembling the non-strengthened case are observed, including diagonal cracks. Fig. 20 presents an overall damage layout resulting from the impact. The forces in the reinforcement and tendons are presented in Fig. 21. The highest tendon forces occurred in the location closest to the impact, the opposite of what was observed in the non-strengthened structural variant. The maximum axial tendon force appeared 0.01 s after impact, and its value, being 188.3 kN, was lower than the maximum force from the non-strengthened structure.

**Fig. 21** Axial forces in [N] in the tendons (top) and reinforcement and stirrups (bottom) for strengthened structure.
