## Selection of the technology of repair works of concrete industrial floors in view of their degree of technical dysfunctions

The paper presents a collection of practical information related to conducting repair work on concrete industrial floors. The article has the character of a case study and refers to specific situations related to the loss of technical efficiency of concrete industrial floors.

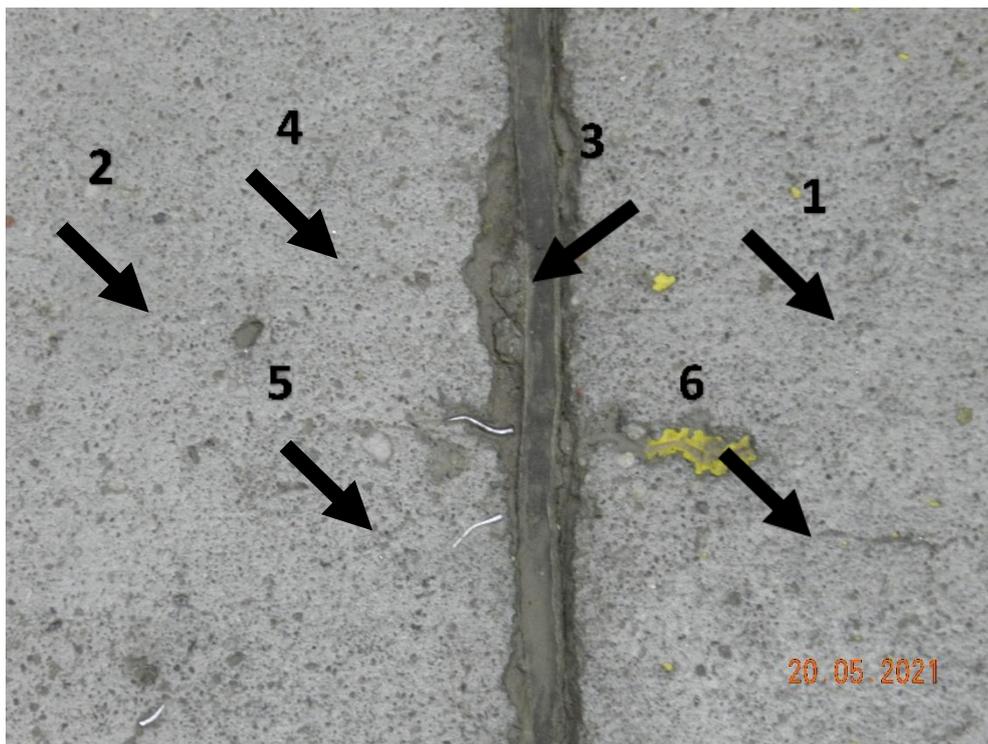
**Fig.1.** Visible signs of wear on the top layer of the floor and the filling of the shrinkage joint (description of markings in the text)

The fastest wear in concrete industrial floors is on coatings and surface coverings such as waxes, acrylics or paints, as well as thin-coat solutions of synthetic resins applied by painting techniques [40÷49]. Fig.1 shows the stages of floor wear. Marked are: 1) abrasion and wear of the top layer of the floor, 2) aggregate losses, 3) separation of the joint compound, 4) chipping of the joint edges, 5) reinforcement fibers visible after rubbing the top layer, 6) micro-scratches in the structure of the concrete.

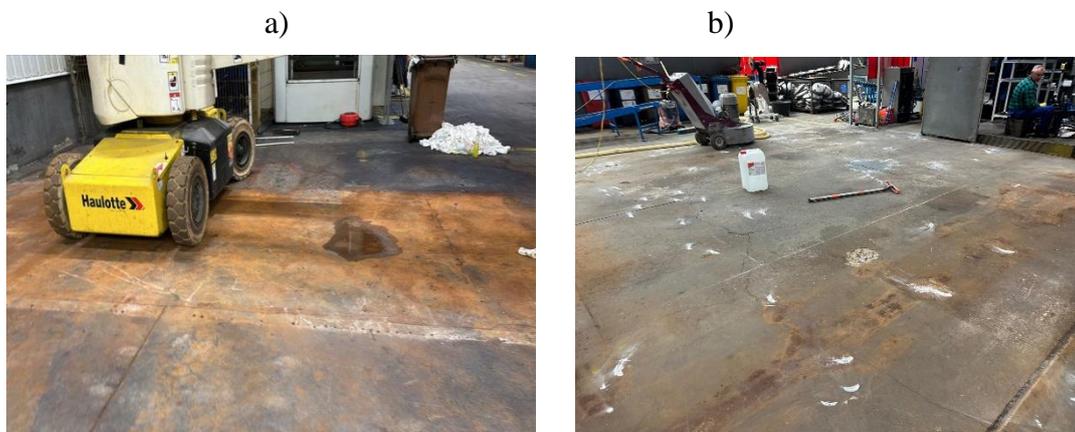
Example 1 is a description of the process of renovation of an old floor, damaged and deteriorated during many years of use, in the state after dismantling the steel plates that make up the top usable layer of the slab, as well as the platform for machinery and equipment (Fig.2).

**Fig.2.** Concrete industrial floor (Example 1) before repair: a), b) after removal of steel plates, visible rust mashing and discoloration on the upper surface of the floor

The repair site required removal of the steel plates and grinding and polishing of the floor to level it and make it suitable for medium load and forklift traffic conditions [25].

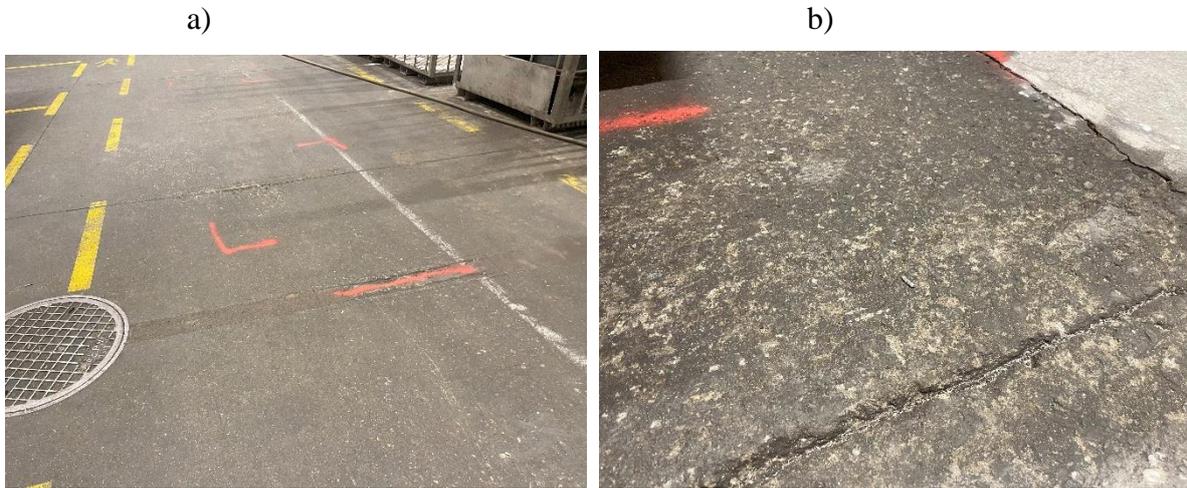
**Fig.3.** Concrete industrial floor (Example 1) before repair: a), b) walkways

Particularly degraded areas were located in the main passageways (Fig.3). In the first stage, machinery and equipment eating into the facility were dismantled, followed by the removal of coverings in the floors in the form of steel plates. An inventory of anchors and cavities in the pavement was made. The anchors were then removed, and the cavities were repaired using a mineral system by filling with mineral compounds and smoothing (Fig.4).

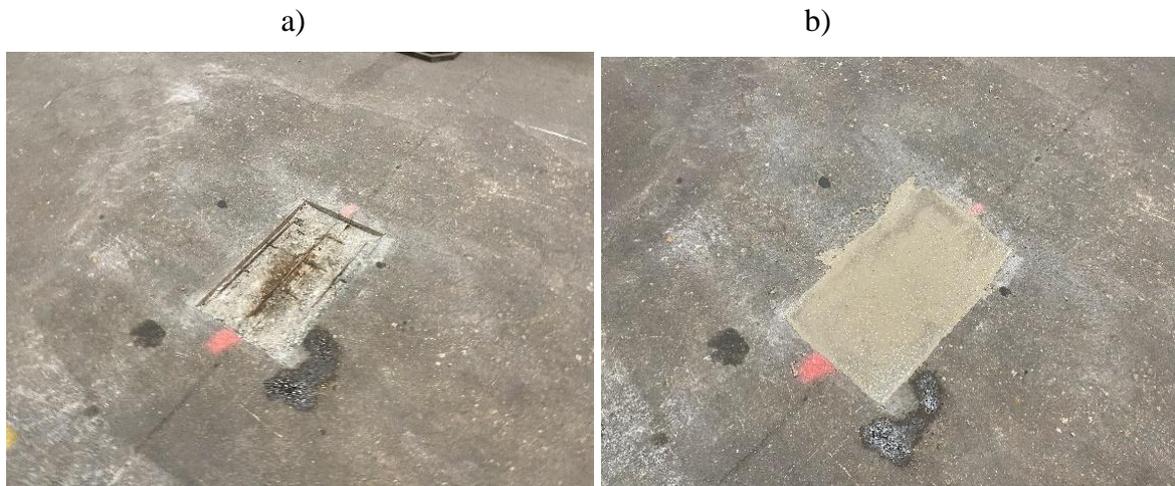
**Fig.4.** Concrete industrial floor (Example 1) filling of defects: a), preparation of work area b) filling of work area with repair compound

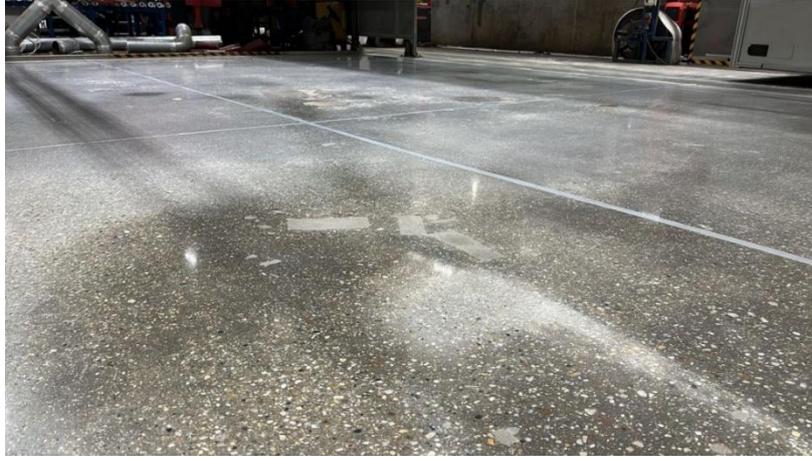
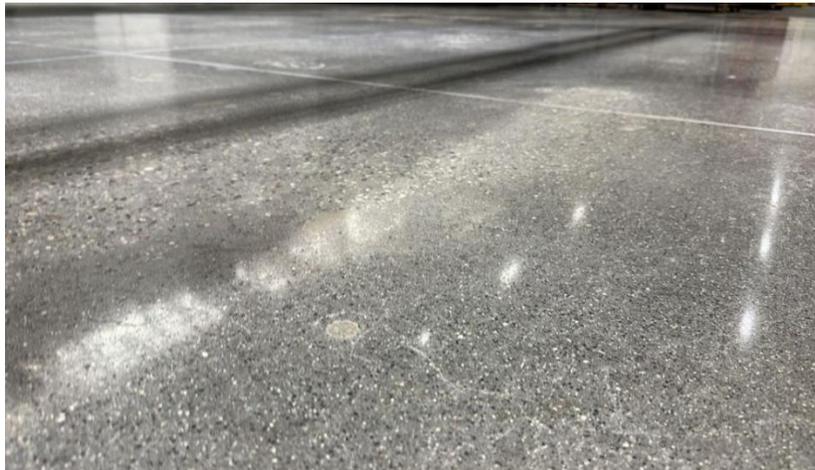
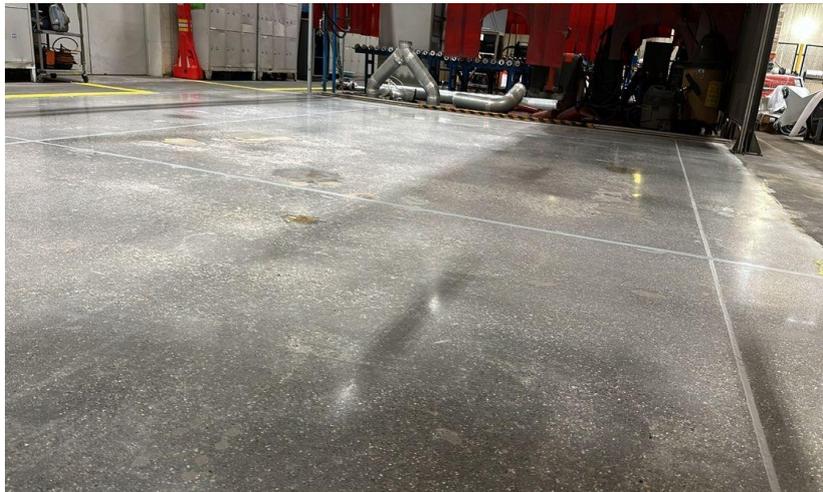
**Fig.5.** Concrete industrial floor (Example 1) after repair: a) view of shiny surface and expansion joint fillings, b), c) view of filled cavities and filled expansion joints

After repair and renovation (Fig.5), the floor gained not only an aesthetic appearance, but also evenness. Before the renovation, the local unevenness measured according to [50] was  $9 \div 11$  mm on a 2 m patch, after the renovation it was 3 mm / 2 m, which corresponds to the increased performance standard of 5 mm / 2 m according to [50]. The smoothness of the surface implied as the degree of light reflection by the matte floor before renovation was estimated at  $\div 5 \div 15\%$ , after renovation more than 70%, where 100% light reflection occurs on mirrored surfaces. Naturally, this was also influenced by the removal of local dirt. The floor also gained increased abrasion resistance, which before renovation was classified as Ar2 [52], while after renovation as the highest abrasion resistance class Ar0.5 [52]. Abrasion tests were performed using the BCA method [21]. Visible signs of quality improvement also include a reduction in the floor's dustiness, as well as a 45% reduction in its water absorption [45].

In the next step, coarse grinding was performed in three steps, successively with metal segments of gradation: 30÷40, 60÷80 and, in the third step, with metal segments of 120÷140 gradation. This was followed by obliteration of surface cracks, using plastic diamond pads of 50 gradation. The floor was washed, vacuumed and impregnated with lithium silicate-based agents.

For the final polishing of the floor, diamond pads of gradation successively were used: 100 and 200. The floor was washed and cleaned of any residual dust from grinding. A polymer-based sealer was applied to the floor to give it the desired performance characteristics. The application of the protective preparation was done using the spray method. After it dried, polishing was proceeded with a white polishing pad using a high-speed polisher, and the gaps were filled with expansion joint compounds.

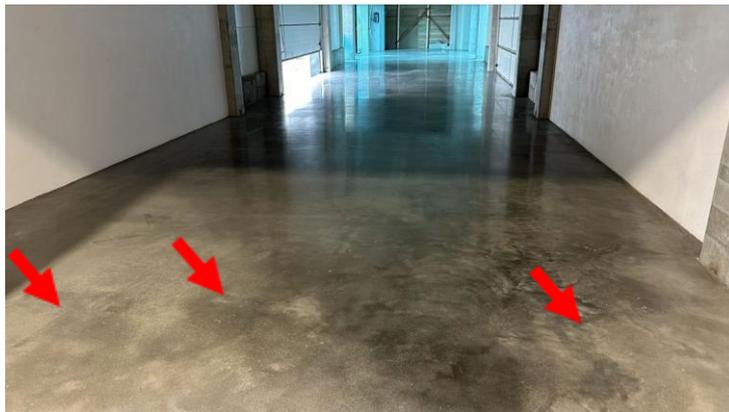
**Fig.6.** Concrete industrial floor (Example 2) before renovation: arrows indicate cold joints

During the execution of the floor, the hall was subject to temperatures exceeding  $35^{\circ}\text{C}$  and drafts. As a result, so-called cold joints formed on the floor surface, the floor was not fully rubbed to a smooth surface (Fig.5). After a period of only a few months of operation due to problems with cleaning, washing and aesthetic properties of the pavement, a decision was made to renovate the pavement in order to improve the overall aesthetics but also to restore it to a condition that would allow normal exploration, including carrying out periodic cleaning work.

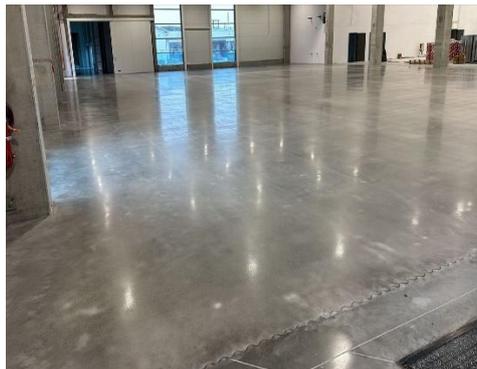
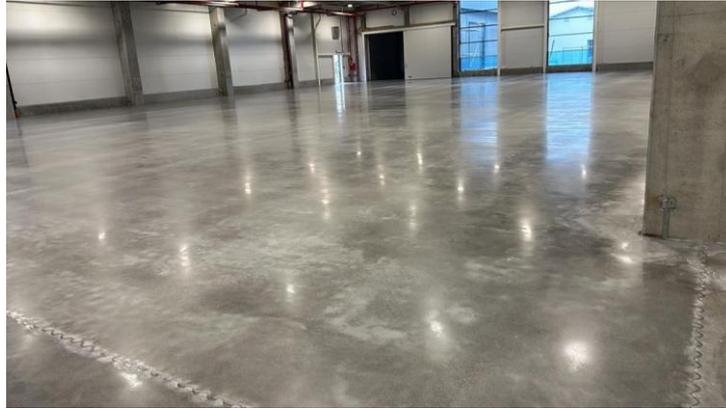
**Fig.7.** Concrete industrial floor (Example 2) after regeneration by polishing and impregnation process: a), b) view of pavement treatment in the area of structural expansion joints

Due to the low level of wear and tear from use, the grinding process omitted the use of metal pads, and the entire restoration process began with grinding with plastic diamond discs with a gradation of 50 in order to perform the so-called “honeying.” The floor was then reinforced with a silicate composite-based impregnant and final grinding was performed with discs of 100 and 200 gradation, which increased its resistance to abrasion and intensive cleaning (Fig.7).
