Solid road environment and its hazards

Abstract. Accidents that involve vehicles departing the road tend to have very high severity, as they often result in the vehicle hitting a permanent obstacle (which can be a tree, a pole, facility pillar, front wall of a culvert or a barrier). In recent years, this type of accident caused approx. 19% of all road deaths in Poland. A particularly high risk can be observed on roads located in northern and western voivodships, with many avenues of trees along the roadside. The paper will present the major road user hazards and their locations, based on the example of detailed analyses conducted for the area of the Warminsko-Mazurskie voivodship in Poland. In the paper, the authors will also present measures that can be applied to improve the safety of road users by improving roads managed by local governments in Warminsko-Mazurskie.

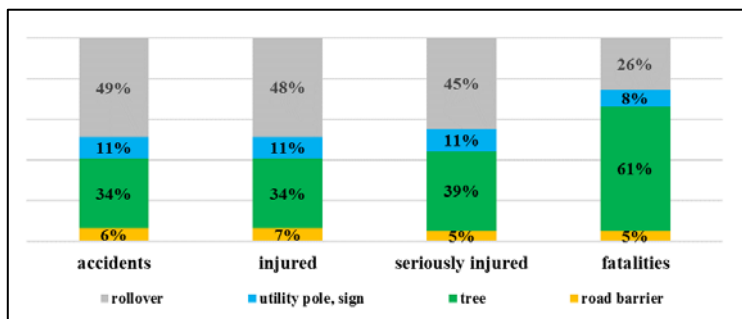
Fig. 1. Types of accidents involving the roadside in Poland.

Between 2013 and 2015 there were 16,500 accidents related to the roadside (11% of all accidents in that period). The accidents involved 20,700 people injured (16%), including 6,400 seriously injured (16%) and 2,100 people killed (24%). Figure 1 shows the types of roadside-related accidents across the country. As much as 61% of fatalities are caused by hitting a tree. The severity of accidents was analysed for the different types of run-off-road accidents (the number of fatalities per 100 accidents). The following are the results: hitting a barrier – 10, hitting a tree - 23, hitting a sign or utility pole – 9, rollover - 7. As the figures show, run-off-road accidents are clearly most severe when they involve hitting a tree.

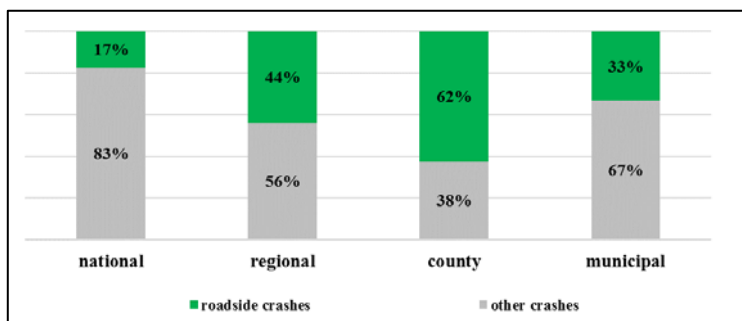
Fig. 2. Share of fatalities in roadside accidents by road category in the region of Warmińsko-Mazurskie.

The region of Warmińsko-Mazurskie was analysed for roadside accidents by road category. Run-off-road accidents are most common on regional roads - 15%, national roads - 9% and others - 10%. As regards fatalities, the majority occurred on other roads at 24%, on regional roads 22% and on national roads 11%. Safety of national roads is much better than in the other road classes. This is because they feature fairly good technical standards and have a high share of upgraded roads (no roadside trees). Figure 2 shows the share of fatalities in roadside-related crashes in the region of Warmińsko-Mazurskie. As much as 62% of casualties occur on county roads and 44% on regional roads.

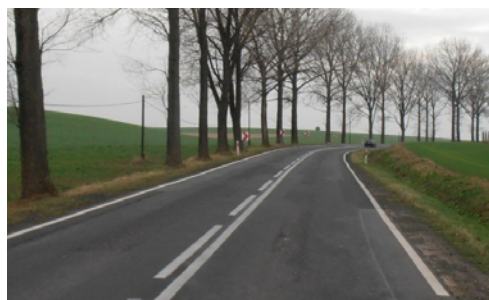
Photo. 3.1 shows a line of trees along the outer edge of a horizontal curve where the risk of running off the road is much higher than on a straight section or the inner edge of the curve. Photo. 3.2 shows very dangerous safety barrier terminations. Photo. 3.3 identifies a risk in the form of the vertical wall of the culvert. Photo. 3.4 shows the different grade of the carriageway and shoulder, clearly a hazard. All the above examples were identified during a check of Poland's national and regional roads.

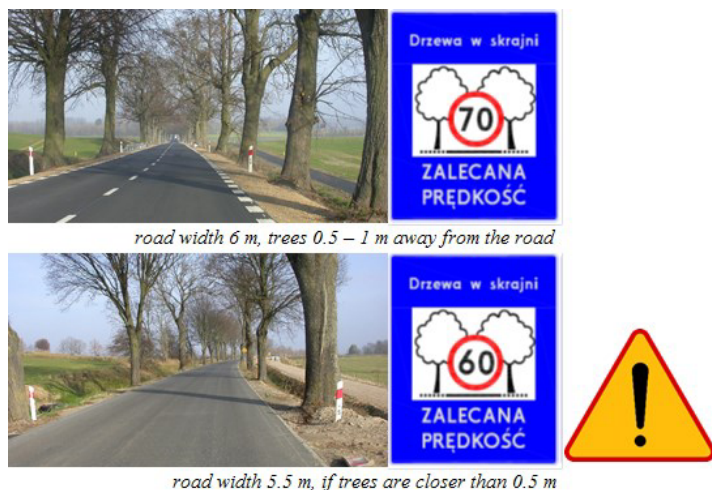
Fig. 5. Recommended speed on sections with trees close to the edge.

A major hindrance at this level is that it only has a very small budget to spend on prevention and treatment. The majority of measures involve signage of trees and sections with trees, speed limits and tree removal. As an example, recommended speed is introduced on sections with trees that are close to the road in the region of Warmińsko-Mazurskie (Fig. 5).
