# SURVEY FOR NEWLY BUILT SPORT FACILITIES

Zygmunt Kurałowicz  
Politechnika Gdańska

Eugeniusz Lepacki, Jacek Śmierzchalski  
FU-H DIAZ Gdańsk

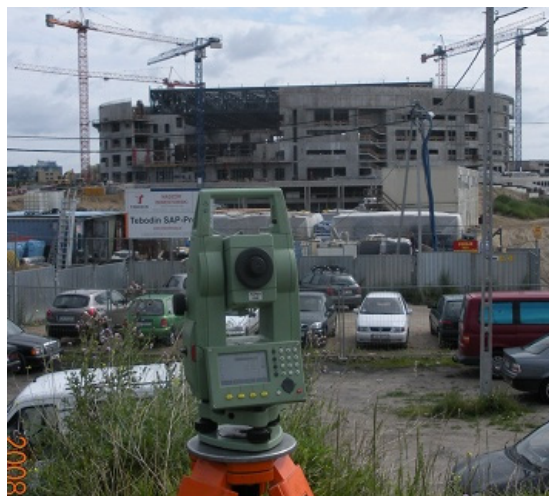
Hall consists of two parts, the bottom is partially sunk into the ground, while the upper part is entirely visible in the form of a simple cylinder (Fig. 2). In the building of Hall, Main Arena with surrounding auditorium of approximately 11.000 seats, and back-up facilities is located. The sport hall serving as a place for warm-up, equipped with a movable rostrum adheres to the main building.

Fig. 2. View of Hall ERGO-ARENA under construction on the administrative border of Gdańsk and Sopot.

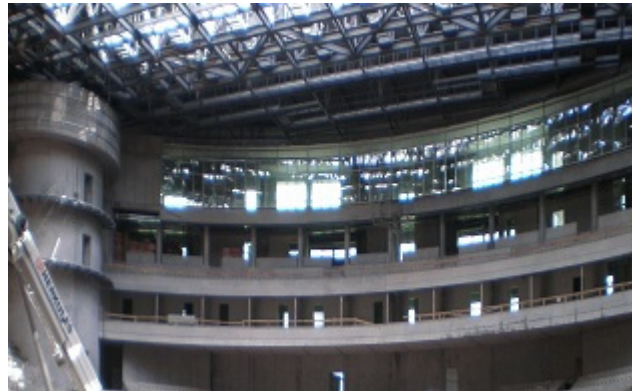
Load-bearing structure of auditorium is a monolithic reinforced concrete slab made of concrete B37 and steel AIII N, based on the walls and pillars and binding joists. Whereas load-bearing structure roof of Hall constitutes a set of four pillars - the pylons with a diameter of 10.800 m and height of 25.000 m (Fig. 3), each of them is rigidly fixed in the pile foundation, articulated to the roof structure, and dilated from the rest of the structure of the object. A roof consists of spatial system of steel truss, supported on reinforced concrete columns, monolithically poured, covered with corrugated metal sheet. The spatial structure is characterized by dimensions of the axes: 70.600 m (length) x 66.600 m (width) x 5.600 m (height) and the axial distances of girders are 6.460 m and 6.060 m, with the technological platforms, attached to their lower flanges.

Fig. 3. View of the pylon and the girder of Hall.

The whole structure is connected to the pylons by bearings, what allows horizontal sliding at the distance 6 - 9 cm. Roof structure was made with contr-bending by reducing the length of individual cross braces. The roof of the hall is supported in four points (in the corners) by means of cranial bearings with teflon lining, allowing the free rotation in each of the supports and the movement in the three corners (in the directions described in the drawings). These bearings allow displacement of the structure resulted from temperature changes, and deflection of the structure. Despite the previously mentioned division, dilatations with the radial course, into eight sections was also anticipated.

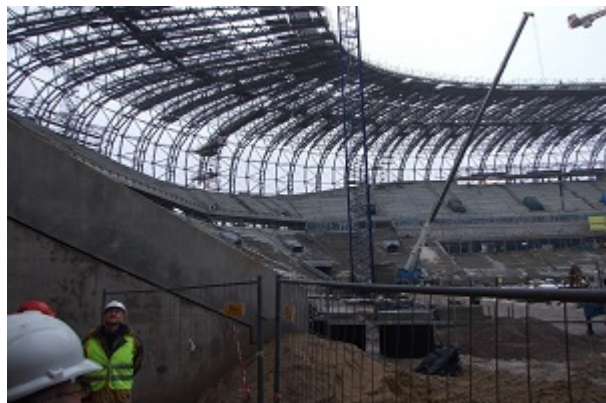
Fig. 4. View of the girders from the side of the pitch - the second stage of assembly.

The sport facility takes about 3.3 hectares, while the dimensions of the stadium are: length 236.000 m, width 203.000 m, height 45.000 m. The roof of the stadium consists of 82 girders weighing 66 tons each (Fig. 4 and 5), supported on independent bearings fixed in the ground parts of the object - a reinforced concrete structure by means of 8 anchors.

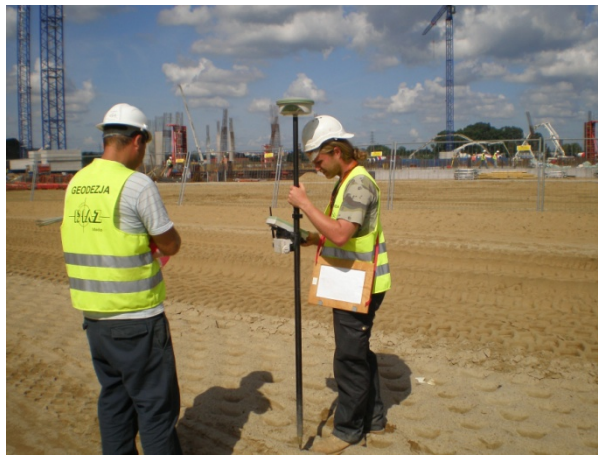
Fig. 8. Staking out axis of heads of reinforcing subsoil piles by means of GPS.

there were 6 - 7 teams. Used instruments are: TCR400 and TCR800 and TCR1201 of Leica. In staking out the axis of the reinforcing subsoil piles GPS was used (Fig. 8).

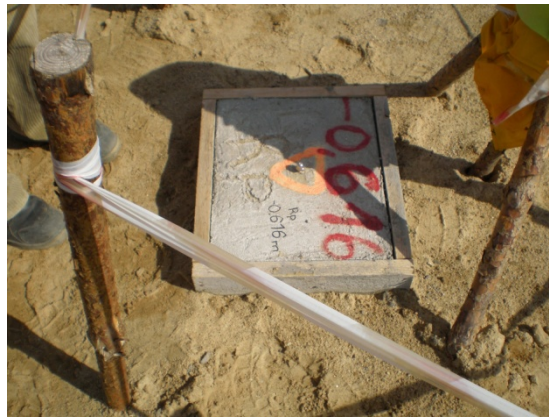
Elements of network connected to the national network of 3<sup>rd</sup> class: 6 points - a geodetic prism affixed to the slab roof of surrounding tall buildings, 15 points - reflective targets on facades of buildings, a ground point - stainless steel bar settled in a concrete block in the middle of the pitch (Fig. 10). Deviations ( $dx$  and  $dy$ ) of newly-assigned points do not exceed 4 mm with a maximum length of 800 m. Detailed geodesic network was the development and densification of the basic realization network and consisted of 80 points signaled by reflective targets. The accuracy of alignment of points is 1 - 2 mm.

Fig. 10. The central geodetic mark - located in the middle of the stadium plate.

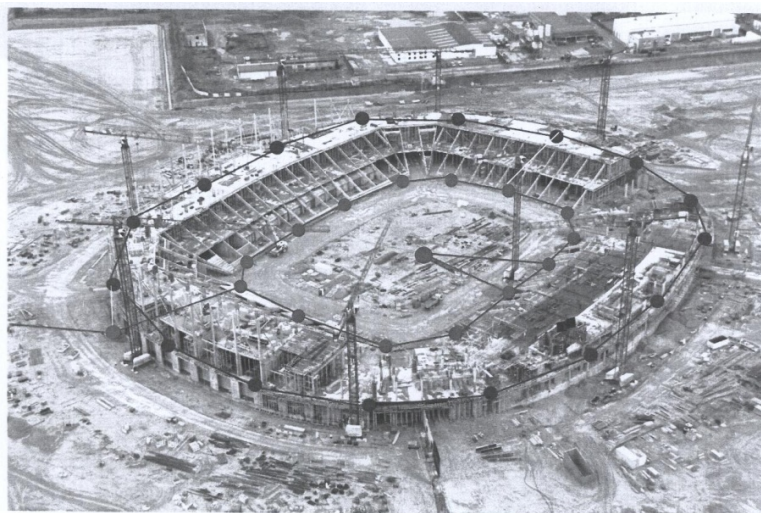
Fig. 11. Vertical geodetic network on the construction site of the stadium.

Vertical geodetic network was designed as two ovals at two levels of the object with the height difference of 6.000 m (Fig. 11): horizontally at the base of foundation, vertically in reinforced concrete of roof and was connected to the national vertical geodetic network (three bench-marks at a distance of about 800 meters from the stadium). The construction project assumed that the settlement of construction should not exceed 100 mm, and the differences of settlement should not exceed 10 mm.
