Technical Limitations in Merging Secular and Sacred Functions in Monumental Churches

Ksenia Piatkowska¹

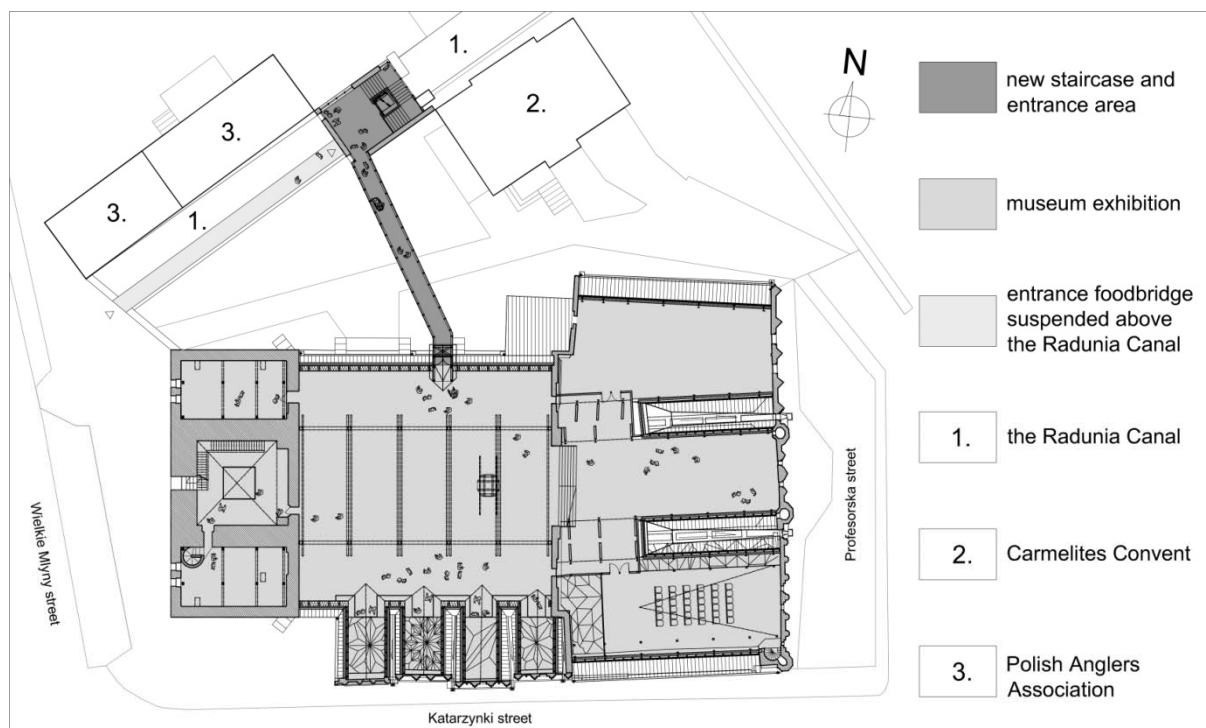
Figure 1. The museum exhibition and the new staircase building with the entrance area - plan on the level +11.70 m.

The scheme of functionality relevant to the architectural design for the New Museum of Science was developed by the Historical Museum of the City of Gdansk. It consisted of the following areas: entrance area for ticket sales and info point, a small museum shop and cloakroom, a zone for permanent and temporary exhibitions, conference hall and educational zone, areas for preparing exhibitions, toilets for visitors, museum offices and social facilities for the museum staff (figure 1).
