TECHNOLOGICAL CONSIDERATIONS OF PERIODIC REPAIR WORKS OF CONCRETE INDUSTRIAL FLOORS

The paper presents a collection of practical information related to conducting periodic repair work on concrete industrial floors. The article is a case study and addresses specific situations related to the loss of serviceability of concrete industrial floors.

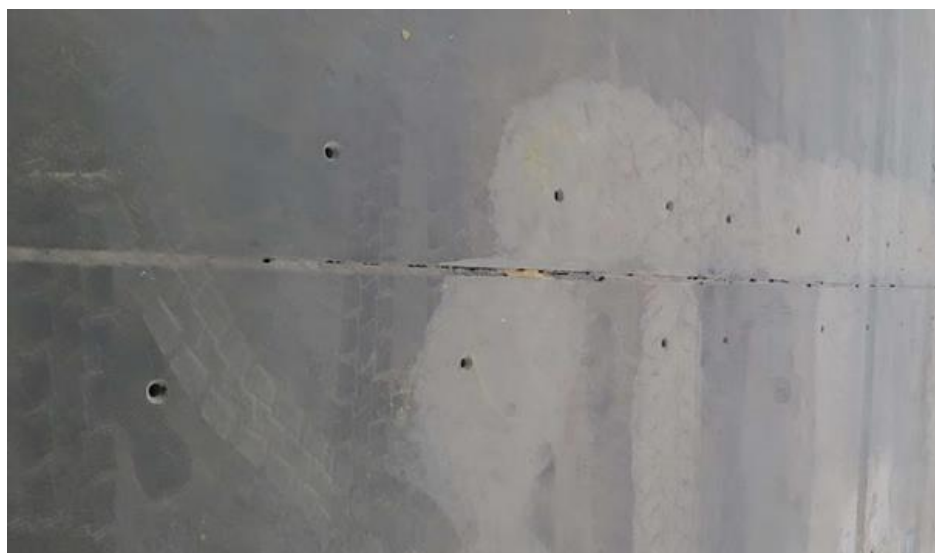
Fig.15. Concrete industrial floor (Example 4) during repair: diagram of drilled holes for injection feeding [38]

The repair by injection consisted of drilling ~14 mm diameter holes in the floor along the working expansion joints (Fig.15). The holes were drilled to the full thickness of the floor alternately on both sides of the expansion joints. The distance of the holes from the edge of the slab is ~30 cm, and the spacing between adjacent holes does not exceed 60 cm. At the corners of the slabs, it was recommended that the spacing be halved to maximize stabilization of the most sensitive areas.
