Article

Visual Capacity Assessment of the Open Landscape in Terms of Protection and Shaping: Case Study of a Village in Poland

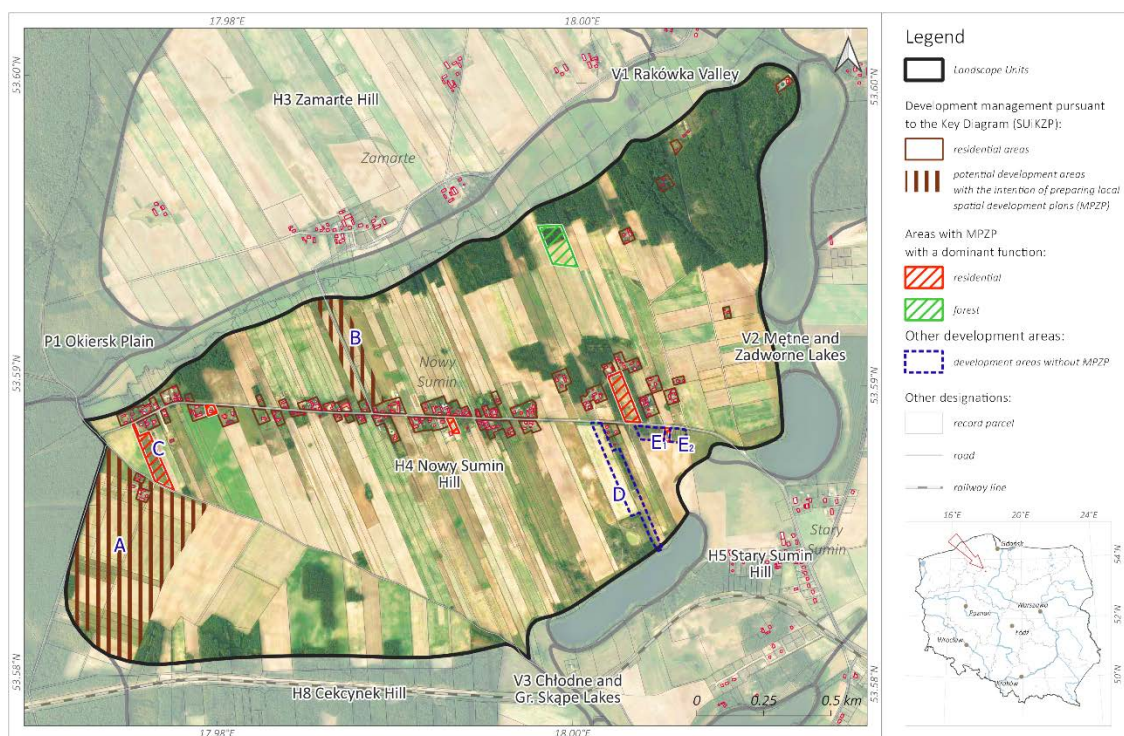
Figure 4. Development of the village of Nowy Sumin with its landscape surroundings in the area of H4 Nowy Sumin Hill landscape unit. The figure shows areas of the current village development and areas of anticipated development with the largest A, B, C, D, E₁–E₂ areas.

Nowy Sumin is among the villages in the commune with the largest expected increase in population by 2045. According to the Key Diagram (SUiKZP), the commune [16] has exhausted the possibilities of siting new development based on the local spatial development plans in force. Five local spatial development plans (MPZP) with a residential function are currently applicable to the area in question. As a result of a simulation conducted with reference to an increase in housing needs and to assessing the possibility of siting new development in areas with a developed structure and areas covered by local development plans, the decision was made to designate new investment areas with a dominant residential, service or resort function. The locations of new development areas assigned with various planning status are presented in Figure 4.

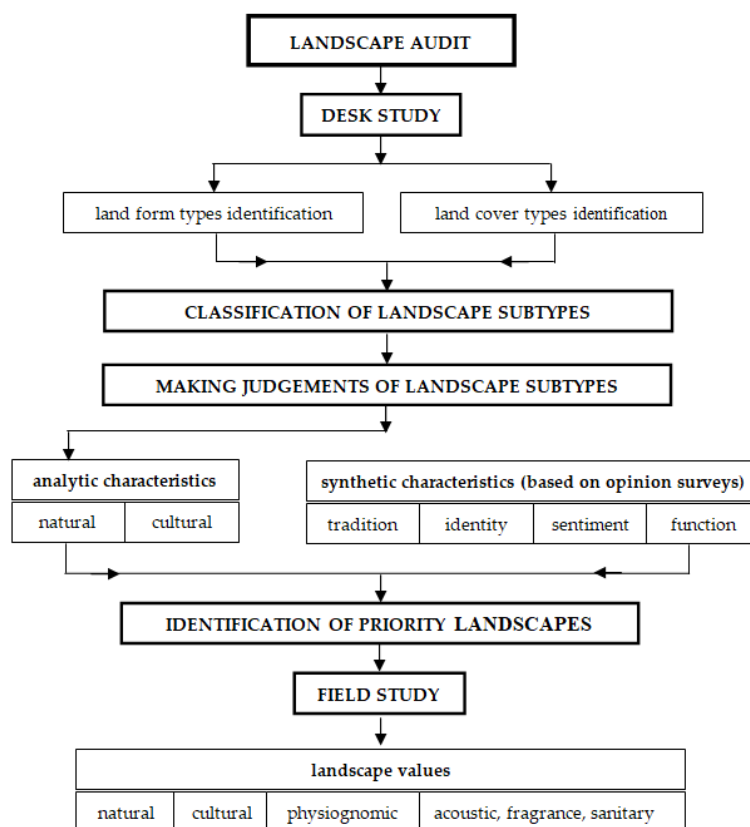
Figure 10. Methodology of landscape audit carried out in Poland on a regional level. Physiognomy study conducted only for priority landscapes.
