Article

Advantages of the Application of the Temper Bead Welding Technique During Wet Welding

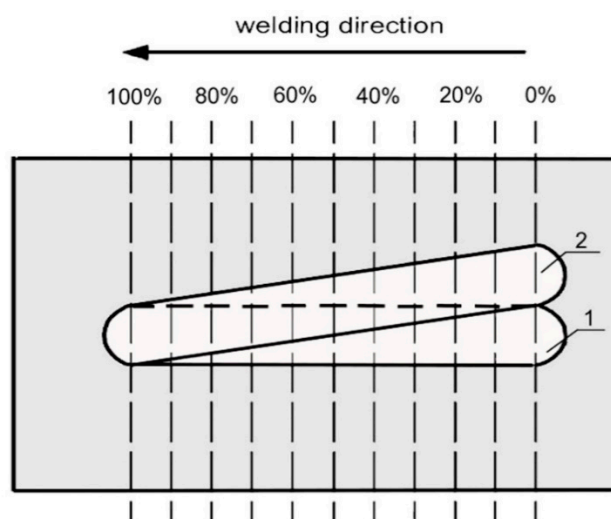
Figure 1. Scheme of the temper bead welding (TBW) technique specimen, 1—first (tempered) padding weld, 2—second (tempering) padding weld.

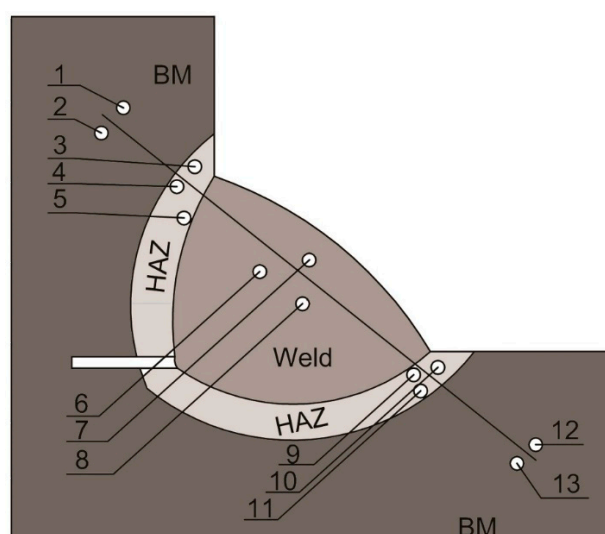
**Figure 2.** Hardness point distribution in the CTS specimens.

The hardness measurement scheme for CTS testing is presented in Figure 2. Figure 3 shows the regions of the TBW specimens in which the hardness was measured. The hardness measurements in the first padding weld of the normalization area of HAZ (HAZN) and the overheated area of the HAZ (HAZO) were located in the HAZ at the axis of the first bead.

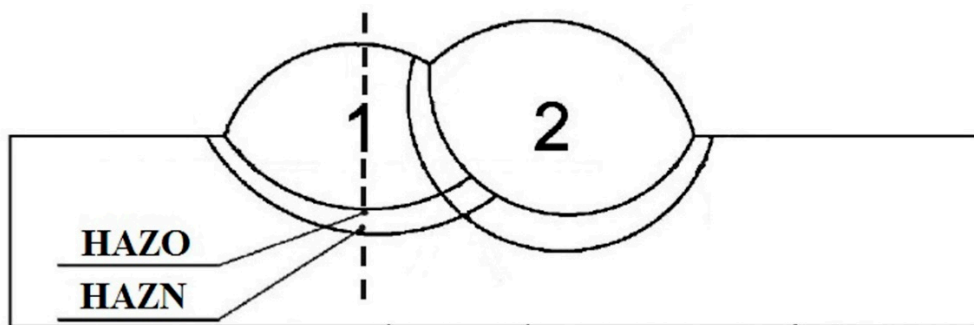
Figure 3. Hardness measurement areas of the heat affected zone (HAZ)—TBW specimens, overheated area of HAZ (HAZO) of the 1st padding weld in the weld axis, normalization area of HAZ (HAZN) of the 1st padding weld in the weld axis.

The hardness measurements were performed on cross-sections of each specimen with all ranges of pitch. The hardness was measured at points in two specific areas of the HAZ (overheated and normalized) of the first tempered weld (Figure 3). The results of the hardness measurements are presented in Figure 7. When the pitch between two beads increased, the hardness in the HAZO of the first padding weld decreased. The HAZO area in the specimens with low pitch values was characterized by the presence of the coarse-grained brittle structures created by the highest cooling rate in the welded joint (Figure 6b). These types of structures are one of the factors responsible for cold cracking. Thus, the HAZO area has a crucial influence on the formation of cracks.

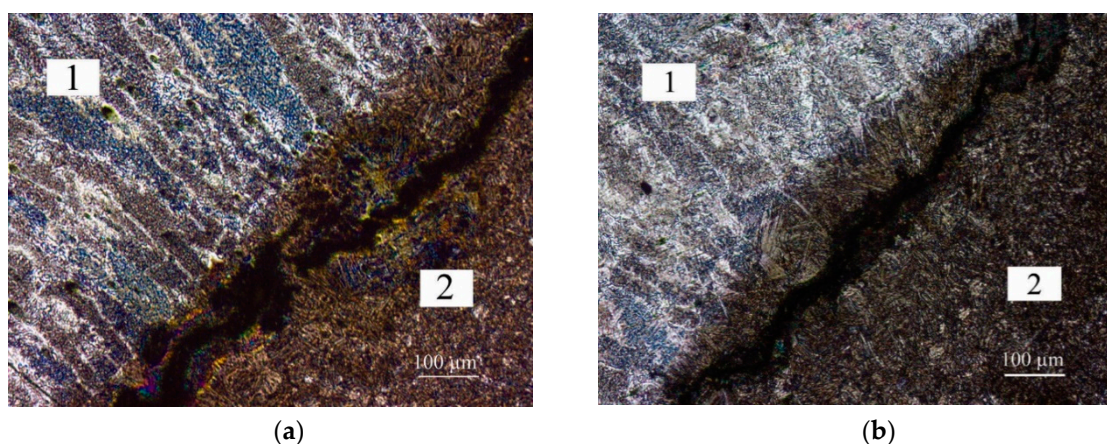
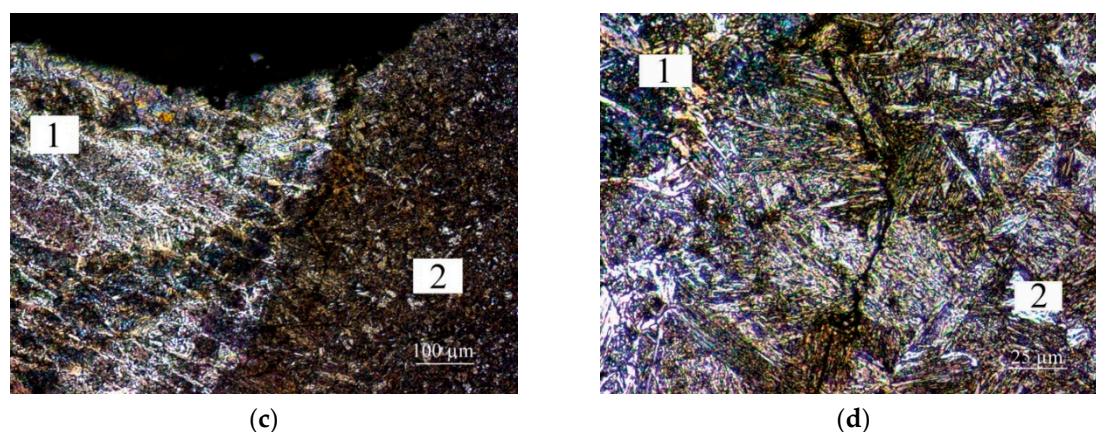
Figure 4. Cont.

Figure 4. Results of CTS microscopic testing shows cracks in HAZ, 1—weld metal, 2—HAZ, (a) Specimen 1; (b) Specimen 2; (c) Specimen 3; (d) Specimen 6. Etch. Nital 4%.

After non-destructive testing, second welds from specimens 1, 2, 5 and 6 were rejected from further examinations due to significant imperfections. The remaining welds were capable of undergoing further examinations. In the HAZ of each specimen, acicular and martensitic structures were found, which are a result of rapid cooling during welding in the water. The short cooling time also caused high residual stresses and limited the extraction of diffusible hydrogen in the welding environment. The weld metal structure was built of dendrites. The results of the microscopic examination of CTS specimens are presented in Figure 4. During macroscopic testing, cracks in the HAZ of the two specimens (the first weld in specimen 4 and specimen 6) and in weld of one specimen (first weld in specimen 4) were observed. The cracks in the HAZ were initiated in the weld root and propagated along approximately 50% of the length of the fusion line. This area was characterized by an overheated, coarse grain, martensitic structure as is shown in Figure 4a,b. The cracks were observed in the welded joints that were made with the lowest value of heat input (ql). Microscopic examination of S460ML steel showed that cracks occurred in all joints welded in the water environment. These cracks were located in the HAZ, along the fusion line. It was estimated that the total length of these cracks were 30%–40% of the total length of the fusion line. Cracks in the weld also were revealed.

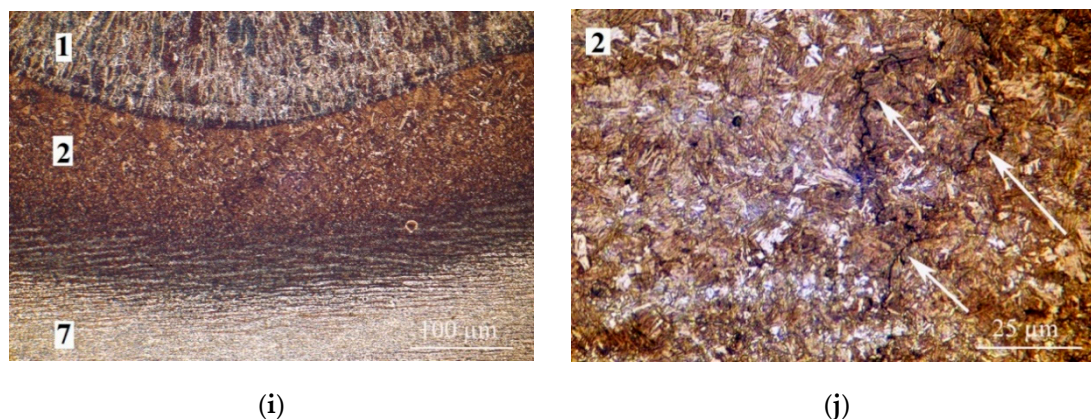
Figure 6. Cont.

Figure 6. Results of TBW microscopic testing; 1—first bead, 2—HAZ under first bead, 3—area of the HAZ of the second bead overlapping the first bead, 4—HAZ of the second bead overlapping the HAZ of the first bead, 5—second bead, 6—HAZ under the second bead, 7—base metal. (a,b) pitch 11%; (c,d) pitch 43%; (e,f) pitch 55%; (g,h) pitch 73%; (i,j) pitch 100%. Etch. Nital 4%.

The results of the microscopic testing are presented in Figure 6. The welds in each of these specimens showed dendritic structures (Figure 6a, area 1). There was bright, fine-grained ferrite arranged in columns, from which grew acicular ferrite at the boundaries of the dendrites. Inside the dendrites there were fine ferrite grains. The structure of the HAZ was different. Near the fusion line, there were expanded quasiperlite grains with a structure following the Widmannstätten system (e.g., Figure 6b,c, area 2). The structure of this zone also indicated the presence of bainitic hardening structures and low-carbon martensite (Figure 6d). In the areas located the furthest distance from the fusion line, there were normalization structures with fine ferrite and pearlite. In all specimens, changes due to the tempering bead were observed. With the highest value of the pitch between two beads, there was a partial disappearance of the structure of the dendritic base bead and the formation of a ferritic fine-grained structure (e.g., Figure 6e,f, area 1). In the HAZ, the heat of the tempering beads refined and tempered the coarse-grained zone of the first bead (Figure 6g). When the pitch increased, the grain size decreased. TBW provided local heat treatment of the joints. The maximum hardness values for wet welding appeared in the coarse grained HAZ [37]. The grain size decreased during TBW (Figure 6h,i, compare with Figure 6a–d), which led to a reduction of hardness in the HAZ. The pitch increased and the number of cracks decreased. However, TBW could not repair the microcracks that occurred during the welding of the first bead and could even propagate these cracks (Figure 6j). Cold cracks can occur up to 48 h after welding is completed. TBW was used in the 120 s after first bead was laid, thus this technique reduced the probability of the occurrence of these cracks.

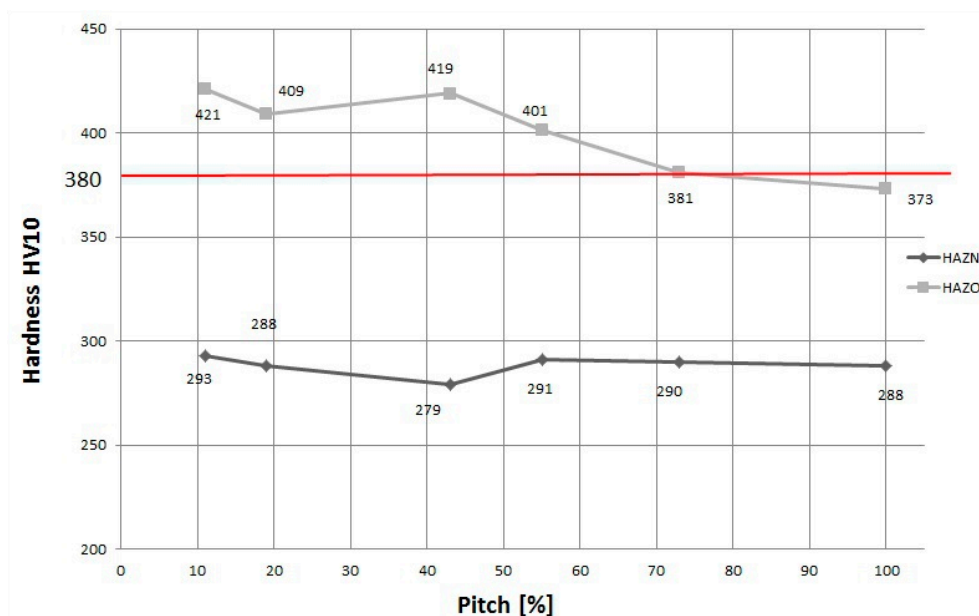
Figure 7. Hardness distribution for specimens with different overlap values in HAZO and HAZN areas of the first (tempered) weld.

In all CTS specimens the hardness was greater than 405 HV10. The HAZ of the tempered beads showed a significant reduction in hardness after using the TBW technique. For specimens with a pitch in the range of 75%–100% the hardness values were below 380 HV10 in the overheated area. In the HAZN, no significant changes in hardness were observed. The comparison in hardness decreased in
