Analysis of the state of preservation the historic arcaded houses in Vistula Delta listed in the National Inventory of Historical Monuments

Abstract: Historic arcaded houses are part of the material heritage of the Vistula Delta. Unfortunately, their number is decreasing year by year. The article is the result of a query of available sources and field research carried out by the author in 2015-2020. The paper presents the current state of preservation the historic arcaded houses in Vistula Delta listed in the National Inventory of Historical Monuments. Criteria for the selection of test objects are described. The author has prepared a tabular list of arcaded houses with information about their location, type according to Kloeppel statistics, date of construction, technical condition and functions. The summary of the analysis are pie charts with a statistical presentation of the data collected by the author during the research.

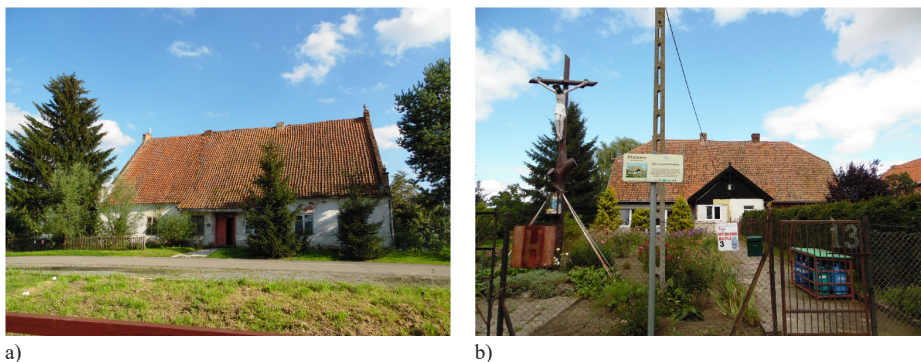
Some houses have lost their avant-corps as a result of breakdowns or reconstructions and are no longer arcaded houses. Examples of such activities are houses in Marynowe no. 23/25 (Fig. 4a) and Stalewo no. 18 (Fig. 4b)²⁷.

Fig. 4. Houses in: a) Maynowy no. 23/25 b) Stalewo no. 18 (*photo by the author*)

²⁷ The house was heavily rebuilt, completely lost its features of an arcaded house, decorations were removed.

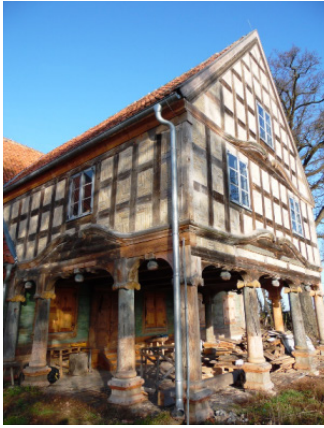
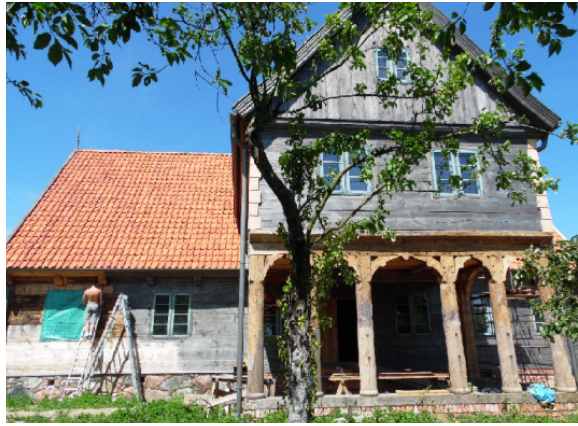
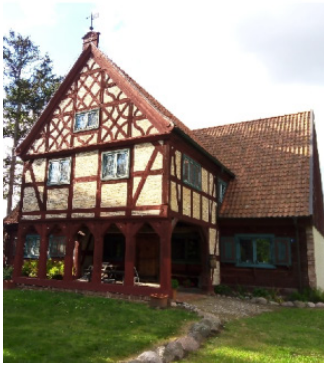
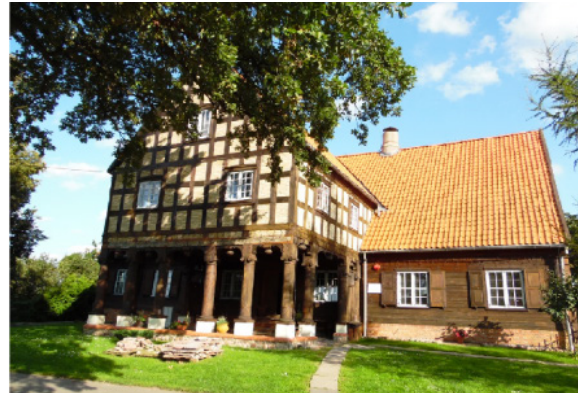
Fig. 5. Arcaded houses in: a) Orłowo no. 66, during construction and conservation works in 2015, b) Miko-szewo no. 55, during construction and conservation works in 2017, c) Przemysław no. 4, d) Marynowy no. 19 / 19a (photo by the author)

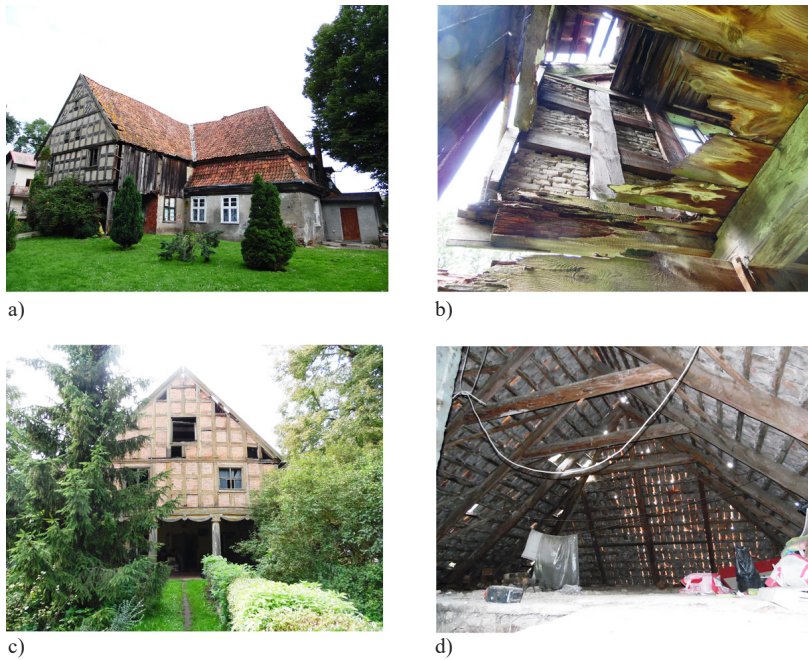
12 houses (27.91%) are in a very good technical condition, 19 houses are in a good condition (44.19%), 10 houses are in sufficient condition (23.26%), 2 houses are in insufficient condition (4.65%) – monuments in Steblewo (Fig. 6) (Graph 3).

Fig. 6. Houses in: a) Steblewo 22/24, b) Steblewo 22/24 the catastrophic condition of the gable wall of the portico, c) Steblewo 15/17, d) Steblewo 15/17 leaking roofing (*photo by the author*)

This number is likely to decrease within a few years. Two houses in Steblewo require immediate construction and conservation works. Their technical condition is insufficient. Lack of adequate funds for repairs and little involvement of the owners in saving them will result in the loss of more monuments from the 18th century.
