POLISH MARITIME RESEARCH 3 (115) 2022 Vol. 29; pp. 167-175 10.2478/pomr-2022-0037

APPLICATION OF THE CORROSION TESTER IN CORROSION TESTS USING THE ACOUSTIC EMISSION METHOD

Krzysztof Emilianowicz **
Milena Supernak **
Agnieszka Ossowska
Gdansk University of Technology, Poland

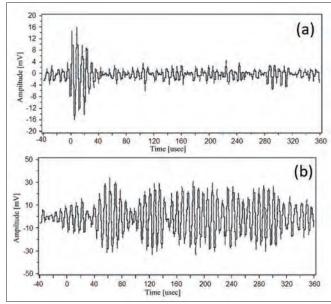
of the released internal energy. A wave formed in this way (Fig. 1(a) and Fig. 1(b)) is registered by the acoustic sensor. In the case of pitting corrosion monitoring, events arise from cracks in the passive layer that form on the surface of the corrosive metal. The events that become the source of wave emissions may be low-energy or high-energy events and determine the progress of pitting formation.

Fig. 1. Run of (a) short wave, (b) reflected wave [26].

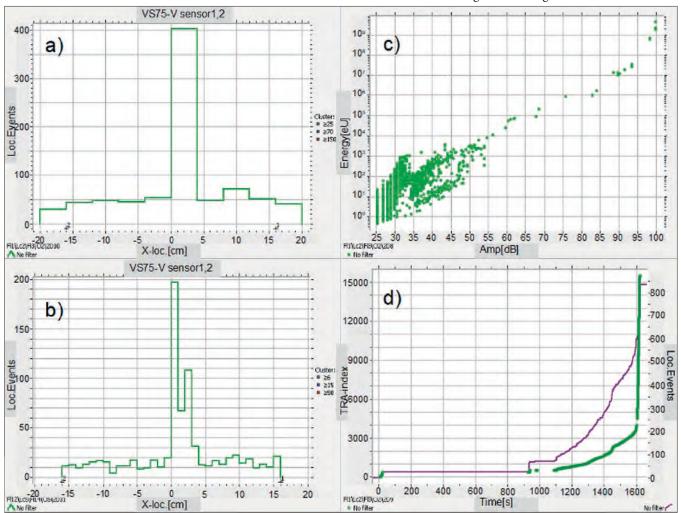
The presented test results prove the possibility of continuous detection of acoustic signals from the corrosion tester. It gives a stable and clear 50 dB signal that stands out clearly from the rest of the acoustic background during the measurement, which

Fig. 7 The KE-2 corrosion tester and its background detectability for VS 75-V sensors, a), b) - the relationship between the location of the tester in relation to the sensors and the number of events recorded by the system, c) the dependence of the signal amplitude given in decibels (dB) to the released energy, d) graph of the measurement time and the number of events.

fluctuates around 20-30 dB, as shown in the graphs (Fig. 7c and 8c). This is a similar result to that found by [25], which is characteristic for the amplitude of the signal originating from corrosion occurring in steels in seawater. The corrosion signal obtained in the laboratory during corrosion tests also corresponds to the amplitude of the signal obtained during further tests carried out on real objects [26]. It can be observed that the tester is visible against the background noise coming from the laboratory. A clearly visible increase in energy in the places where the acoustic sensors of both VS75-V and VS150-RIC are attached, can also be observed. This proves not only the possibility of detecting the signal coming from the corrosion tester, but also the possibility of its partial localisation, which is very well illustrated in the graphs in Fig. 7a, 7b, 8a and 8b.

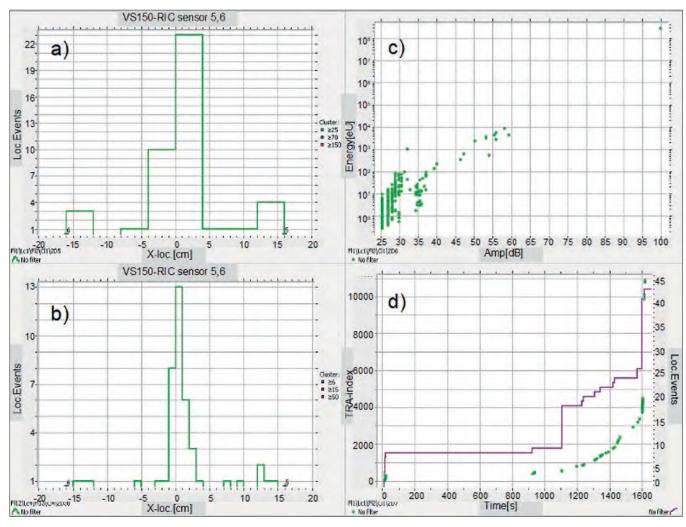
Fig. 8. The KE-2 corrosion tester and its detectability for VS150-RIC sensors. a), b). dependence between the location of the tester in relation to the sensors and the number of events recorded by the system, c) dependence of the signal amplitude in decibels (dB) to the released energy, d) dependence of the measurement time of the number of events
