# Can Historic Interiors with Large Cubature be Turned Acoustically Correct?

The paper is a presentation of architectural interference in three historic interiors with large cubature leading to changes in their acoustic qualities. In two cases, the changes were beneficial to the functional qualities of the halls to satisfaction of the investors carrying out the renovation work. In the third instance, the architectural interference aimed at showing off the monumental valor of the interior resulted in significant degradation of its acoustics. To remedy the situation impairing the functional program of the facility, corrective measures are proposed neutral with respect to its historic character.

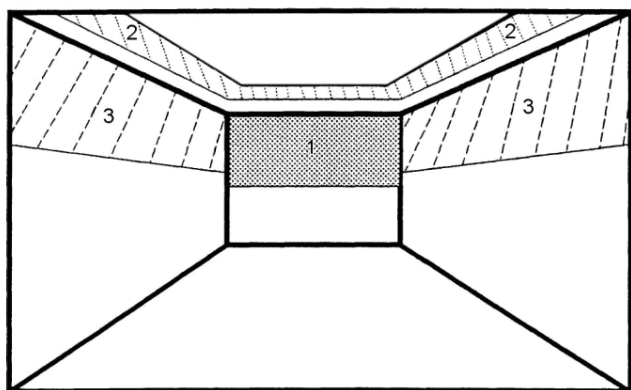
Fig. 3. The recommended sequence in which the sound-absorbing materials should be applied, in the order corresponding to increasing effect on the room acoustics: 1 – rear wall; 2 – ceiling portions bordering to walls, 3 – upper portions of side walls (KULOWSKI, 2011; FASOLD, WINKLER, 1976).

Historical character of the interior excluded the use of typical materials (such as mineral or glass wool lined with fabric), but it was possible to hang window curtains and additionally, cover the floor with fitted carpet in case of certain events. Presence of 11 large paintings unexpectedly turned out to be a favorable circumstance – they could be lined on the back side with a 50-mm thick layer of mineral wool with density of about  $60\text{ kg/m}^3$ . The canvas surfaces covered with a thick layer of oil paint, stretched on thick frames filled in with sound-absorbing materials, have formed a box-shaped acoustic structures absorbing effectively low-frequency sound components. Location of the paintings in upper portions of the walls was also a favorable circumstance (Fig. 3). Acoustic properties of the used materials are listed in Table 1.

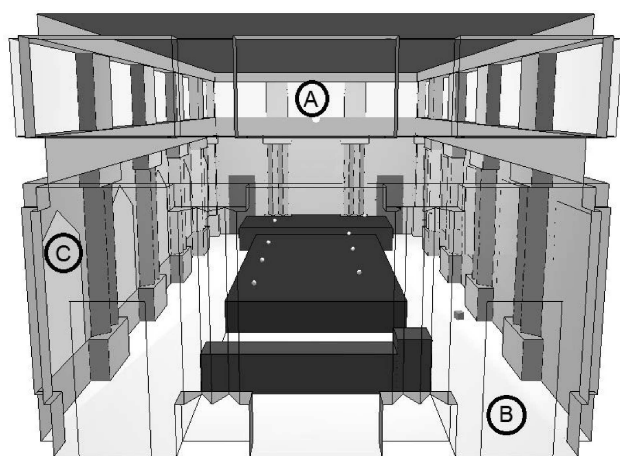
Fig. 4. The Assembly Hall model developed in CATT-Acoustic with arrangement of sound-absorbing materials listed in Table 1.

A graphical representation of the model used to simulate the hall in CATT-Acoustic programming environment is shown in Fig. 4. The model was developed with geometrical dimensions of the hall taken into account together with sound absorption and diffusion coefficients characterizing the existing finishing materials and furniture (4 long tables, a lectern, and 160 upholstered chairs). The model has been calibrated based on the measured reverberation time values.

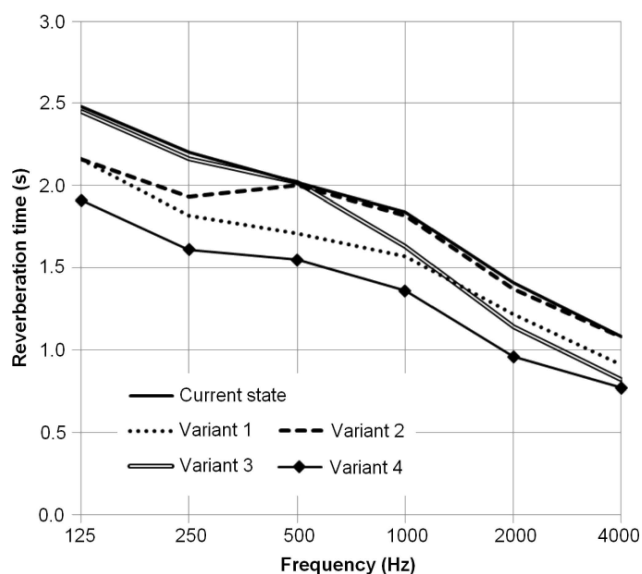
Fig. 5. Reverberation time frequency characteristics for the LUT Assembly Hall (unoccupied, computer simulation).

Simulation results closest to the design assumptions correspond to the use of all measures admissible in the hall in view of heritage conservation restrictions (cf. Table 2, Variant 4). The obtained value of  $STI = 0.57$  corresponds to a good speech intelligibility (the reverberation time value for frequency 500–1000 Hz is 1.45 s). An interesting feature is the favorable behavior of the sound absorbing material used as lining under the paintings, thanks to which a significant reduction of the reverberation time in the low-frequency range has been obtained.

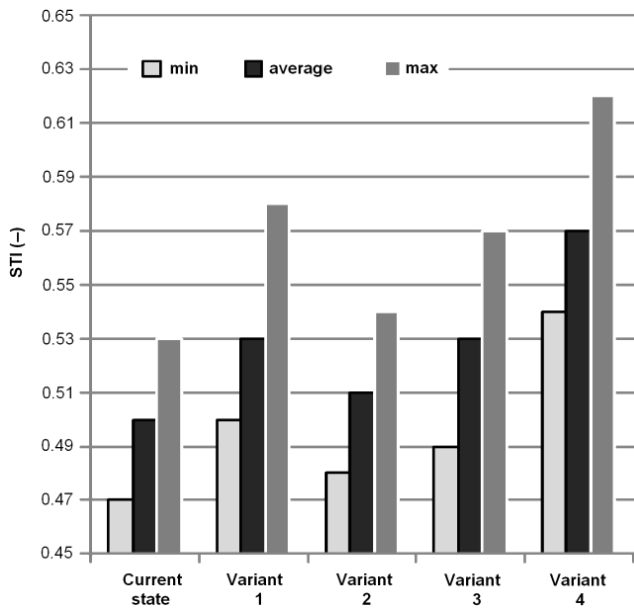
Fig. 6. The sound transmission index in the LUT Assembly Hall (unoccupied, computer simulation).

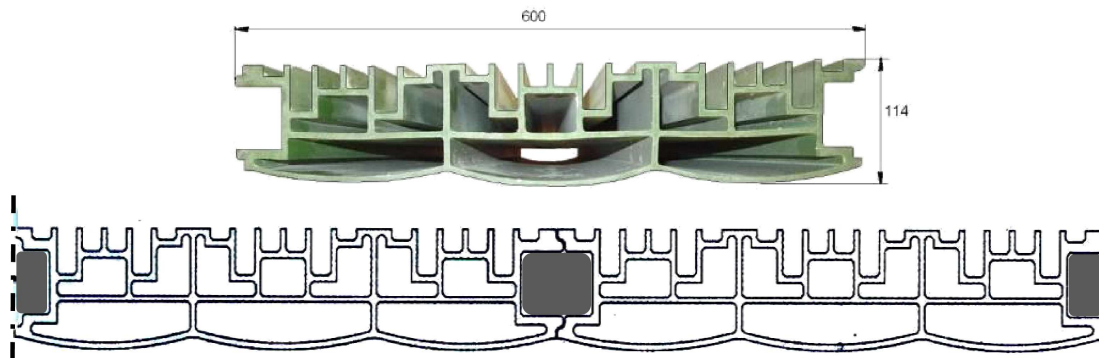
Fig. 9. A cross-section of the sound diffusers (dimensions in mm). The material and manufacturing process is protected as an industrial design (Community Designs Bulletin, 2012).

Structures of that type are composed of geometrical elements arranged in repeatable series. However, cyclical form and “technocratic” appearance of the diffusers impose serious limitations as far as their applicability to interiors with clearly exposed architectural style is concerned. Especially in rooms designed and finished in the eclectic style, where interiors are decorated with irregular carvings inspired by plant-like forms, pieces of figural sculpture, and highly diversified geometrical motifs following the canon of specific stylistics, any modern finishing element with highly technical form can be perceived as an alien feature. However, high efficiency of Schroeder diffusers invented four decades ago encourages designers to use them to correct acoustics of highly renowned historic concert halls, such as the Carnegie Hall in New York which opened in 1891 (COX, D’ANTONIO, 2004). An important factor in this case is the technological awareness of contemporary architects and heritage conservation officers who, unlike their counterparts operating in the 19th century, accept interference of that kind into appearance of period halls. The economic aspects play also an important role in making such decisions, because when a hall representing the quality of a historic monument retains its original function and realizes it successfully in line with contemporary technical standards, it becomes very attractive to both the public and the owner.

Schroeder diffusers are usually constructed by craftsmen in the course of interior finishing work or are offered in short series by specialized manufacturers. A solution concerning both the material and technological process used to fabricate the diffuser elements on an industrial scale has been patented in the European Union as an industrial design (Fig. 9). The diffuser has a form of a pressing continuously extruded out of a composite based on epoxy resin (EPD) filled with wood dust. The system is mounted on 60 mm × 60 mm posts inserted into holes provided in the diffuser’s structure.

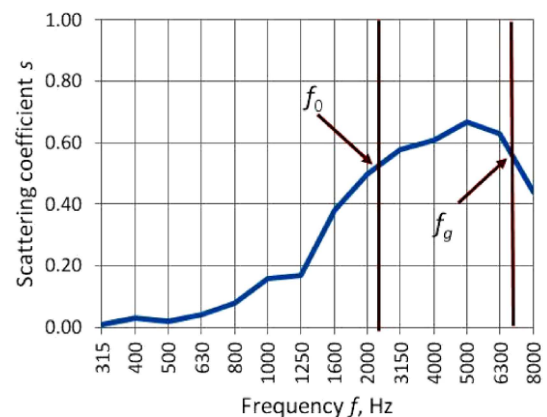
Fig. 10. The sound scattering coefficient  $s$  for the diffuser of Fig. 9 obtained from acoustics measurements (third-octave resolution, frequency range 314–8000 Hz).  $f_0$  and  $f_g$  are the lower and the higher sound diffusion limiting frequencies, respectively. It is assumed that sound diffusion occurs at frequencies above  $0.5 f_0$  (KAMISIŃSKI *et al.*, 2012b).

as the ratio of the sound energy reflected in the diffused way to the total reflected sound energy. Values of the coefficient  $s$  depend strongly on the sound frequency (Fig. 10). The frequency range  $[f_0, f_g]$  within which the sound diffusion is particularly effective is a derivative of the sequence of wells constituting the structure. The sequence, i.e. the number of wells per cycle, their width, and depth, is determined by an algorithm developed by MANFRED SCHROEDER (1975). The lower limiting frequency  $f_0$  is related to maximum depth of the wells. The value adopted in the present case (2234 Hz) followed from technological limitations and the fact that for deep wells, the diffuser is characterized with high absorption coefficient at low frequencies (KAMISIŃSKI *et al.*, 2012a).

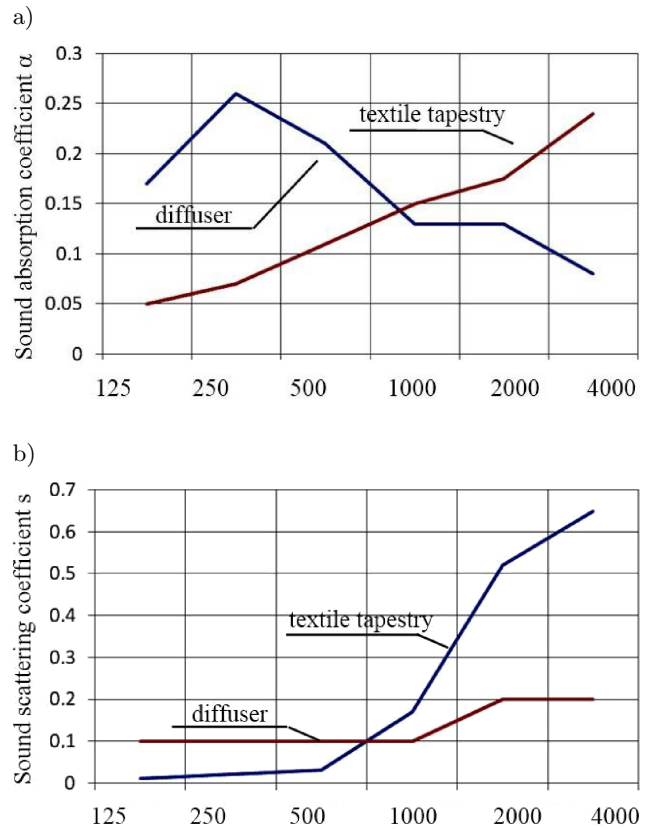
Fig. 11. Acoustic parameters of the textile tapestry and the diffuser of Fig. 9 used in computer simulation (octave resolution, frequency range 125–4000 Hz): a) sound absorption coefficient  $\alpha$ , b) sound scattering coefficient  $s$  (KAMISIŃSKI *et al.*, 2012b).

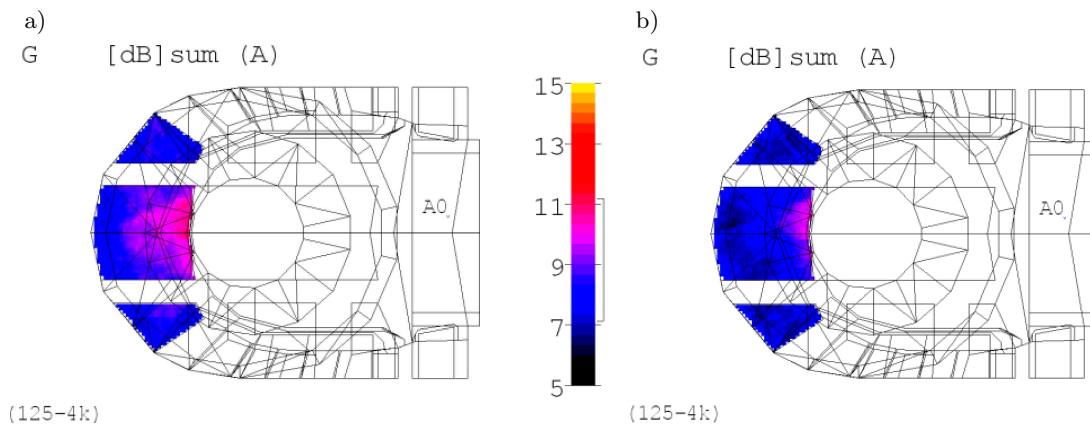
Fig. 12. The forecasted distribution of  $G$  values in the underbalcony area for the rear wall covered with: a) textile tapestry, b) sound diffuser.

smooth and hard rear wall with a sound scattering structure, distribution of the parameter became significantly more even (Fig. 12). The effect is particularly prominent for frequencies above 1 kHz, as in this very range, the sound absorption introduced by the diffuser is lower, while the scattering effect is stronger (Fig. 11). Even more favorable is the forecasted change in the clarity factor  $C_{80}$  (Fig. 13). This is especially

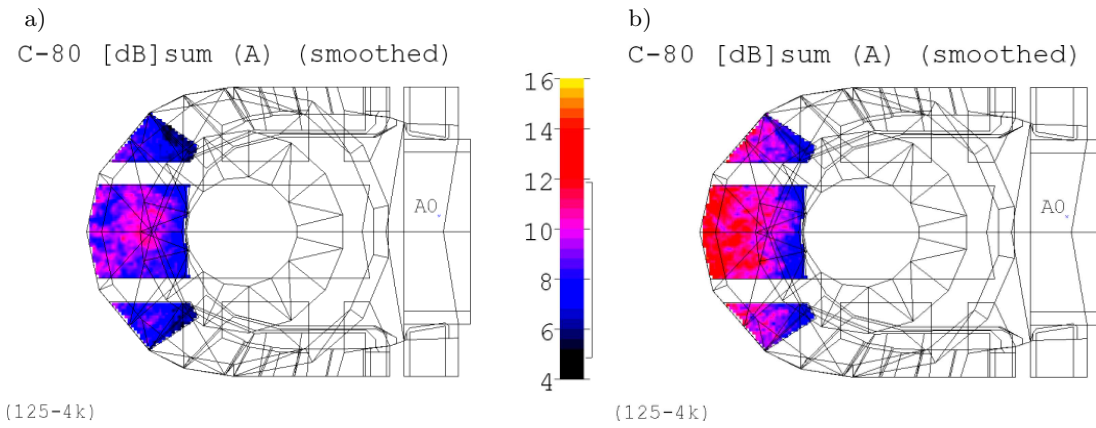
Fig. 13. The forecasted distribution of  $C_{80}$  values in the underbalcony area for the rear wall covered with: a) textile tapestry, b) sound diffuser.

true for the last rear rows where acoustic deficiencies were most uncomfortable. In this area,  $C_{80}$  increases by as much as 5 dB, and what is more, distribution of this increased value remains even in the whole underbalcony zone. In view of the complex measurement procedure (ISO 17497-1, ISO 17497-2), sound scattering coefficients are rarely published. Graphs shown in Fig. 11 a come from the authors' own measurements (KAMIŃSKI *et al.*, 2012b), while scattering coefficients of other materials have been adopted as suggested in the instructions for the program CATT-Acoustic.

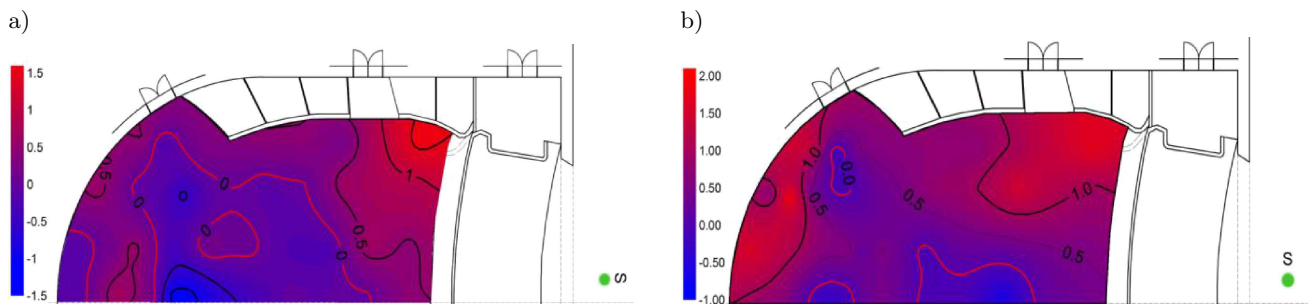
Fig. 14. The effect of mounting the diffusers on the sound strength  $G$  in octave bands: (a) 0.5–1 kHz and (b) 4 kHz.

surements covered the whole stalls. The measurements were taken in the unoccupied hall. From among all parameters that were examined, the sound strength  $G$  was the one which demonstrated the most noticeable effect related to mounting the diffuser on the rear wall. The increase was particularly high in the medium ( $G_{0.5-1\text{ kHz}}$ ) and high ( $G_{4\text{ kHz}}$ ) frequency regime in the whole area of stalls (Fig. 14). The other parameters noticeably improved in the underbalcony cavity and in the areas close to proscenium, at the expense of a slight reduction of their values in the auditorium center (Figs. 15 and 16). A view of the underbalcony cavity with the diffusers installed on the rear wall is presented in Fig. 17.

the whole impulse response decay period (cf. Fig. 15a and 14b, respectively). This means that the impression of sound strength in the auditorium and the parameter  $G$  corresponding to sensation related to this quantity is created in the initial stage of formation of the impulse response. The observation is consistent with the generally accepted regularity concerning enhanced response of the human ear to early high-energy sound reflections.

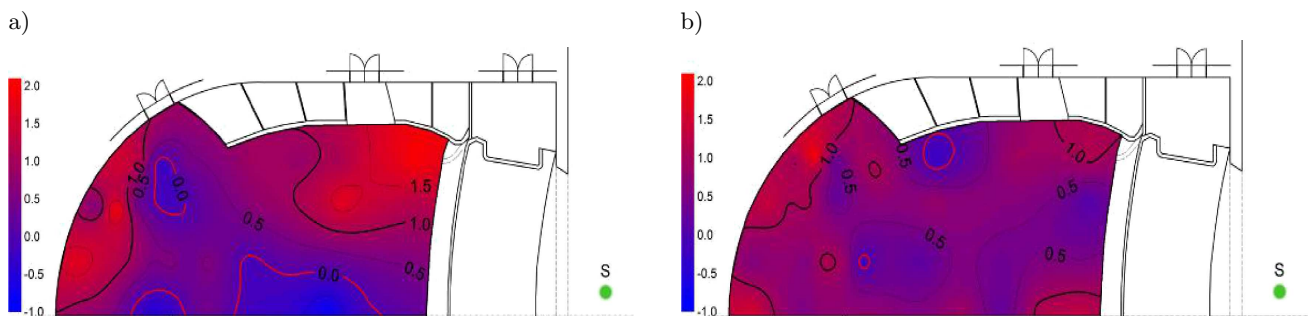
Fig. 15. The effect of mounting the diffusers on the sound strength  $G$ : a)  $G_{80\text{ ms}, 4k}$  and b)  $G_{\text{Late}, 4k}$ .

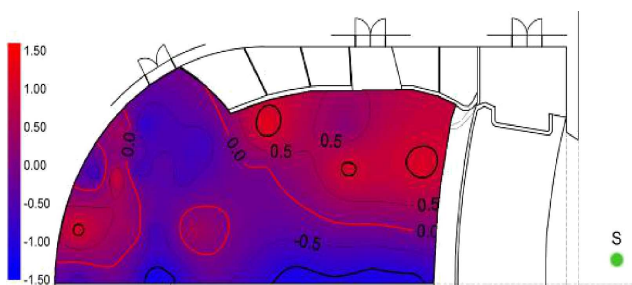
Fig. 16. The effect of mounting the diffusers on the sound clarity  $C_{80,4k}$ .

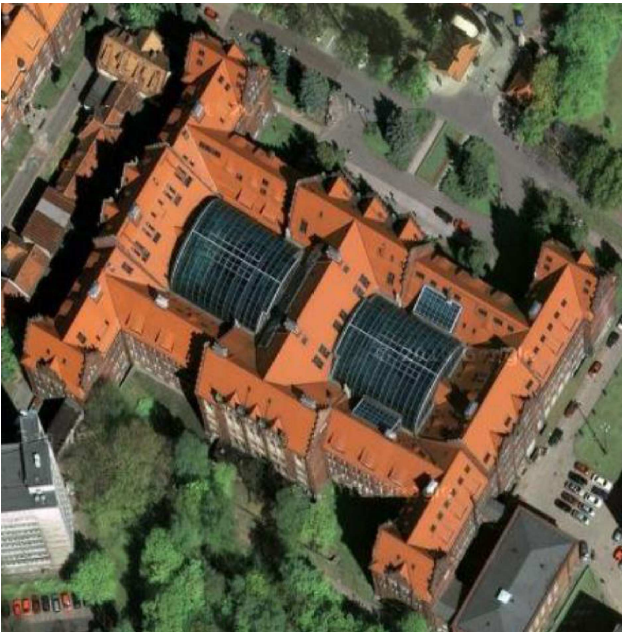
Fig. 18. Glazing roofs over Gdańsk University of Technology's main building courtyards (Google maps, 2015).

The courtyards remained open-air spaces until 2004 when glazed roofs were installed over both of them. The load-bearing structure is based on arched steel trusses with the span reaching about 22.5 m. The roof shell is made of double-pane insulation glass units with voids filled with argon. The outer panes made of tempered glass are 10-mm and 8-mm thick, while the inner pane is a 2 × 4 mm glass laminate with plastic film glued between the layers (Figs. 18–20).

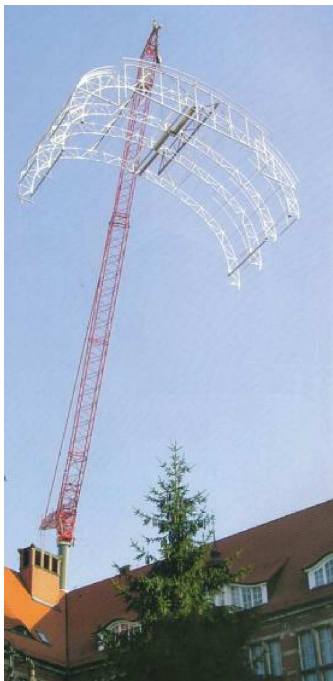
Fig. 19. Transferring glazed roof framework from the assembly site onto the Hevelius Courtyard (CYWIŃSKI, 2012).

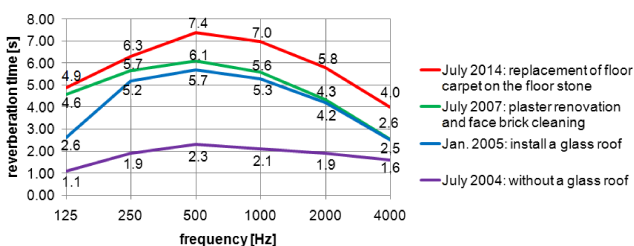
Fig. 23. The Fahrenheit Courtyard reverberation time after successive renovation stages.

The original acoustics of the courtyards was characterized with a short reverberation time (cf. Fig. 23, the lowest curve). The original acoustics of the courtyards was distinguished with a short reverberation time and high degree of sound diffusion. This followed from diversified structure of the brick elevation with significantly resolved stone decorations and resulted in good speech intelligibility. Such characteristics was favorable from the point of view of the functional program of the courtyards despite exposition of the space to the elements.

als are intended mainly for outdoor applications, such repairs result in further deterioration of acoustic conditions prevailing in the courtyards. For instant, the recent stage of renovation included laying a stone floor (Fig. 22) which was the cause of further increase of the reverberation time, as the stone, alike the glass used for the roofing, is a material reflecting virtually the whole of incident acoustic energy. After subsequent work stages, the reverberation time increased gradually and from the initial 2.5 s, it increased up to the current 7.5 s, whereas the value recommended for the official functional program of the interiors should not exceed 2.0–2.5 s (Fig. 23).

where  $T_0 \approx 7.0$  s is the currently observed reverberation time (cf. Fig. 23), and  $\Delta A$  is the acoustic absorptivity increase relating to application of the foil, value of which can be calculated as

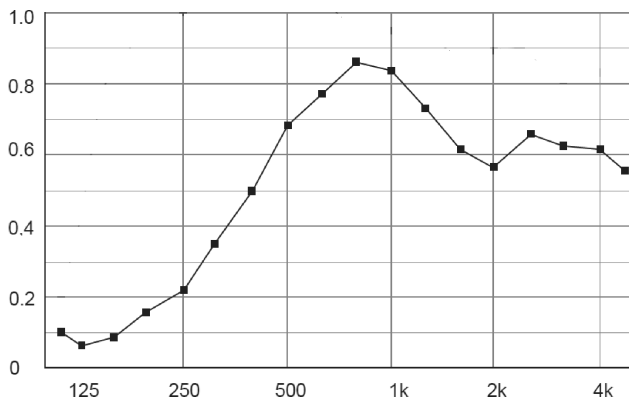
Fig. 24. The sound absorption frequency characteristic for the microperforated foil stretched at a distance of 10 cm from glass pane. Film parameters: thickness 0.18 mm; 500,000  $\varnothing 0.1$  mm holes per m<sup>2</sup>; perforation rate 1%; sound absorptivity class D,  $\alpha_w = 0.55$  (NOCKE, 2014).

where  $\alpha = 0.85$  is the absorption coefficient of the foil (cf. Fig. 24) and  $S = 1.079$  m<sup>2</sup> is the total area of glazed surfaces (cf. Subsec. 4.1).
