Cavitation behaviour of the SUPERSTON alloy after laser treatment

Purpose: Results of laser treatment at cryogenic conditions and its influence on microstructure, microhardness and cavitation resistance of the SUPERSTON alloy are presented in this paper.

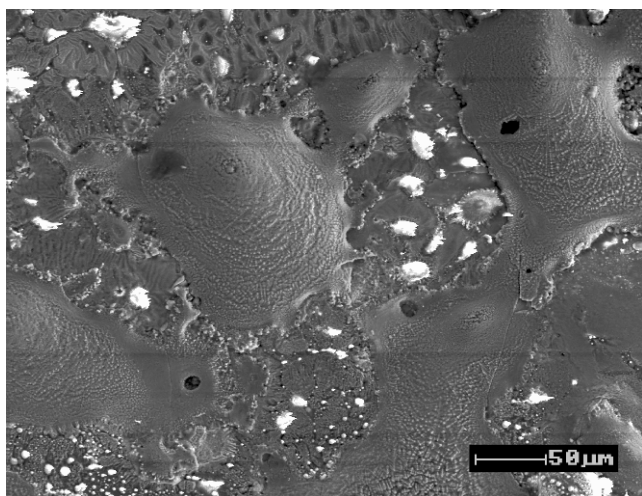
Fig. 1. Surface microstructure of laser remelted the SUPERSTON alloy (4000W, 0.5m/min)

Surface morphology of the SUPERSTON alloy remelted with 4000 W power, scanning velocity 0.5 and 1.0 m/min is presented in Figs 1 and 2.

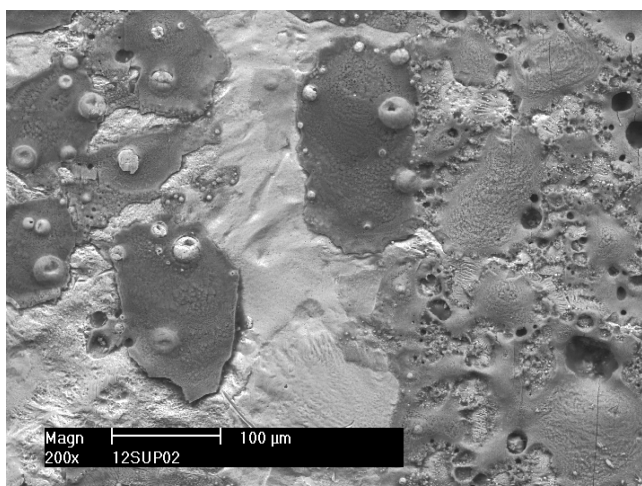
Fig. 2. Surface microstructure of laser remelted the SUPERSTON alloy (4000W, 1.0m/min)

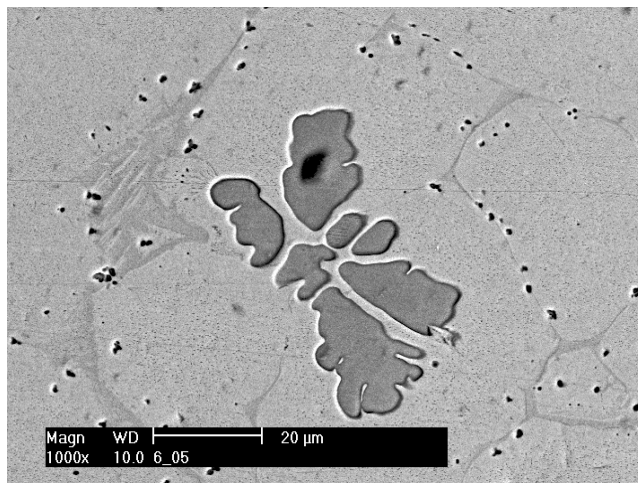
Fig. 3. Microstructure of the casted the SUPERSTON alloy

Microstructure of casted and remelted the SUPERSTON alloy is shown in Figs 3 and 4. Microstructure of the SUPERSTON alloy as coating consist of α phase, eutectoid mixture and manganese-iron phase (Fig. 3). After laser remelting fine microstructure without cracks in the surface layer is observed. (Fig. 4).

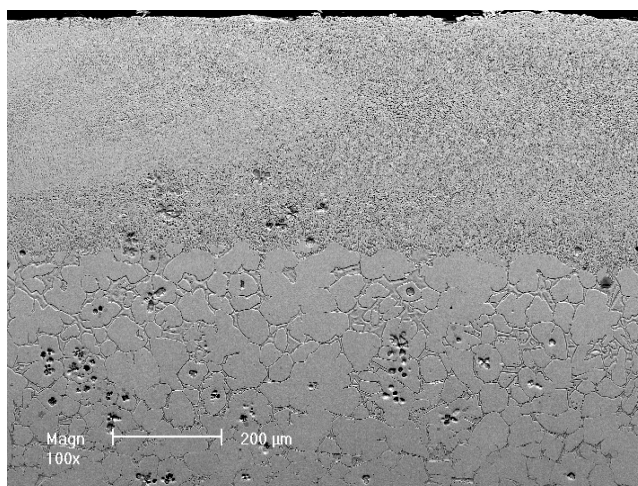
Fig. 4. Cross section microstructure of remelted the SUPERSTON alloy

Average thickness of the remelted layer is about 300 μ m and demonstrate a structural connection with base material (Fig. 4).

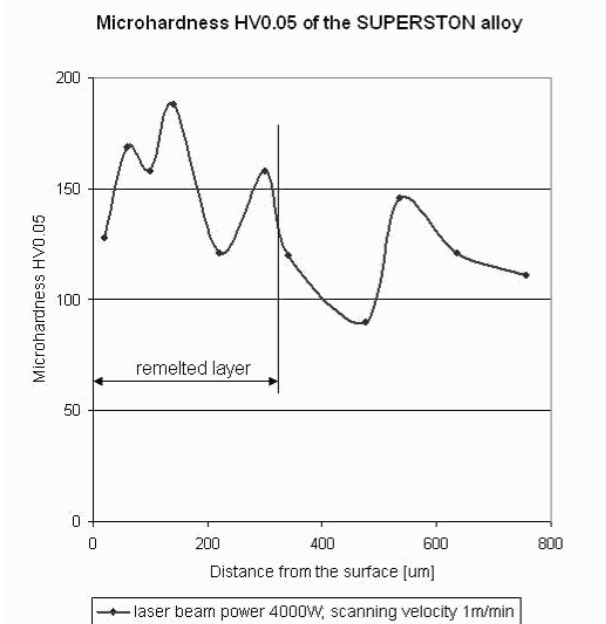
Fig. 6. Microhardness in cross-section of laser remelted layer of the SUPERSTON alloy (4000W, 1.0 m/min)

Microhardness in the remelted layer of the SUPERSTON alloy made by the Vickers method under load 0.49 N.

Results of the microhardness measurements are presented in Figs 5 and 6.
