Cavitation behaviour of the SUPERSTON alloy after laser treatment

Purpose: Results of laser treatment at cryogenic conditions and its influence on microstructure, microhardness and cavitation resistance of the SUPERSTON alloy are presented in this paper.

Keywords: Surface treatment; Laser remelting; Copper alloys; Cavitation

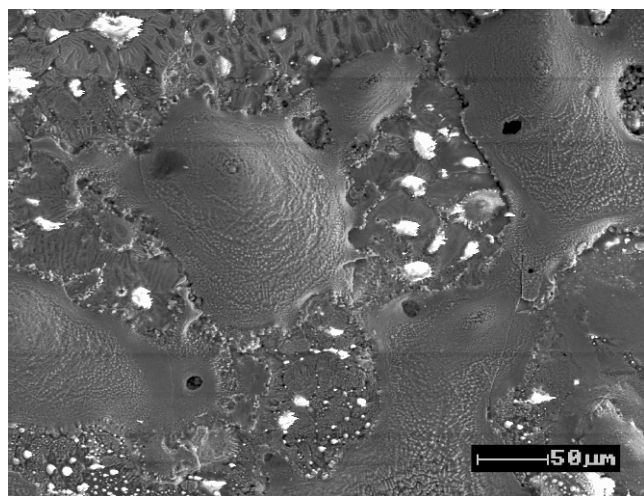
Fig. 1. Surface microstructure of laser remelted the SUPERSTON alloy (4000W, 0.5m/min)

Surface morphology of the SUPERSTON alloy remelted with 4000 W power, scanning velocity 0.5 and 1.0 m/min is presented in Figs 1 and 2.

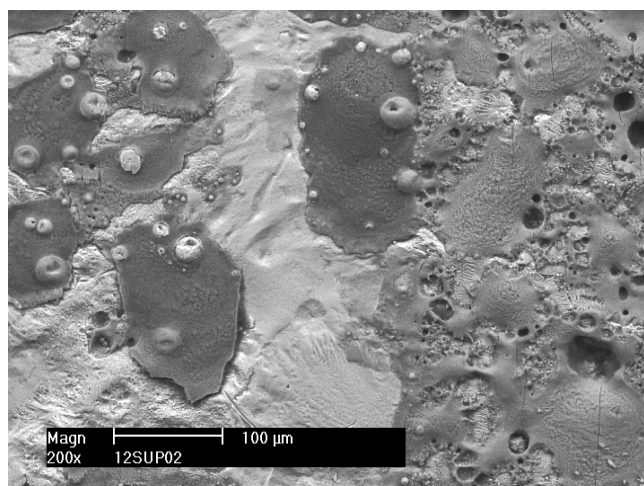
Fig. 2. Surface microstructure of laser remelted the SUPERSTON alloy (4000W, 1.0m/min)

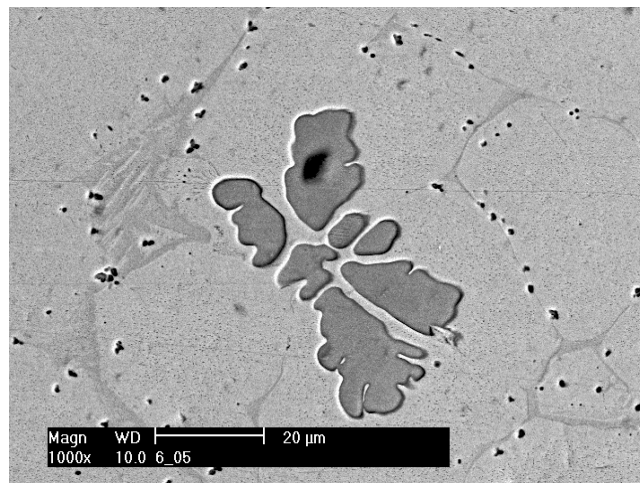
Fig. 3. Microstructure of the casted the SUPERSTON alloy

Microstructure of casted and remelted the SUPERSTON alloy is shown in Figs 3 and 4. Microstructure of the SUPERSTON alloy as coating consist of α phase, eutectoid mixture and manganese-iron phase (Fig. 3). After laser remelting fine microstructure without cracks in the surface layer is observed. (Fig. 4).

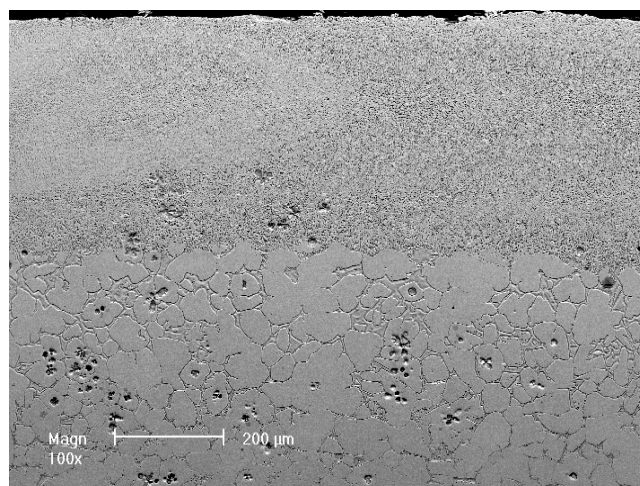
Fig. 4. Cross section microstructure of remelted the SUPERSTON alloy

Average thickness of the remelted layer is about 300μm and demonstrate a structural connection with base material (Fig. 4).

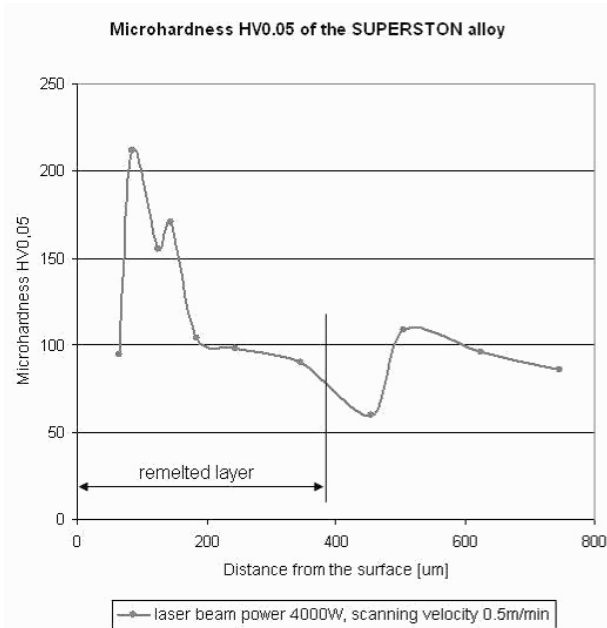
Fig. 5. Microhardness in cross-section of laser remelted layer of the SUPERSTON alloy (4000W, 0.5m/min)

Microhardness in the remelted layer of the SUPERSTON alloy made by the Vickers method under load 0.49 N.

Results of the microhardness measurements are presented in Figs 5 and 6.

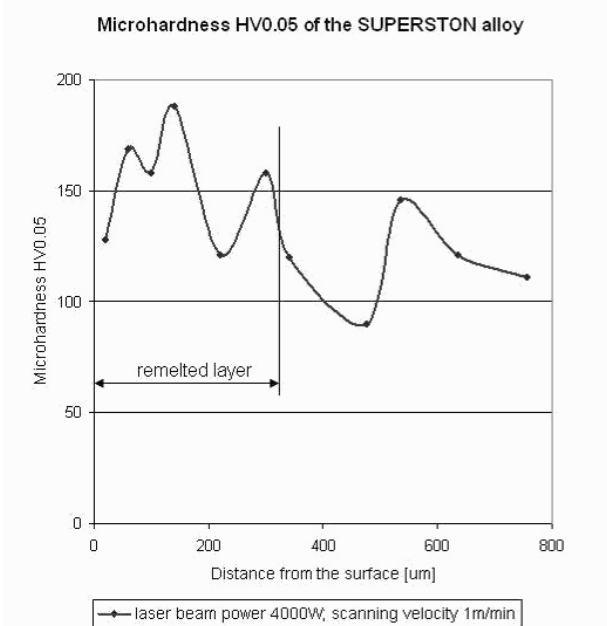
Fig. 6. Microhardness in cross-section of laser remelted layer of the SUPERSTON alloy (4000W, 1.0 m/min)

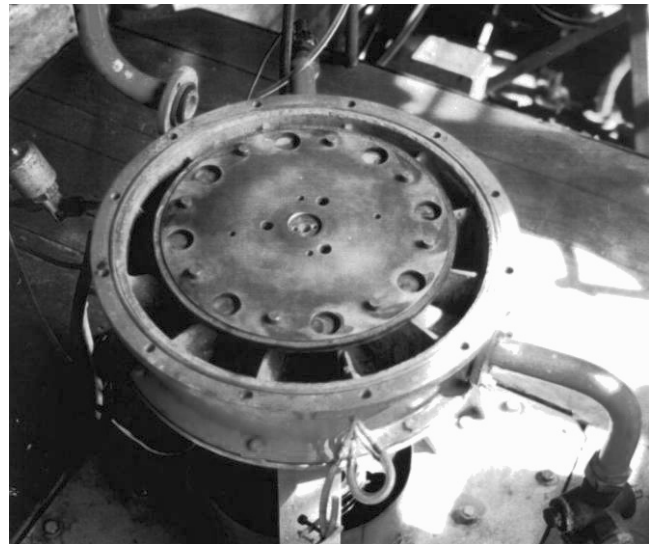
Fig. 7. The rotating disc facility for measurements of cavitation resistance

Cavitation test in the water (average temperature 20°C) was performed at rotating disc facility (Fig. 7). During the cavitation process the kinetics of the mass loss was determined.

The cavitation resistance test of the SUPERSTON alloy after laser remelting at cryogenic conditions was performed at the rotating disc facility Fig. 7.

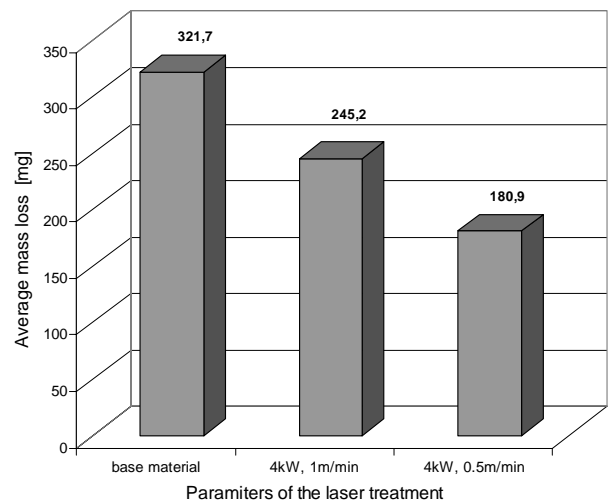
Fig. 8. Average mass loss of the SUPESTON alloy remelted in the different conditions

Average mass loss of the specimens after 5.25h of the cavitation test is presented in Fig. 8.

Most beneficial increase of cavitation resistance (about 30%) obtained for laser remelting the SUPERSTON alloy with 4000 W power and 0.5 m/min scanning velocity.

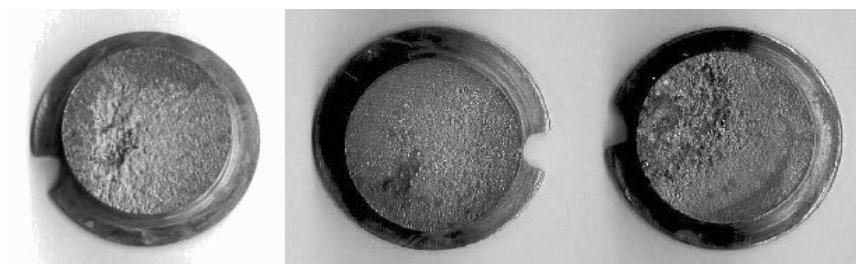
Fig. 9. Surface of the SUPERSTON alloy after cavitation test by 5.25h: a) 4000W, 0.5m/min; b) 4000W, 1.0m/min; c) base material - as casting

View of the base material and laser remelted specimens made of the SUEPRESTON alloy after cavitation test is shown in Fig. 9.
