Corrosion hazards and inhibitor protection in the seawater injection system on the Baltic sea rig

Oil extraction efficiency in LOTOS Petrobaltic Company is increased by means of injection of seawater into an oilfield aquifer, which is implemented on the Baltic Beta rig, operating on the Baltic Sea. Operational experience has shown a significant degree of corrosion aggressiveness in the injected water, which necessitates frequent repairs of the seawater injection installation. Evaluation of the corrosion phenomena is crucial for rig platforms due to extremely high renovation costs and a negative impact on injected water quality. Chemical and microbiological analyses of seawater treated in the technological process have been carried out. Actions to estimate the corrosion risk in the installation and the estimated corrosion rates measured using an automated monitoring system are presented in this work. Monitoring of the corrosion rate conducted alongside measurements of the physicochemical properties of water allowed to identify the corrosion mechanisms of stainless steel in a seawater environment. Additionally, it became possible to assess the impact of the chlorine and carbon dioxi

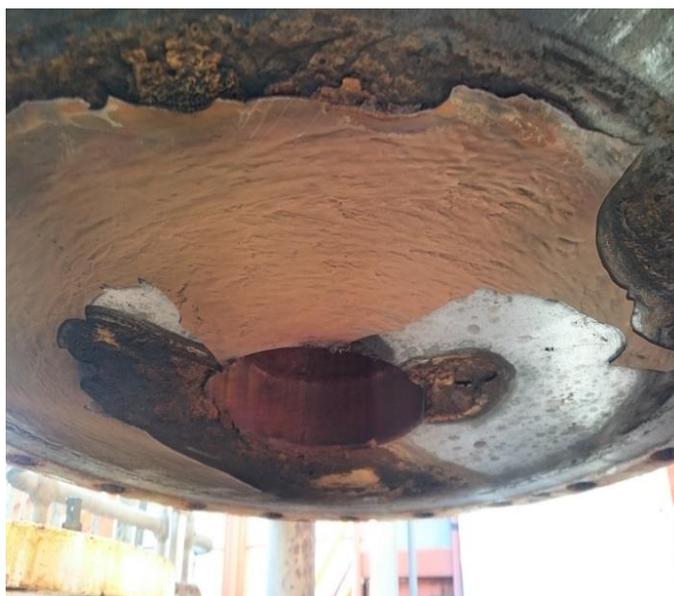
Figure 2. Surface of the inner parts of the dual media filter.

The operational experience of the Baltic Beta rig has shown a significant degree of corrosion aggressiveness of water, which necessitates frequent repairs of the installation, especially downstream of the dual media filters. Such a poor condition of the installation had a negative impact on the injected water quality. The average content of total suspended solids content in the last year was 2.25 mg/l and total iron content was 1.19 mg/l. These values exceed the permissible quality indices for injected water. Figure 2 presents the actual state of the hatches of the dual media filters.
