Diagnostics of pillars in St. Mary's Church (Gdańsk, Poland) using the GPR method

Jacek Lachowicz*, Magdalena Rucka

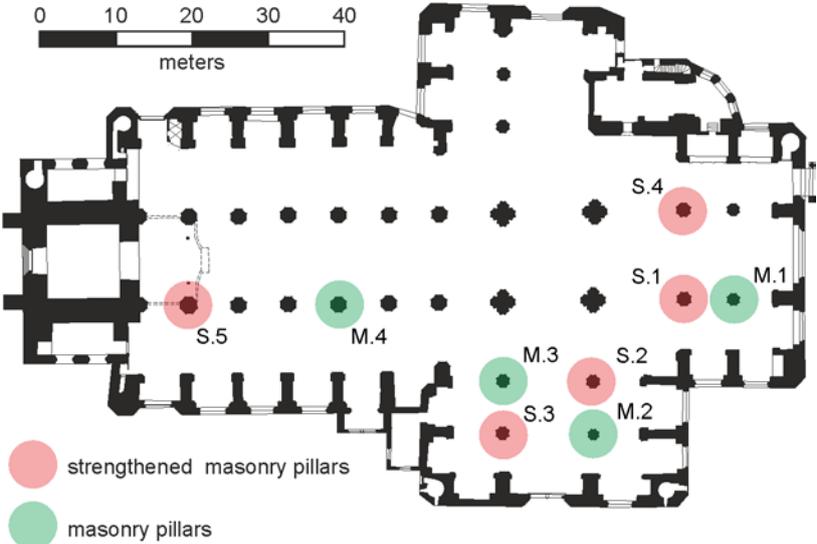
Figure 2. Plan view (redrawn after (Bogdanowicz 1990)) with locations of GPR surveys indicated

The GPR inspection was conducted on 9 pillars (as highlighted in Figure 2), including 4 brick masonry pillars (M.1 to M.4) and 5 strengthened pillars (S.1 to S.5). The cross section of the pillars was octagonal. The side dimension varied from 50 cm to 67 cm except for two pillars for which the side dimension was larger: 88 cm for pillar M.4 and 98 cm for pillar S.5. On each pillar, longitudinal (L) and transverse (T) scans were acquired. Each transverse scan was composed of eight profiles captured across each side of the octagonal pillar. Additionally,

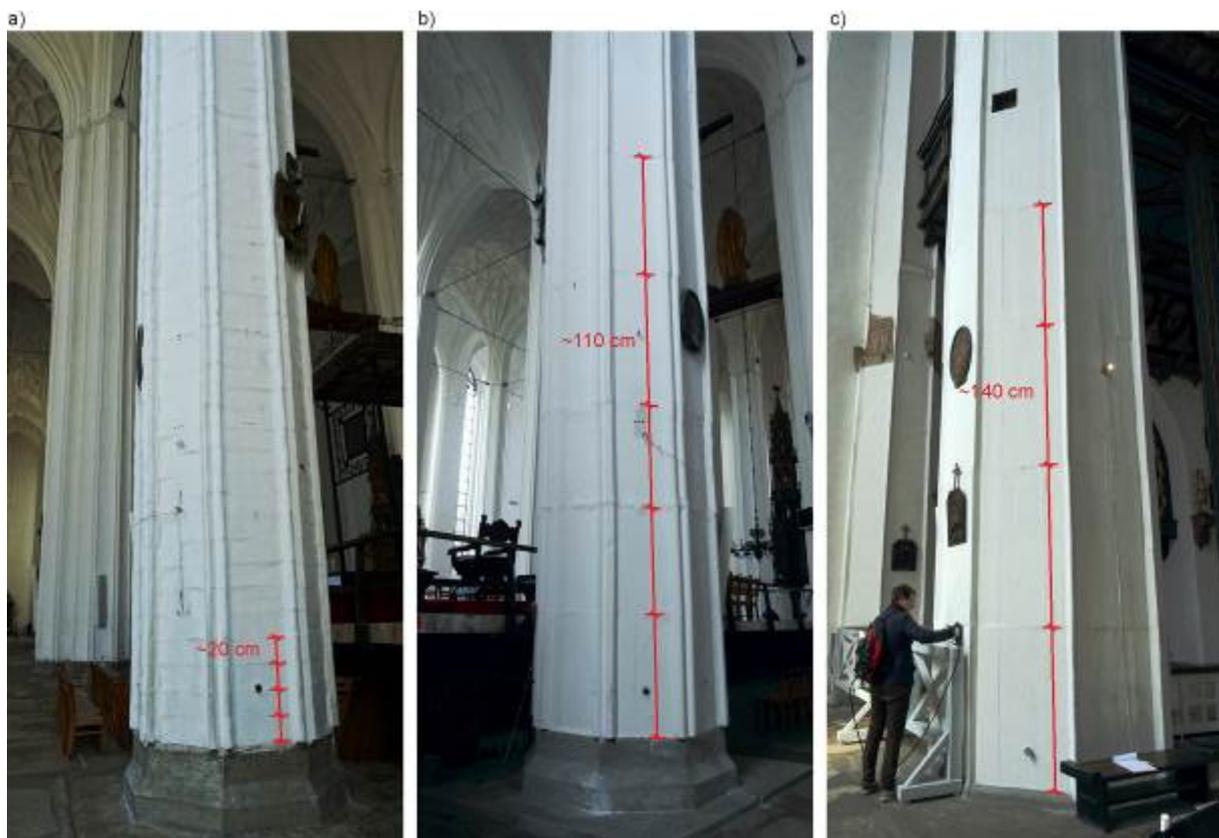
Figure 3. Strengthened pillars: a) pillar S.1; b) pillar S.4; c) pillar S.5

The rebuilding of the roof and vaults began in 1947. During reconstruction work, five pillars began to crack and tilted from the vertical (Bogdanowicz 1990). All damaged pillars were strengthened using a technique of jacketing (c.f. (Júlio, Branco, and Silva 2003)). In Figure 2, the reinforced pillars are indicated. As the first example, pillar S.1 was repaired in 1948 with the use of prefabricated elements (Figure 3a). Moulds were prepared, and 500 pieces of concrete cover with heights of 20 cm were fabricated. The pillar was then covered with the prefabricated elements over 3 months at a height of 18 m. One year later, cracks appeared on pillar S.4 during vault reconstruction. Damage started to propagate rapidly, and a horizontal crack emerged. In this situation, immediate reinforcement of the pillar was necessary, and monolithic reinforced concrete was used. The reinforcement of a cracked area was completed in 24 hours. The concreting was conducted in few stages, each with a section height of approximately 110-140 cm (Figure 3b). The remaining three pillars (S.2, S.3, and S.5) were also reinforced using monolithic concrete.

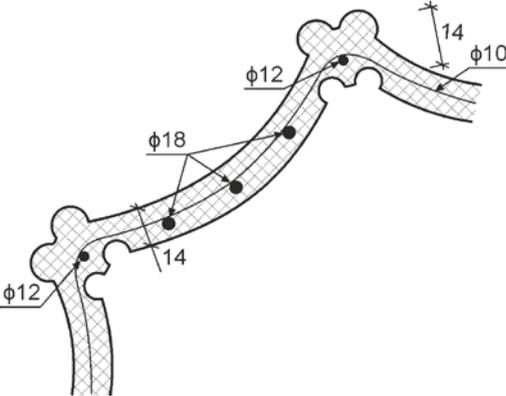
Figure 4. Sketch of a pillar strengthened by jacking (redrawn after the construction logbook)

As in the case for many historical monuments, the availability of technical documentation from the past is limited. For example, in the case of St. Mary's Church, the only source of knowledge concerning pillar reconstruction are written memories of the reconstruction of the main city (Trojanowska 1997) and a sketch from a construction logbook

showing a reinforced concrete ring (Figure 4). An additional challenge is that the pillars are plastered. Only a few areas are open, allowing for observation of the inner structure of the pillars. Figure 5 gives two details showing masonry and reinforced masonry in two pillars. In such situations, visual inspection and NDT are the only suitable methods for diagnosis and assessment of the condition of the pillars.

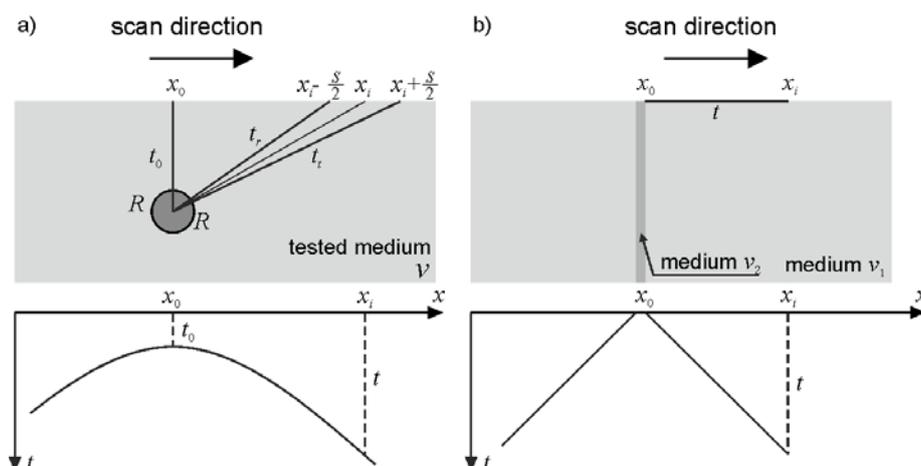
Figure 6. Reflection models in various types of structures:
a) reinforcing bar in concrete; b) vertical joint between bricks

The electromagnetic wave that encounters a circular inclusion with various electrical parameters from the tested medium diffracts, causing a hyperbola pattern on the GPR map, as shown in Figure 6a. The model of the hyperbola taking into account the radius R of reinforcement and the offset s between the receiving and transmitting antennas can be described as follows (Sagnard and Tarel 2016):

In the case of brick structures, the shapes occurring on GPR maps are reflections from vertical joints between bricks. The surface wave emitted from the transmitting antenna returns after reflection from the joint travelling along the same path; therefore, the wave retains the shape of a straight line with an inclination angle that contains information on the wave velocity in the tested medium (Figure 6b). The mathematical description of the reflection consists of the following simple relationship:

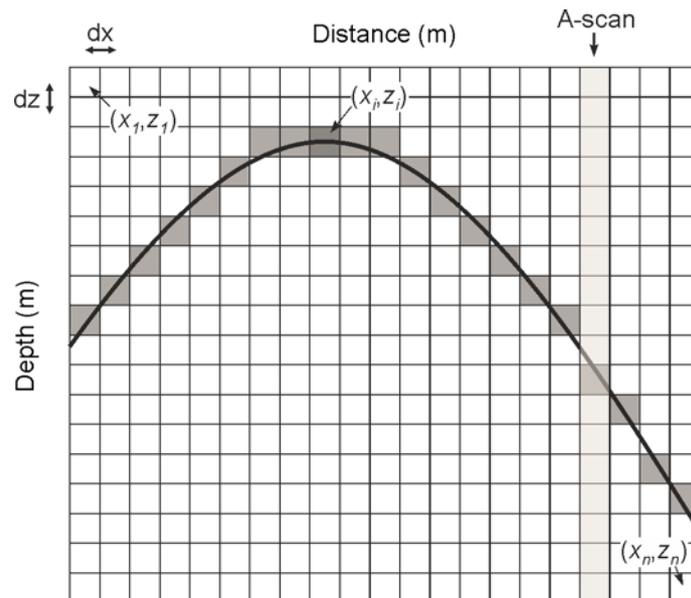
Figure 7. Scheme of the hyperbolic summation method

The assumptions of the method are the homogeneity of the material and the fact that the antenna is directly adhered to the scanned surface. The algorithm was implemented in MATLAB® environment. In the first step, the time scale of the GPR map is converted into the distance scale, for which an estimation of the electromagnetic wave velocity is performed. Next, it is assumed that each point of the GPR map (x_i, z_i) can produce a hyperbola. Thus, at each point of the map, a hyperbola is defined according to Eq. (3), and then voltage values coinciding with the calculated formula are added (Figure 7). The value calculated in this way is saved on a new map. The algorithm repeats until all points of the entire B-scan are migrated from (x_1, z_1) to (x_n, z_n) . The result of the migration process is a new GPR map containing a significant increase of the summed voltage values at the top of the hyperbola.

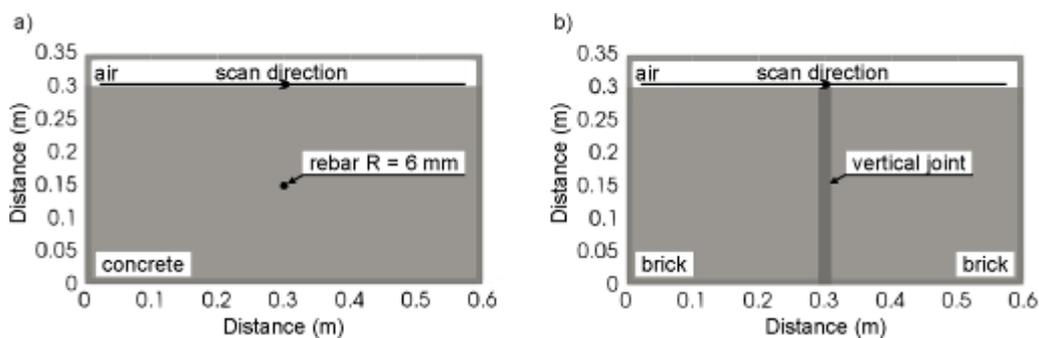
Figure 8. Numerical models: a) reinforcing bar in concrete; b) vertical joint between bricks

Calculations were performed using the gprMax software (Warren, Giannopoulos, and Giannakis 2016) using the finite-difference time-domain (FDTD) method. Two numerical models were created. The first considered example was a concrete specimen with an embedded steel bar of 12 mm diameter (Figure 8a). The second model contained a vertical inclusion between two brick specimens (Figure 8b). Such model can be considered as a representation of a masonry structure in which the vertical inclusion is a mortar joint between bricks. The values of the relative permittivity of bricks ($\epsilon_r = 3.5$) and concrete ($\epsilon_r = 7$) were determined in accordance with velocities obtained from in-situ surveys. For the mortar, the value of the permittivity was set as $\epsilon_r = 5$. The external dimensions of the models were 0.35 m \times 0.6 m. The models were discretized using the grid with spatial steps of 0.001m \times 0.001m. At the edges of the area, the perfectly match layer (PML) absorbing boundary conditions were set up. The Ricker function with a centre frequency of 2 GHz was used as a source. The distance between the transmitting and receiving antennas was set to 6 cm according to the applied IDS antenna.

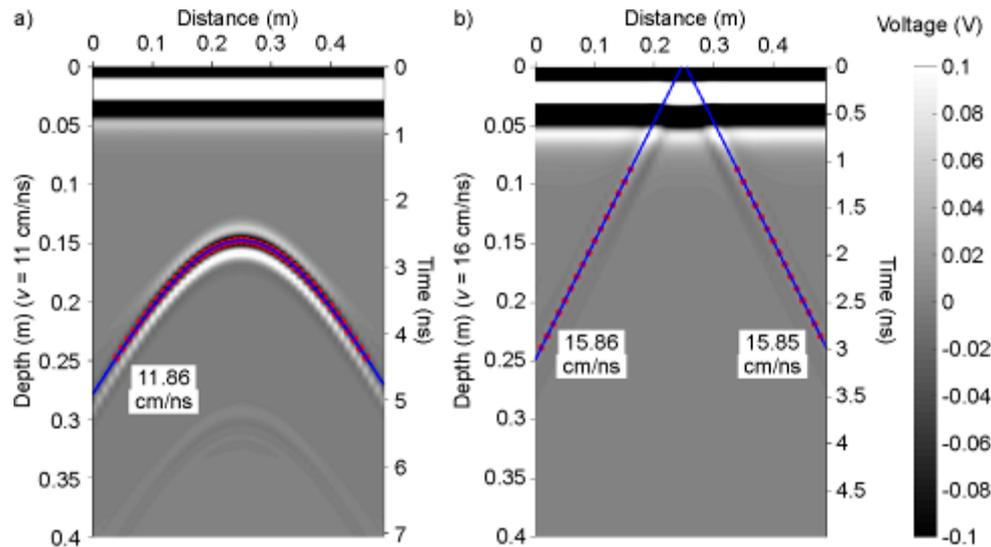
Figure 9. Numerical GPR maps with estimated velocity values based on:
a) hyperbolic diffraction; b) linear diffraction

Figure 9 shows numerical GPR maps. A hyperbolic reflection can be seen on the radargram obtained for the concrete specimen model (Figure 9a). The hyperbola points were extracted and approximated according to Eq. (1) with the use of the Levenberg-Marquardt algorithm (Marquardt 1963) implemented in MATLAB[®] environment. In the fitting process, a

radius value was set as $R = 6$ mm. The identified value of electromagnetic wave velocity was 11.86 cm/ns, which in comparison to the real value of 11.4 cm/ns gave a relative error of 4%.

Two linear reflections are visible in the radargram obtained for the model with the vertical joint (Figure 9b). The points with the maximum voltage value were selected. Next, the least squares method was used for the approximation process according to Eq. (2), providing the values $v = 15.86$ cm/ns (left line) and $v = 15.85$ cm/ns (right line). The real value for the tested medium was $v = 16$ cm/ns. Therefore, the estimation error was below 1%.

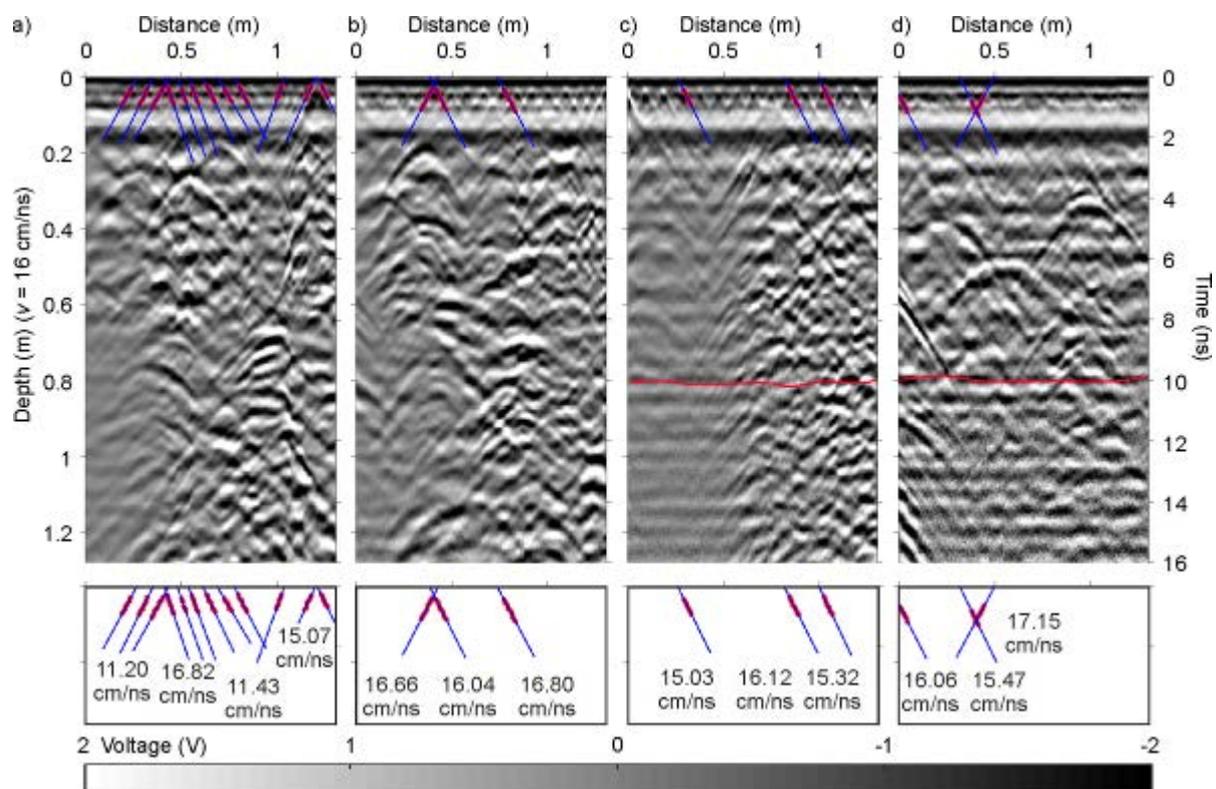
Figure 10. Longitudinal GPR maps with estimated velocity values from measurements of masonry pillars:

The estimation of the electromagnetic wave velocity in the masonry was evaluated based on the surface wave reflected from the joint between bricks according to Eq. (2). In the case of certain pillars, this phenomenon was barely detectable due to the likely small difference in the electrical permeability values of brick and mortar. However, for each pillar in which the phenomenon of the reflected surface wave was found, a linear approximation was made for selected points. The results of the estimation of the wave velocity based on longitudinal GPR maps are shown in Figure 10.

a) pillar M.1 b) pillar M.2 c) pillar M.3 d) pillar M.4

The average velocity for each pillar fluctuates around 16 cm/ns. A notable phenomenon was observed for pillar M.1, consisting of a change in the wave velocity in certain sections along the pillar height. The drop in the velocity value could be caused by an increase in material moisture, as the electric permittivity that is responsible for the speed of the electromagnetic wave has a much higher value for water ($\epsilon_r = 81$) than for brick ($\epsilon_r = 3.5$) (Rucka, Lachowicz, and Zielińska 2016). Moreover, on GPR maps obtained for pillars M.3 and M.4, a longitudinal reflection probably from the end of a layer of bricks can be observed at a delay of approximately 10 ns, indicating that the thickness of this layer can be estimated to be approximately 75 cm based on the estimated velocities. The other reflections appearing on the GPR maps may indicate small air voids or larger elements like bricks or stones.

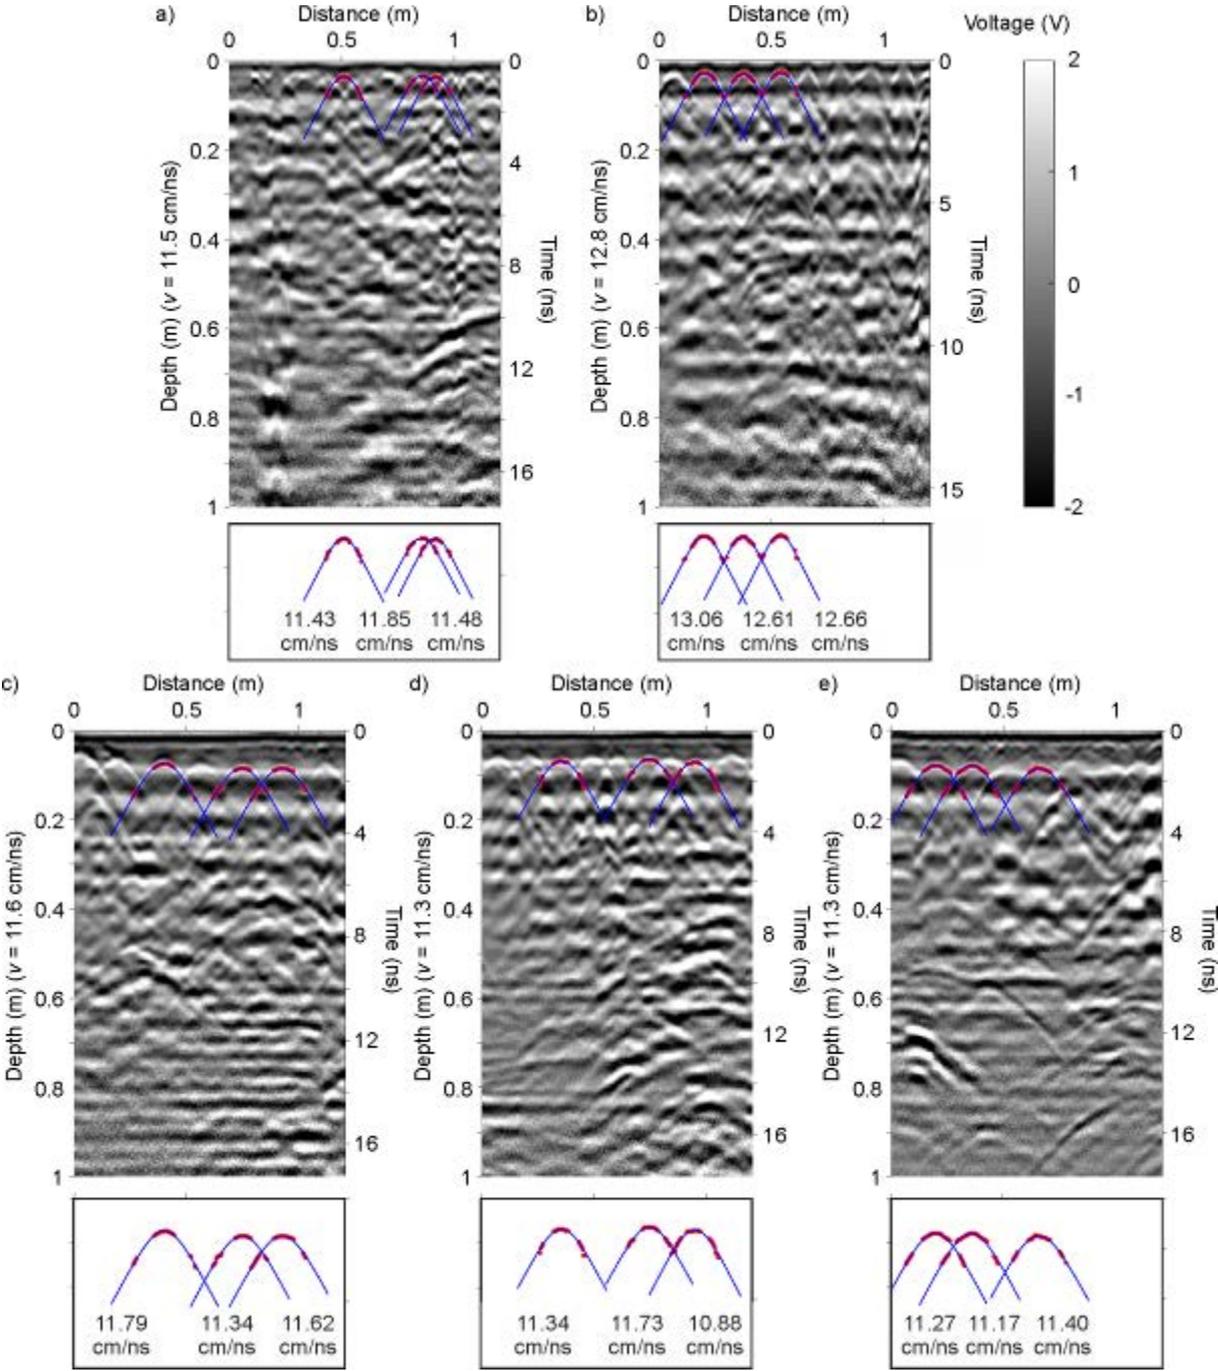
Figure 11. Longitudinal GPR maps with estimated velocity values from measurements of strengthened masonry pillars: a) pillar S.1 b) pillar S.2 c) pillar S.3 d) pillar S.4 e) pillar S.5

To estimate the velocity of electromagnetic waves in the concrete band, the hyperbola fitting method was used. For each strengthened pillar, the nonlinear approximation of selected hyperbolas was performed using the Levenberg-Marquardt algorithm (Marquardt 1963). For each B-scan, three hyperbolas (the least distorted and the most representative) were chosen for the approximation process. The points forming the hyperbola were calculated as the maximum values of the voltage at a given distance from the curve selected a priori on the GPR map. Figure 11 illustrates the longitudinal GPR maps acquired along each strengthened pillar with marked hyperbolas and velocities resulting from the approximation process. For pillars S.1, S.3, S.4 and S.5, similar average values of the velocity (approximately 11.4 cm/ns) were obtained in the approximation process. For pillar S.2, an average velocity of 12.8 cm/ns was determined. According to the identified average velocity values, the time scale was changed into a spatial domain in the longitudinal GPR maps (Figure 11). The velocities obtained based on longitudinal maps were also used for the scale conversion of the transverse maps shown in Figure 12.

In both the longitudinal (Figure 11) and transverse (Figure 12) GPR maps, hyperbolic diffractions indicating reinforcing bars can be observed. To accurately display the reinforcement distribution, the migration processing was performed using the hyperbolic summation method in accordance with the algorithm described earlier. As mentioned before, the velocity value is required for the migration processing. In the conducted investigations, the average velocity of the three hyperbolas (shown in Figure 11) was used for each map. The results of migration are shown in Figure 13 and Figure 14 for longitudinal and transverse scans, respectively. On the migrated GPR maps, the reinforcing bars are clearly represented

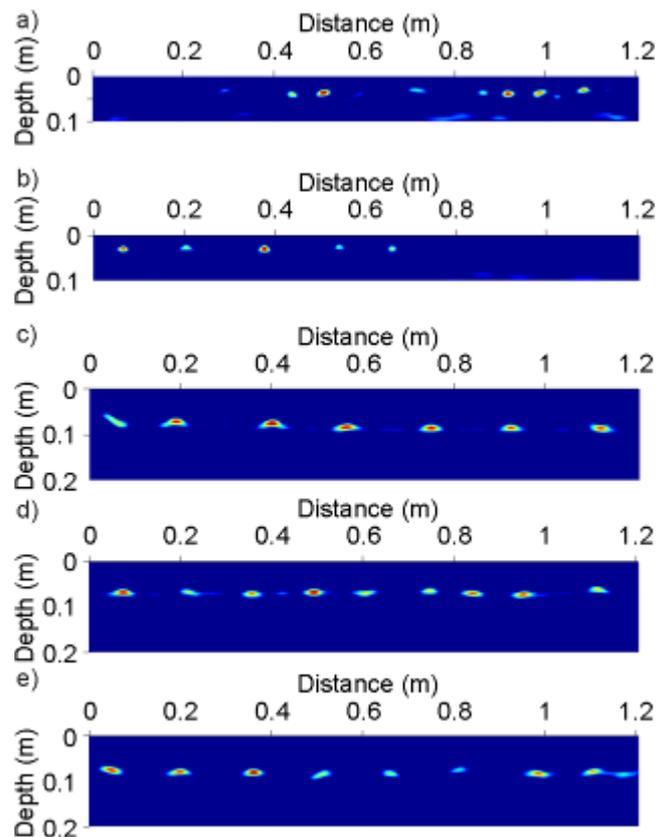
Figure 13. Migrated longitudinal GPR maps: a) pillar S.1; b) pillar S.2; c) pillar S.3; d) pillar S.4; e) pillar S.5

On the basis of the obtained migration results for pillar S.1, reinforcing bars in the transverse direction (across the pillar height) were found to exhibit an average spacing of 10 cm at a depth of approximately 5 cm (Figure 13a). For pillar S.2, the transverse

reinforcement was identified at a depth of approximately 4 cm with an average spacing of 20 cm (Figure 13b). The results for pillar S.3 are shown in Figure 13c, in which transverse bars at a depth of approximately 8 cm with an average spacing of 20 cm are visible. In the case of pillar S.4, it was observed that the transverse reinforcement is located at a denser spacing of approximately 15 cm (Figure 13d). For the largest pillar, S.5, the transverse reinforcement was found at an average spacing of 15 cm at a depth of approximately 8 cm.

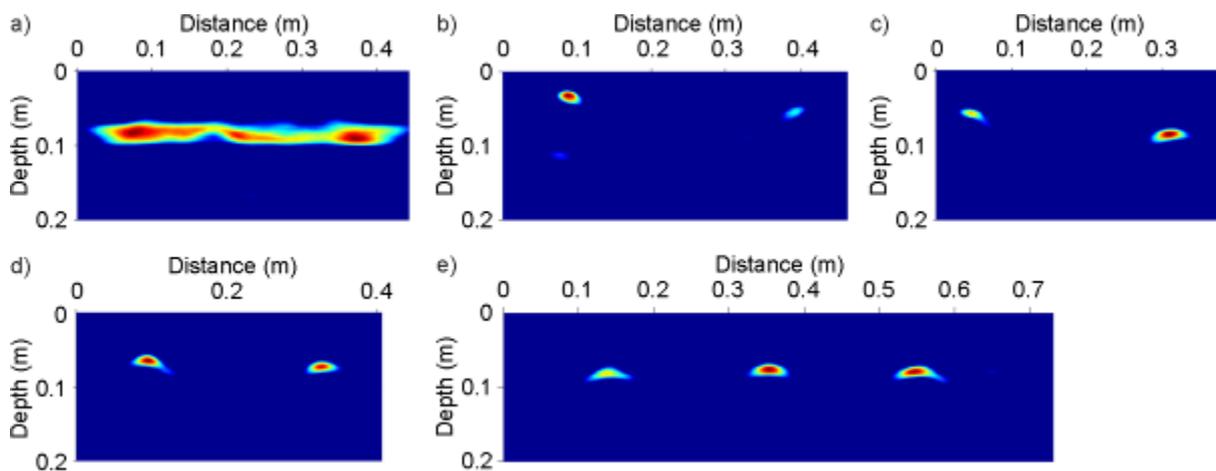
Figure 14. Migrated transverse GPR maps: a) pillar S.1; b) pillar S.2; c) pillar S.3; d) pillar S.4; e) pillar S.5

The longitudinal reinforcement was identified in the case of four investigated pillars for which monolithic reinforced concrete was used as the strengthening solution. Two bars were found in pillars S.2, S.3 and S.4 with spacing distances of 30 cm, 26 cm and 23 cm, respectively (Figure 14b-d). In the case of pillar S.5, three bars with a spacing of 20 cm can be observed (Figure 14e). No bars in the longitudinal direction were found for pillar S.1 (see Figure 14a and Figure 12) because this pillar was strengthened with the use of prefabricated elements in which reinforcement was applied in only one direction. However, a strong reflection on the migrated GPR map is visible, indicating that the thickness of the reinforced concrete jacket is approximately 10 cm.
