## ECONOMICAL METHODS FOR MEASURING ROAD SURFACE ROUGHNESS

Dariusz Grabowski, Maciej Szczodrak, Andrzej Czyżewski

Gdańsk University of Technology, Faculty of Electronics, Telecommunications and Informatics,  
G. Narutowicza 11/12, 80-233 Gdańsk, Poland (✉ [ksm@sound.eti.pg.edu.pl](mailto:ksm@sound.eti.pg.edu.pl), 48 58 347 1114)

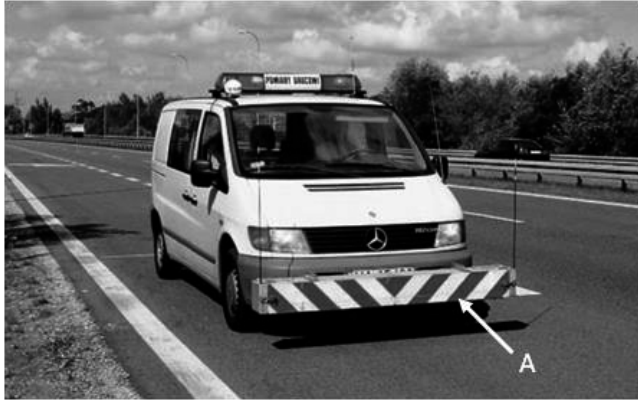
Fig. 1. A professional laser profilograph (A) mounted on a vehicle [11].

Another solution used, among others, by the General Directorate for National Roads and Motorways in Poland, is a laser profilograph [11]. One such device is a Dynatest's product, model 5051 Mk-II Test System. The device is installed on a beam mounted at the front of the vehicle, as shown in Fig. 1, equipped with densely distributed laser sensors. They scan the road surface area approximately every 5 mm and then the obtained data are stored in the fixed memory. The test is based on recording the maximum value of ground clearance between the damaged surface and the horizontal beam [12]. Usually the measurements are taken at 50 km/h, but it is also possible

In addition to laser sensors, the device is equipped with accelerometers, gyros, a GPS receiver and a distance meter. This enables to study the longitudinal and transverse roadway profiles, the curvature of curves, *etc.* [14].

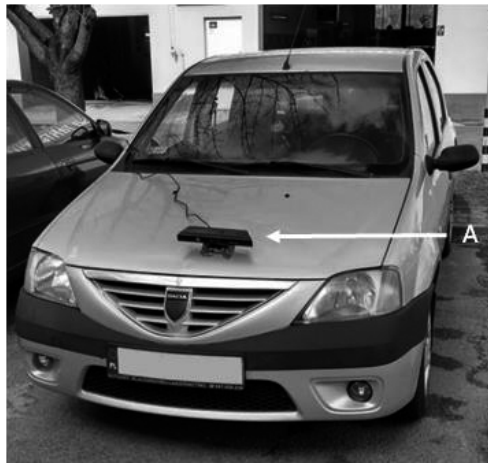
Fig. 5. A car equipped with a Kinect sensor (A).

sensor was mounted on the car engine flap using a mounting tape. The sensor’s framerate enabled to drive at a speed of about 30 km/h. A photo of the vehicle setup for the test drive is shown in Fig. 5.
