# Experimental study on the behaviour of steel columns under seismic-induced axial impact load

W. Migda<sup>\*,1</sup>, R. Jankowski<sup>\*\*,2</sup>

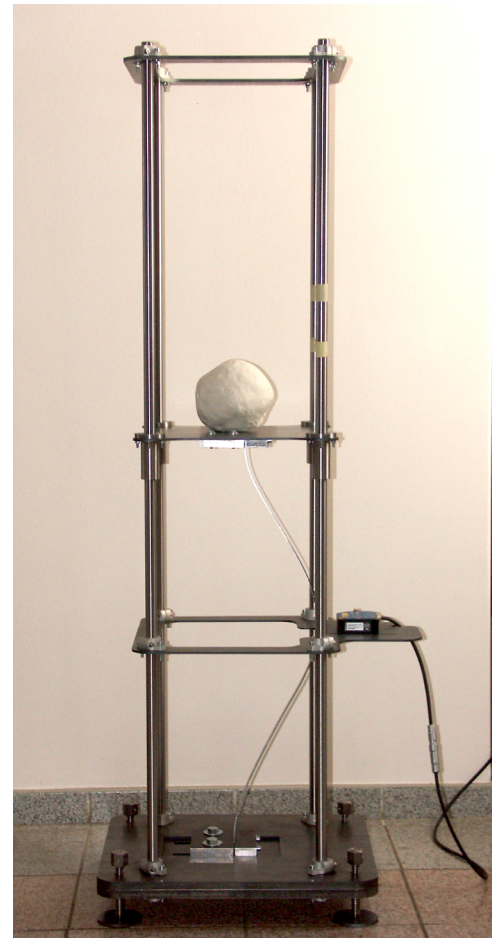
Fig. 1 Setup of the experiment.

A stand structure (see Fig. 1) was constructed for the purposes of the experimental study. It consisted of a thick steel plate at the bottom, to which four steel rods were mounted. Four precision shafts were used for these rods. A platform moving along the rods was installed using four linear bearings. A number of steel columns, with the length of 800 mm and cross section of  $2 \times 20$  mm, were prepared to be tested experimentally. Each column specimen was mounted in fixed supports located at the bottom and at the moving platform (see Fig. 1). The critical load of the specimen was analytically calculated as equal to 168.6 N; however, the actual critical load was experimentally estimated at about 150 N. The mass of the platform was 6 kg. During the experiment, a ball made of modelling clay with a mass of 2 kg was dropped from a specified height onto the top platform. The drop height,  $H$ , was equal to 50 mm and 100 mm. Before, during and after the impact, the horizontal displacement of the specimen was measured at its mid-height using the laser displacement meter (see Fig. 1) and the peak values were recorded. In order to investigate the buckling behaviour of the columns under bending (observed during an earthquake), the initial relative displacement (pre-deflection  $\Delta$ ) was introduced between the base and the top of the column by moving the bottom support horizontally. In the first stage of the experiment, the straight columns were tested. Then, the pre-deflection was uniformly increased each time by 20 mm up to 60 mm.
