## Glass-ceramic joining of Fe22Cr porous alloy to Crofer22APU: interfacial issues and mechanical properties

This work deals with the joining of porous Fe22Cr ferritic stainless steel to a dense Crofer22APU plate by using a silica-based, Ba-containing glass-ceramic. The chemical and interfacial stability and the mechanical properties of the joints were evaluated before and after thermal ageing at 700°C for 500hrs. The sintering behaviour of the glass was assessed by using heating stage microscopy (HSM) to study the influence of a porous metal substrate on the shrinkage of the joining material. Scanning electron microscopy revealed that there were no defects or cracks at the porous alloy/glass-ceramic interface for both the as-joined samples and the samples after thermal ageing at 700°C for 500 hrs. However, at this exposure temperature, the porous alloy started to form an oxide scale at the interface with the glass-ceramic and the internal surface of

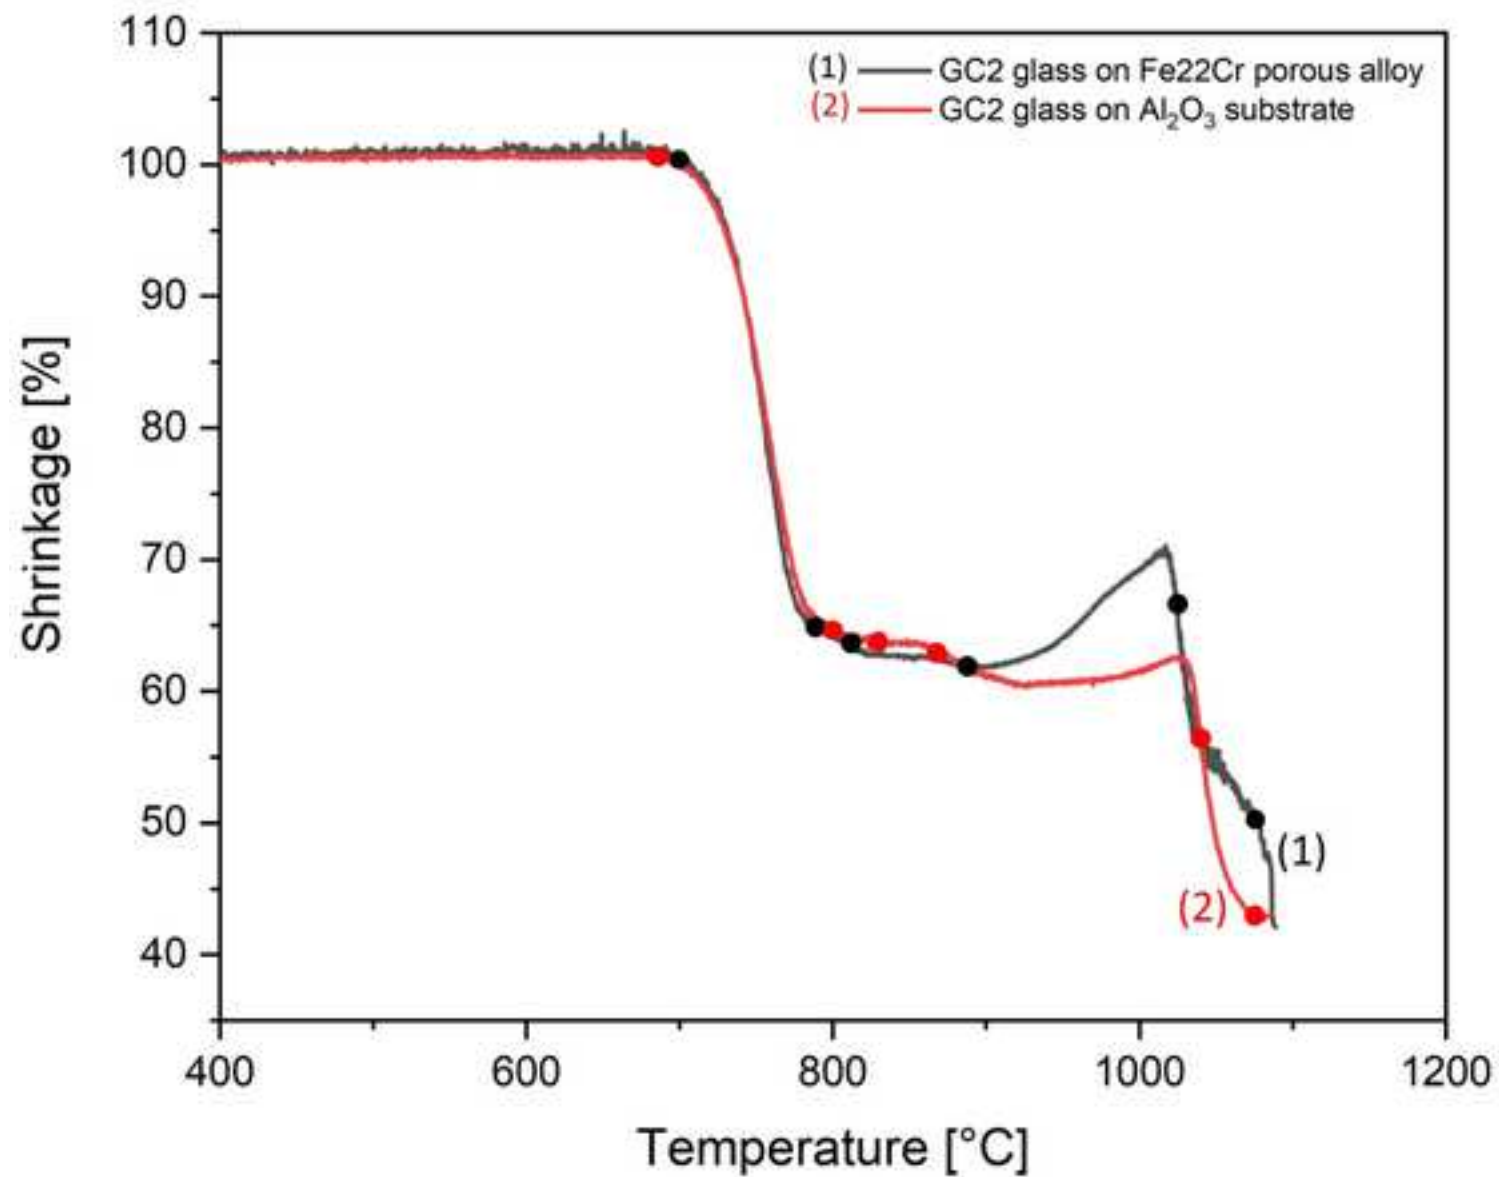
10  
11 **Figure 2.** Heating Stage Microscopy (HSM) curves of the GC2 glass (5°C/min heating rate) on the  
12 Fe22Cr porous alloy (curve 1) and on the inert Al<sub>2</sub>O<sub>3</sub> support (curve 2); characteristic temperatures  
13  
14 of GC2 glass identified with HSM are shown below the figure.  
15  
16  
17

10  
11 **Figure 2** reports the experimental curves obtained from heating stage microscopy  
12 (HSM) analyses of the as-cast GC2 glass powder pellets on the porous Fe22Cr alloy  
13 (curve 1) and on an inert Al<sub>2</sub>O<sub>3</sub> support (curve 2), where the linear shrinkages % are  
14 (curve 1) and on an inert Al<sub>2</sub>O<sub>3</sub> support (curve 2), where the linear shrinkages % are  
15 plotted against the temperature. The first two characteristic temperatures are the points  
16 at which linear shrinkage of the glass starts ( $T_{fs}$ ) and assumes the maximum value ( $T_{ms}$ ):  
17 they are 705°C and 790°C on the porous alloy, 696°C and 802°C on the Al<sub>2</sub>O<sub>3</sub>  
18 substrate. The temperature at which the first signs of softening are observed (DT) was  
19 identified at 811°C (onto Fe22Cr) and 822°C (onto Al<sub>2</sub>O<sub>3</sub>), while the sphere  
20 temperature (ST) was at 893°C on the porous alloy and 872°C on Al<sub>2</sub>O<sub>3</sub>, where the

21 height of the sample is equal to the width of the base. The half-sphere temperature (HT),  
22 which is the temperature at which the height of the sample is half the width of the base,  
23 was measured at 1028°C on the Fe22Cr porous alloy and at 1040°C on the inert  
24 substrate. Finally, the flow temperature (FT) was evident at 1079°C and 1076°C; the  
25 latter is the temperature at which the height of the sample drops to below one-third of  
26 the base. A visible plateau between 800 and 1000°C was observed and this represents  
27 the crystallization phenomenon that occurs. A significant expansion of the glass  
28 powder pellet is visible for the GC2 glass onto the Fe22Cr porous alloy, which is  
29 evidently absent on the inert substrate; this is likely due to gaseous species developed at  
30 T higher than 920°C, determined by the oxidation of the porous alloy during the GC2  
31 viscous flow sintering. Based on these observations, the conditions for joining the

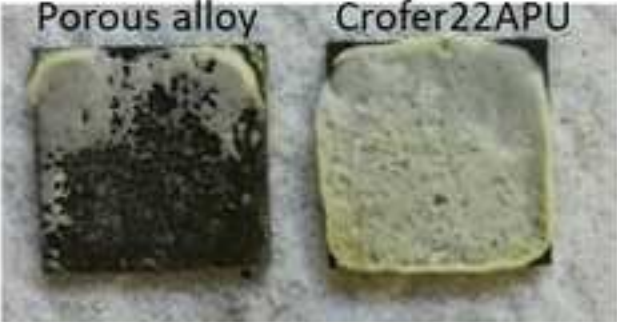
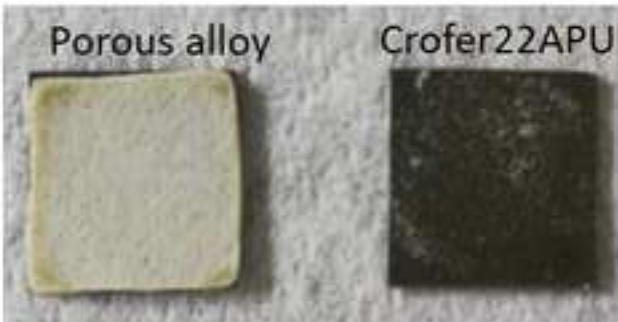
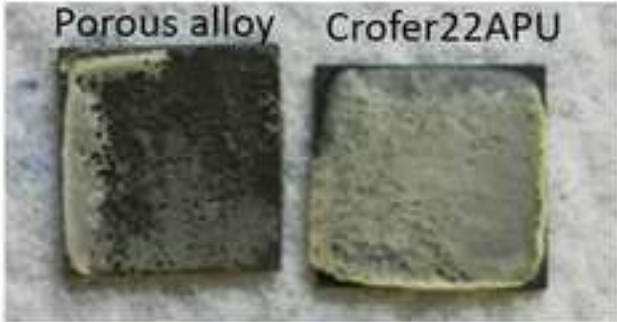
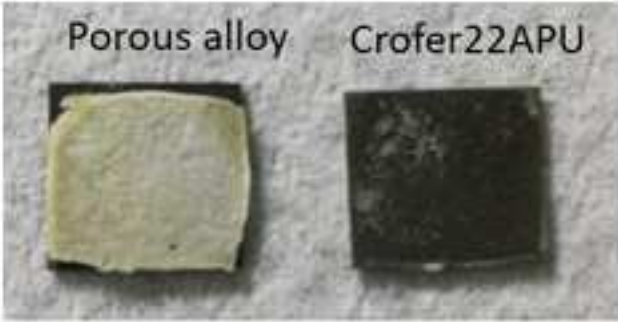
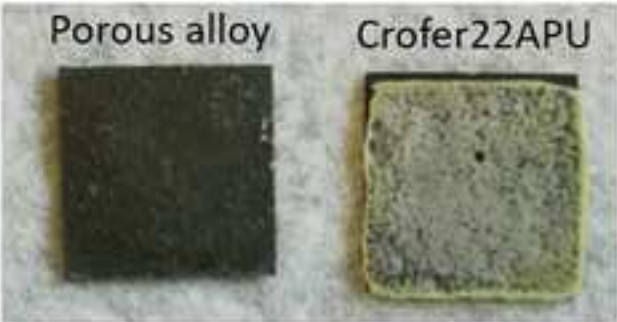
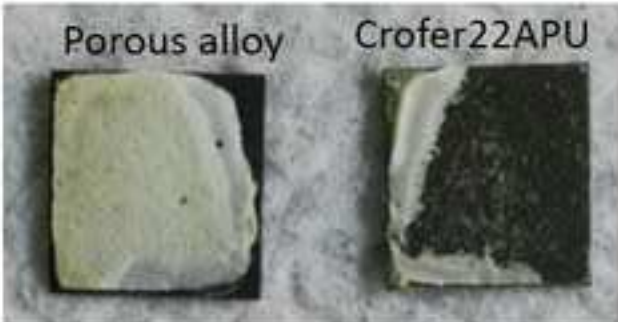
38  
39 **Figure 7.** Macrographs of as-joined and aged Crofer22APU/GC2glass-ceramic/ Fe22Cr samples  
40 after tensile testing.  
41

22  
23 Tensile testing was used to evaluate the mechanical properties of the joined  
24 samples. The tests carried out on as-joined Crofer22APU/GC2 glass-ceramic/Fe22Cr  
25 porous alloy samples showed an average tensile strength of  $7.4 \pm 0.5$  MPa (identified  
26 with  $\sigma_m$  in Figure 7). This value is slightly higher than the tensile strength of the  
27 majority of glass-ceramic sealants reported in the literature (3.8-6.3 MPa) and used for  
28 joining Crofer22APU and Crofer22H [33].  
29  
30  
31  
32  
33  
34  
35  
36  
37

42  
43 Macrographs of the fracture surface of 3 as-joined specimens are shown in Figure 7.  
44 While most of the fractured area of the Fe22Cr porous substrate in Figure 7 seems to  
45 show exposed metal alloy, however, EDS analyses (not reported here) revealed many  
46 parts of the surface covered by the GC2 glass-ceramic; in some areas, large sections (in  
47 white) of the GC2 glass-ceramic suggest the presence of cohesive failure, while small  
48 white specks show evidence of fractured glass-ceramic that had impregnated the pores  
49 of the Fe22Cr substrate. Inspection of the opposite part shows small fractured black  
50  
51

1 specks of Fe22Cr embedded in the GC2 glass-ceramic. These observations suggest that  
2  
3 the impregnation of the glass-ceramic into the Fe22Cr porous alloy enhances the  
4  
5 interfacial strength. Indeed, part of the failure seems to be occurring in the porous  
6  
7 Fe22Cr just beyond the area of GC2 impregnation due to stress concentration in the  
8  
9 porous alloy (due to the absence of GC2 glass-ceramic). Overall there is mixed  
10  
11 adhesive/cohesive failure, where the adhesive failure is mainly localised at the  
12  
13 porous/GC2 interface. [Figure 8a](#) shows a magnified fracture surface of the glass-  
14  
15 ceramic on the Crofer22APU side after mechanical testing; the bright phase well visible  
16  
17 in the back-scattered SEM image identified by the EDS analysis as BaCrO<sub>4</sub>, was mainly  
18  
19 located on the edges of the joined area and was present on both the porous and the dense

34  
35  
36 The results of mechanical testing for the thermally-aged samples exhibited an  
37  
38 average tensile strength of  $7.7 \pm 2.9$  MPa, a value that was similar to the as-joined  
39  
40 samples. Inspection of the macrographs in [Figure 7](#) shows that the samples suffered a  
41  
42 completely or mainly adhesive failure. [Figure 8b](#) shows a higher magnification of the  
43  
44 fracture surface of the Crofer22APU after ageing at 700°C for 500 hrs following  
45  
46 mechanical testing. The EDS analysis showed high atomic% of Ba and Cr and therefore  
47  
48 the presence of barium chromate can be hypothesized also after ageing .  
49  
50  
51

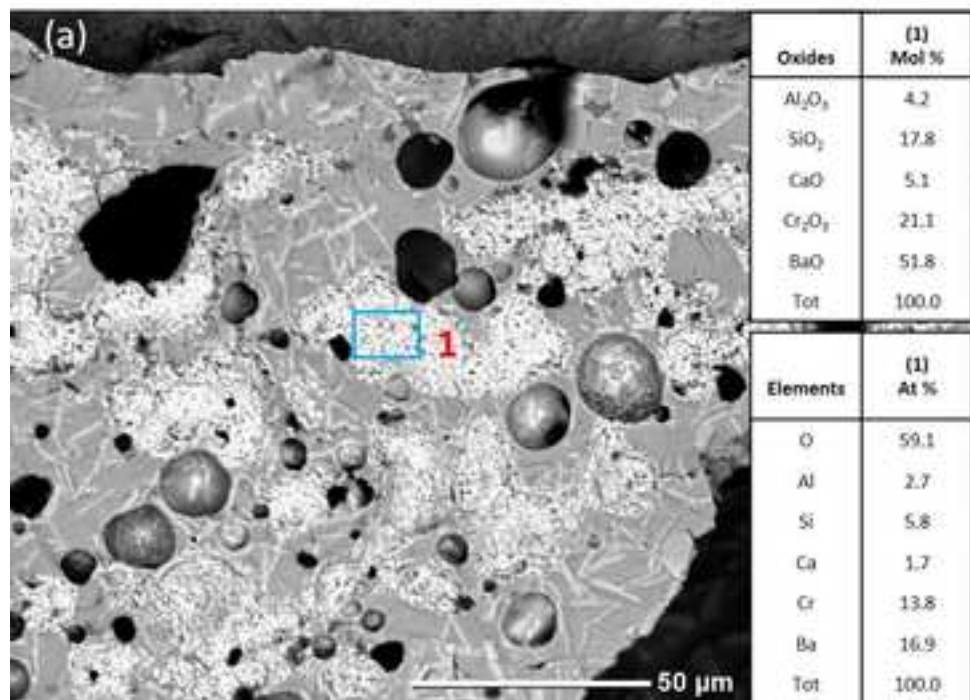
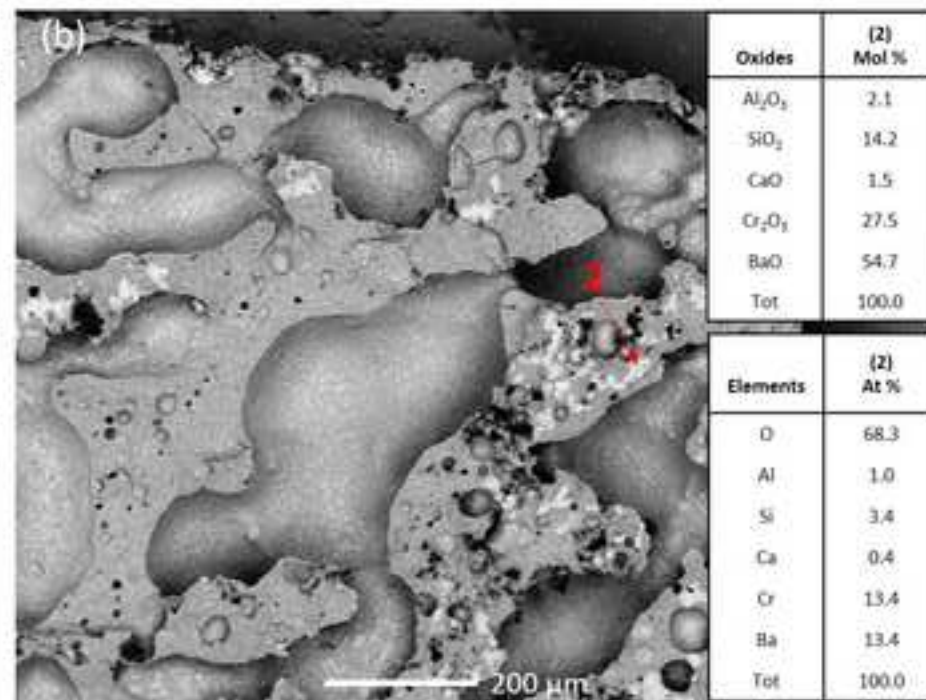
27  
28 [Figure 8](#). SEM images of top views of fracture surface of an as-joined (a) and an aged (b)  
29  
30 Crofer22APU/GC2glass-ceramic/ Fe22Cr porous alloy sample after mechanical testing  
31  
32 (Crofer22APU side); EDS analyses carried out on the fracture surfaces in the joining area.  
33  
34  
35

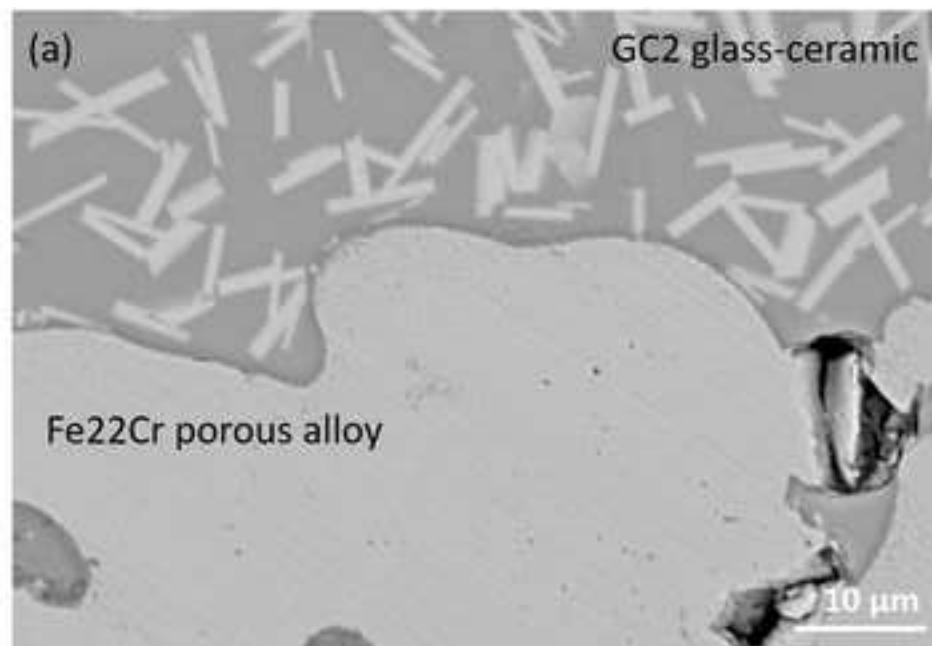
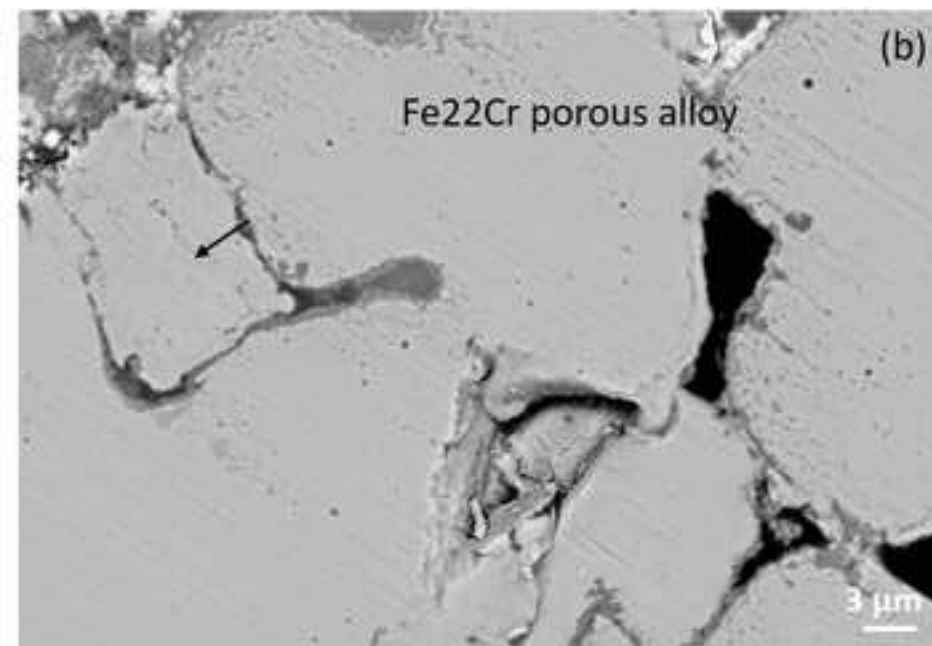
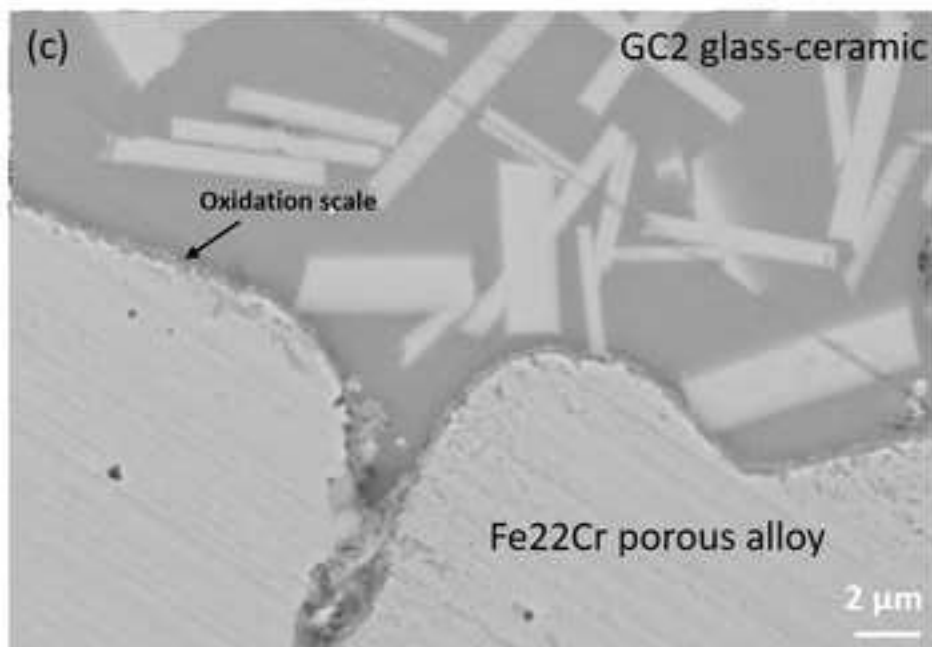
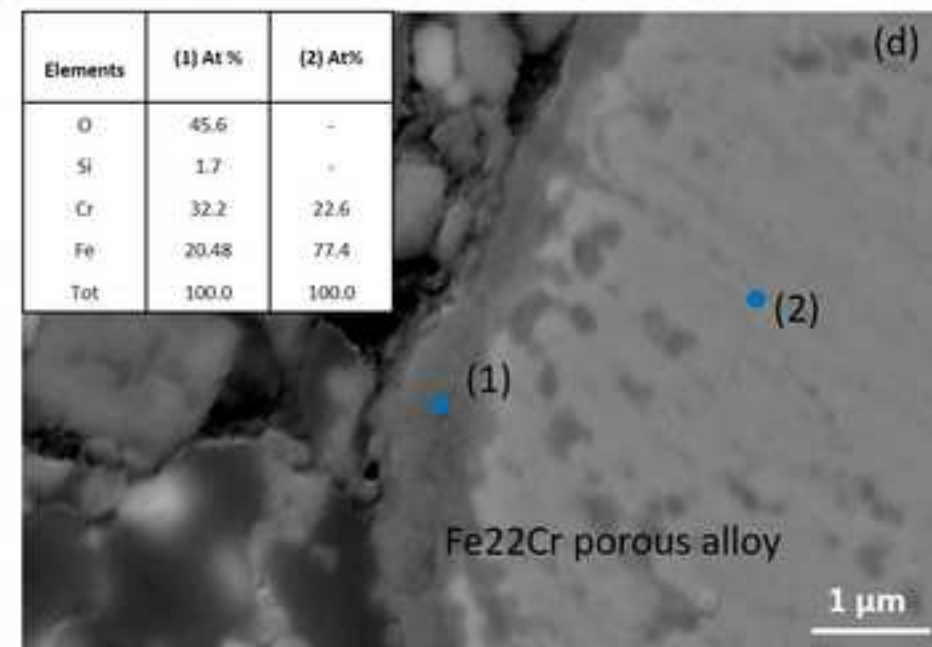
23  
24  
25  
26  
27 [Figure 9](#). FE-SEM images of a cross-section after ageing at 700°C for 500hrs: (a,c) Fe22Cr porous  
28  
29 alloy/GC2 glass-ceramic interface and (b) Fe22Cr porous alloy; (d) higher magnification of Fe22Cr  
30  
31 porous alloy and EDS analysis carried out on the porosity edge of the porous alloy.  
32  
33

36  
37 [Figure 9](#) shows a cross-section of a joined sample after ageing at 700°C for 500 hrs.  
38  
39 There was no evidence of cracks following ageing, thus implying that detrimental  
40  
41 thermal stresses did not occur. In addition, the microstructure of the GC2 glass-ceramic  
42  
43 did not seem to be affected by the heat treatment ([Figure 9a](#)). However, [Figure 9b](#)  
44  
45 shows evidence of the formation of an oxidation scale on the pores surface; oxidation  
46  
47 was also apparent at the GC2 glass-ceramic/porous alloy interface ([Figure 9c](#)). Due to  
48  
49 the large surface/volume ratio of the porous samples, there is a risk that oxide formation  
50  
51 (typically Cr<sub>2</sub>O<sub>3</sub> [34]) can potentially lead to depletion of Cr within the porous alloy. In  
a previously cited work [9], the surface of the same porous alloy, which was exposed to  
a temperature of 700°C for 100hrs, did not show any significant microstructural changes

1 in comparison to alloy samples that had not been aged. The weight gain at 700°C after  
2  
3  
4 100 hrs was reported to be around 1%. However, a sample that had been exposed to  
5  
6 750°C for the same time, experienced a weight gain of ~2.5 % and was characterised by  
7  
8 changes at the surface; a small amount of oxide had clearly formed at the surface which  
9  
10 exhibited signs of greater roughness which may have resulted by the fact that the  
11  
12 surface of the porous alloy was slightly rough. From [Figure 9d](#) the formation of a  
13  
14 darker layer covering the Fe22Cr porous alloy following ageing is apparent. Based on  
15  
16 the results of the EDS analysis the scale seems to be composed of a mixed Fe and Cr-  
17  
18 based oxide and, since the latter is visible also further from the glass-ceramic/Fe22Cr  
19  
20 porous alloy interface, it could be due to a longer ageing heat treatment (700°C for

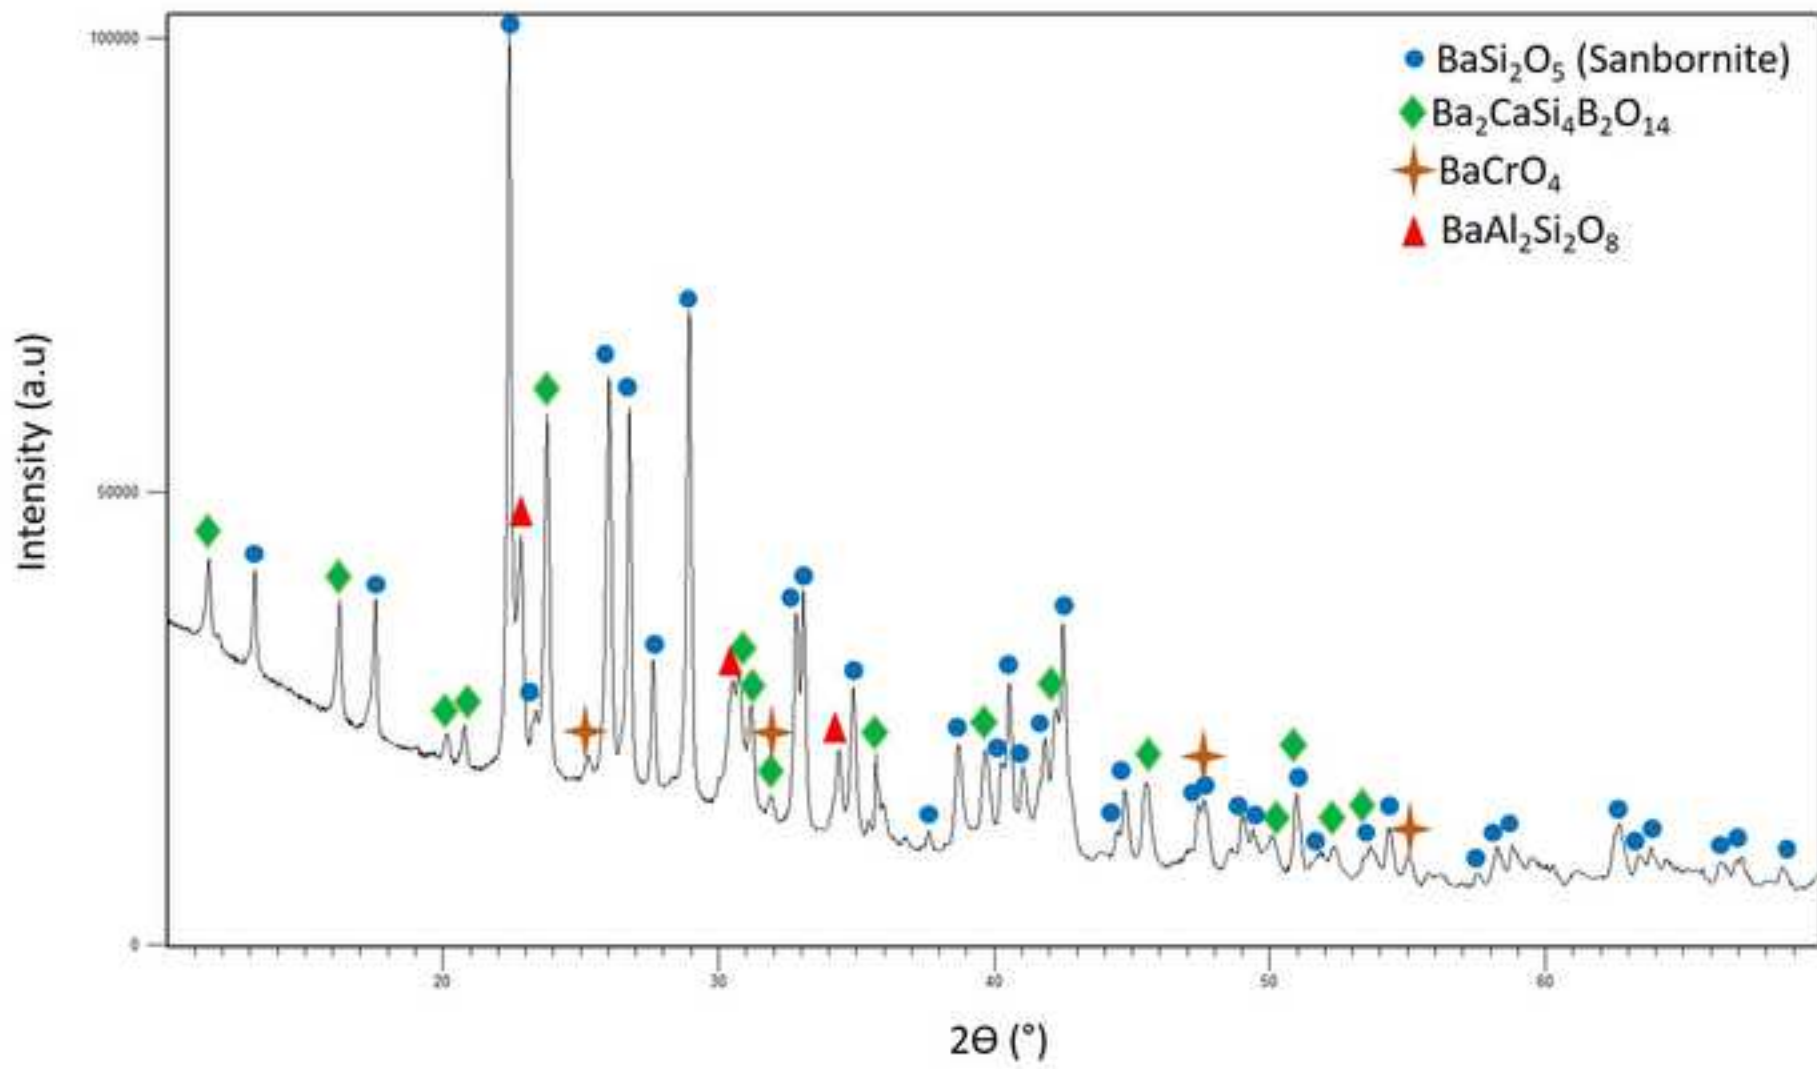
Figure 10. XRD pattern of the fracture surface (Crofer22APU side) of a Fe22Cr/GC2 glass-ceramic/Crofer22APU joined sample after ageing at  $700^\circ\text{C}$  for 500 hrs.

XRD analysis that was carried out on the Crofer22APU side (on the porous side, the remaining glass-ceramic layer was not enough) after ageing and mechanical testing, is shown in [Figure 10](#). The main peaks matched with those of the orthorhombic barium

1 silicate (Sanbornite with chemical formula  $\text{BaSi}_2\text{O}_5$ , PDF card n. 01-071-1441), which  
2  
3 was the main phase present after ageing. Prior to the ageing treatment, the only phase  
4  
5 that was present was  $\text{BaSi}_2\text{O}_5$  as previously reported for the as joined glass-ceramic  
6  
7 system before ageing heat treatment [32]. However, following ageing, new phases  
8  
9 emerged like those reported in previous studies with similar glasses [25], where the  
10  
11 formation of additional Ba-Ca-silicate phases that were not homogeneously distributed  
12  
13 within the microstructure was observed. In the present work a secondary phase  
14  
15 identified as the barium calcium boron silicate (named Itsiite[35], crystal system:  
16  
17 tetragonal; space group: I-42m)  $\text{Ba}_2\text{CaSi}_4\text{B}_2\text{O}_{14}$ , with PDF card n. 04-021-1159 was  
18  
19 found. In addition, some low-intensity peaks were identified as the  $\text{BaCrO}_4$  phase,

20  
21 confirming the EDS analyses carried out at the same fracture surface. Finally, the three  
22  
23 peaks at about  $2\theta=22.8^\circ$ ,  $2\theta = 30.2^\circ$  and  $2\theta=34.5^\circ$  could likely be attributed to  
24  
25  $\text{BaAl}_2\text{Si}_2\text{O}_8$  (ref. code 00-012-0725). In the present work, the glass-ceramic joining  
26  
27 material was subjected to a thermal ageing temperature that was  $40^\circ\text{C}$  higher than the  
28  
29 GC2 glass-ceramic  $T_g$  value. These findings, while preliminary, suggest that this  
30  
31 system is prone to further devitrification at temperatures slightly above the  $T_g$ . Despite  
32  
33 this, the mechanical behaviour of the joints is not affected by this microstructural  
34  
35 rearrangement. Further research should be undertaken to investigate the  
36  
37 thermomechanical behaviour at temperatures higher than  $700^\circ\text{C}$ .
