# HEALTH MONITORING OF A COMPRESSION IGNITION ENGINE FED WITH DIFFERENT LOW-SULPHUR MARINE FUELS BY ENDOSCOPIC IMAGE PROCESSING AND ANALYSIS

## ABSTRACT

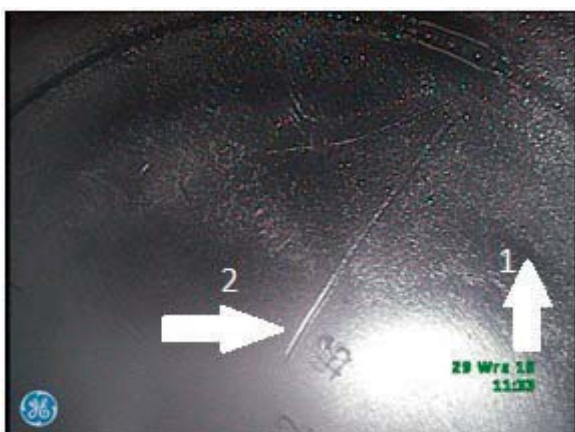
c) Piston crown – visible traces of carbon deposits (1) and scratches on the surface (2)

- the presence of longitudinal traces of slight abrasive wear of the cylinder liners
- (microslicings, scratchings, ploughings);
- the presence of small surface defects on the piston crown (mainly scratchings);
- slight deposits of impurities (mainly soot) on the bottom plate of the cylinder head, as well
- as on the surfaces of the cylinder's intake and exhaust valve heads.

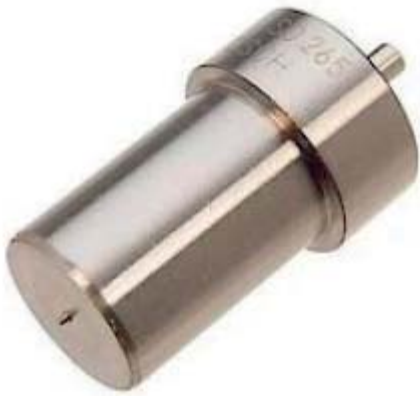
g) Fuel injector spray tip fitted immediately prior to parametric examinations

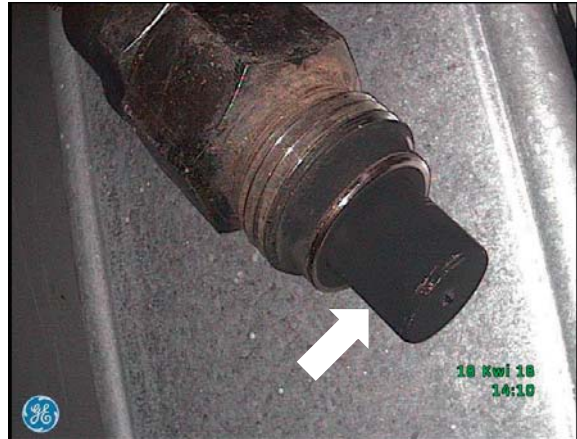
h) Fuel injector removed from the cylinder head – thick layer of soot on the spray tip

On the basis of the results recorded from the endoscopic examinations of the laboratory diesel engine after the completion of the entire testing program for low-sulphur marine fuels, it can be concluded that the technical condition of the available structural elements limiting its working space is satisfactory. The condition did not undergo significant changes under the influence of changes in the elemental composition of the fuel or the additives used to improve its lubricity. Also, changes in temperature and viscosity, during the implementation of transient processes in particular (e.g. rapid changes in a fuel dose during engine running), did not result in noticeable wear of the surface layers of the available structural elements of the working space. The detected surface defects, in the form of carbon deposits, indicate the need to adjust the fuel dose and the injection advance angle.
