# Influence of PWHT Parameters on the Mechanical Properties and Microstructural Behavior of Multi-Pass GTAW Joints of P92 Steel

**Abstract:** The 9% Cr steels were developed for ultra-supercritical (USC) power plants to meet the requirements of high operating temperature and pressure. These steels are produced to operate at high temperatures where impact toughness is not a concern; however, it becomes important for the welded joints to have good impact toughness at room temperature for manufacturing. The present work investigates the effect of the post-weld heat treatment (PWHT) parameters, i.e., temperature and time, on the impact toughness of multi-pass gas tungsten arc welded (GTAW) joints of ferritic/martensitic grade P92 steel. The microstructural evolution in welded joints given varying post-weld temperatures and times was studied. The lath martensitic structure of the weld metal for the as-welded joints resulted in high hardness and low impact toughness. The weld fusion zone toughness was 12 J, which was lower than the minimum specified values of 41 J (ASME standards) and 47 J (EN ISO 3580:2017). The PWHT temperature and time were found to have a significant effect on the i

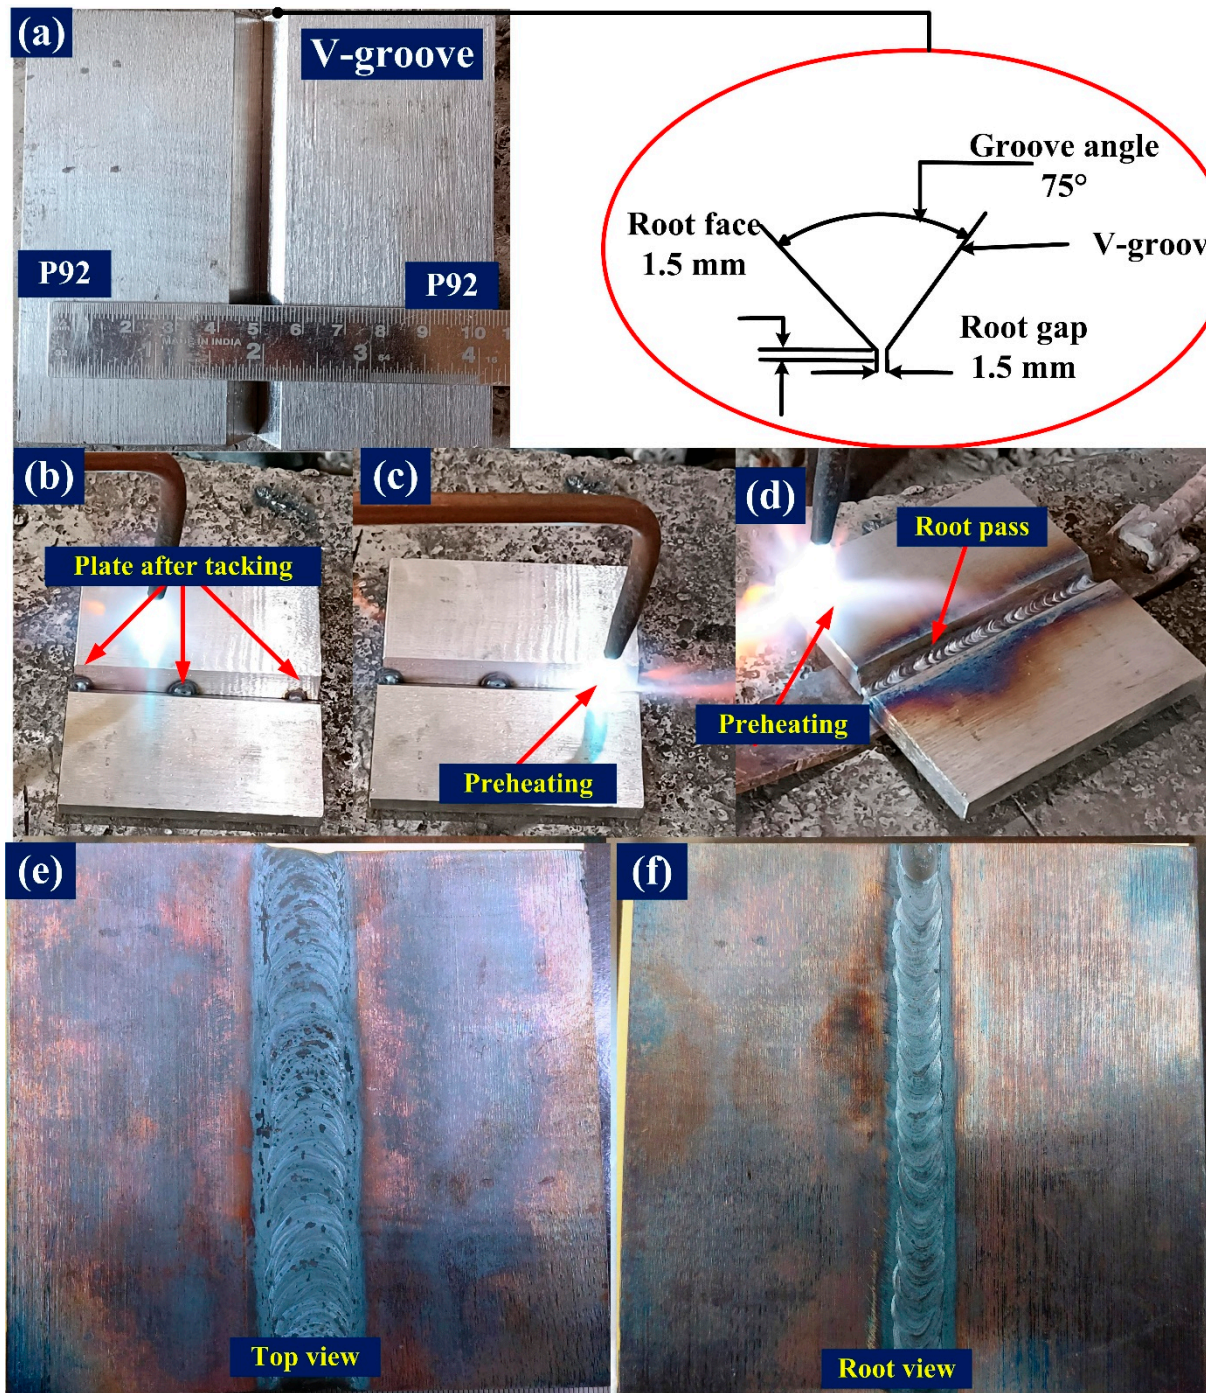
**Figure 1.** (a) Grooved plate and detail of groove geometry, (b) plate after tacking, (c) preheating, (d) root pass, (e) top view of plate, (f) root view of the plate.

The plate after the root pass is depicted in Figure 1d. The top and root views of the welded plate are shown in Figure 1e,f. After each pass, the weld area was cleaned using a wire brush. The inter-pass temperature was maintained at 280–300 °C. Commercially pure argon (99.9%) was used to shield the arc column and weld area and was supplied at a

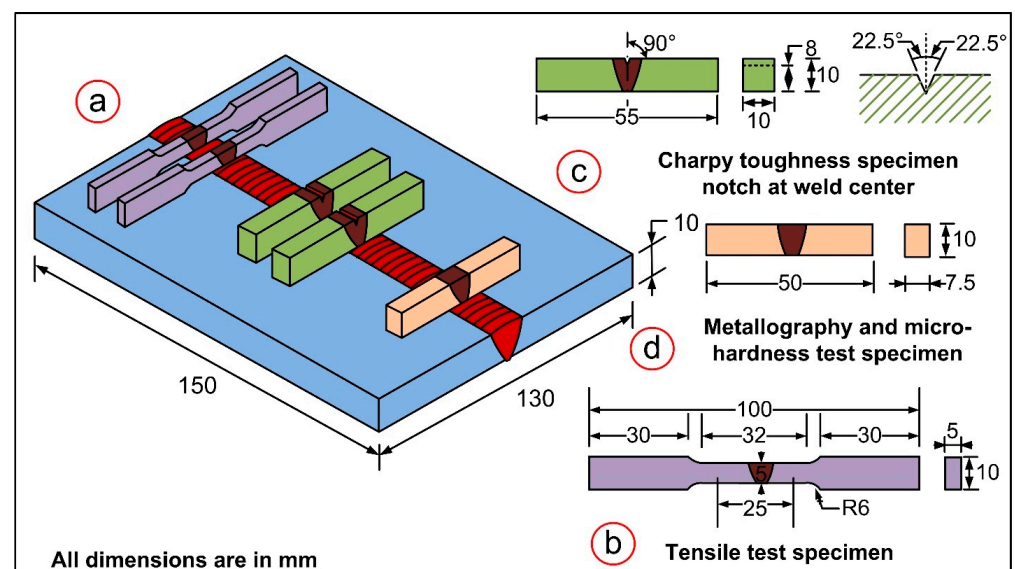
**Figure 2.** Schematic showing the (a) welded plate with specimen positions, (b) standard tensile specimen, (c) impact toughness specimen, (d) specimen machined for metallography and hardness testing.

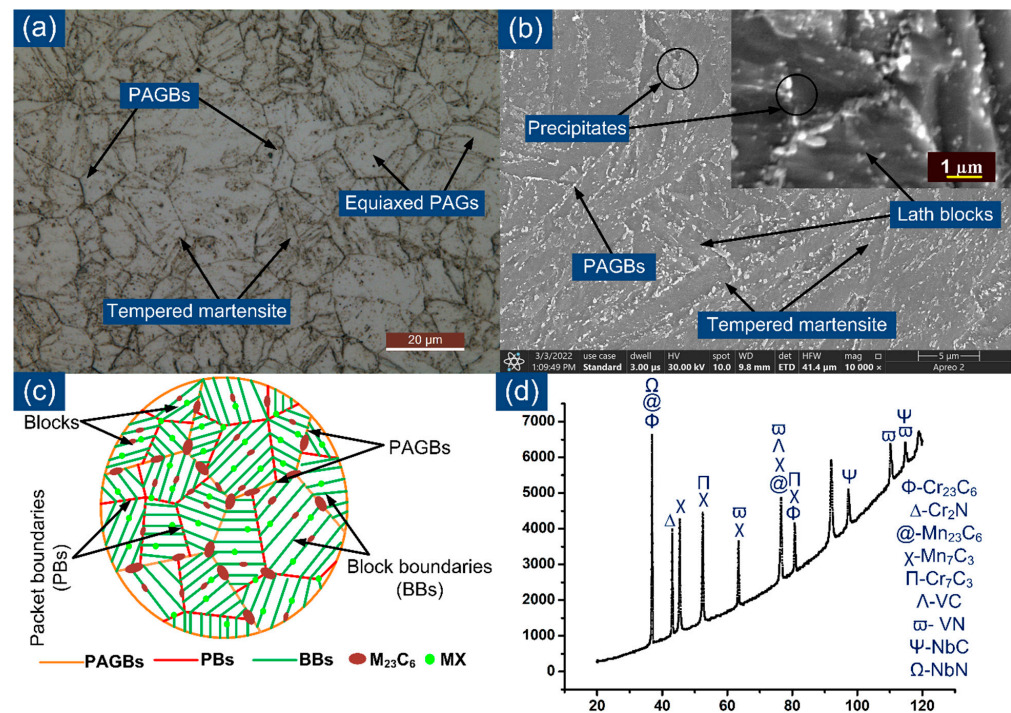
**Figure 3.** (a) Optical image showing tempered martensitic microstructure and boundaries, (b) SEM image showing lath blocks, boundaries and precipitate decoration along boundaries and inside the matrix, (c) schematic showing precipitate decoration along boundaries and blocks, and (d) XRD profile showing the phases present in P92 steel.

The micrograph of the P92 steel exhibited a tempered martensitic microstructure, as depicted in Figure 3a. Figure 3a shows equiaxed prior austenite grains (PAGs) with an average size of  $12 \pm 5 \mu\text{m}$ , lath blocks and boundaries. The SEM image, captured at a magnification of  $10,000\times$ , reveals the lath blocks, boundaries (block boundaries (BBs), packet boundaries (PBs) and prior austenite grain boundaries (PAGBs)) and decoration of the precipitates (Figure 3b). The precipitates located along the PBs and PAGBs are coarse in size and were confirmed to be Fe-, Mn- and Cr-rich  $\text{M}_{23}\text{C}_6$  precipitates [56]. The size of the coarse precipitates was in the range of 100–200 nm. Other fine precipitates, with sizes lower than 50 nm, were also observed within the lath blocks and confirmed to be Nb- and V-rich carbonitrides (VC, VN, NbC and NbN) [56]. The evolution of the microstructure in N&T P92 steel is also represented by a schematic image, given in Figure 3c. The other precipitates, except  $\text{M}_{23}\text{C}_6$  and MX, were  $\text{M}_7\text{C}_3$  and  $\text{Cr}_2\text{N}$  as confirmed via X-ray diffraction (XRD) analysis (Figure 3d). Hurtado-Noreña et al. [57] also reported the presence of  $\text{M}_{23}\text{C}_6$ ,  $\text{M}_3\text{C}$  and MX precipitates in 9% Cr steels. The tensile strength and yield strength of P92 after N&T treatment were  $758 \pm 6 \text{ MPa}$  and  $520 \pm 8 \text{ MPa}$ , respectively.

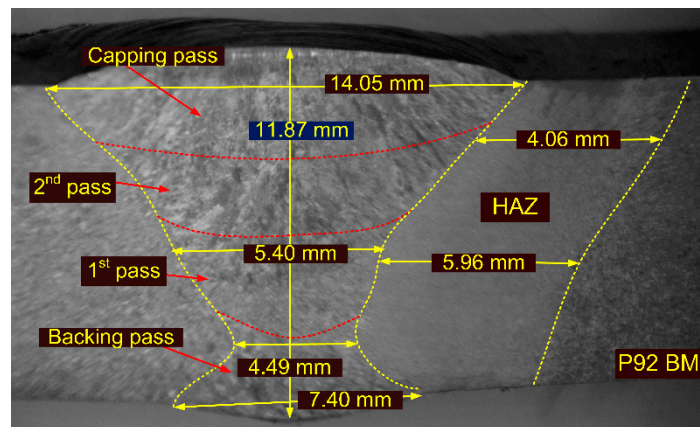
**Figure 4.** Macrograph of the welded joint.

The welding was completed in four passes and each pass is marked in the macrograph of the welded joint shown in Figure 4. The weld widths at the capping and backing passes were 14.05 mm and 7.40 mm, respectively. The widths of the HAZ corresponding to the capping pass and filling pass (second pass) were 4.06 mm and 5.96 mm, respectively.

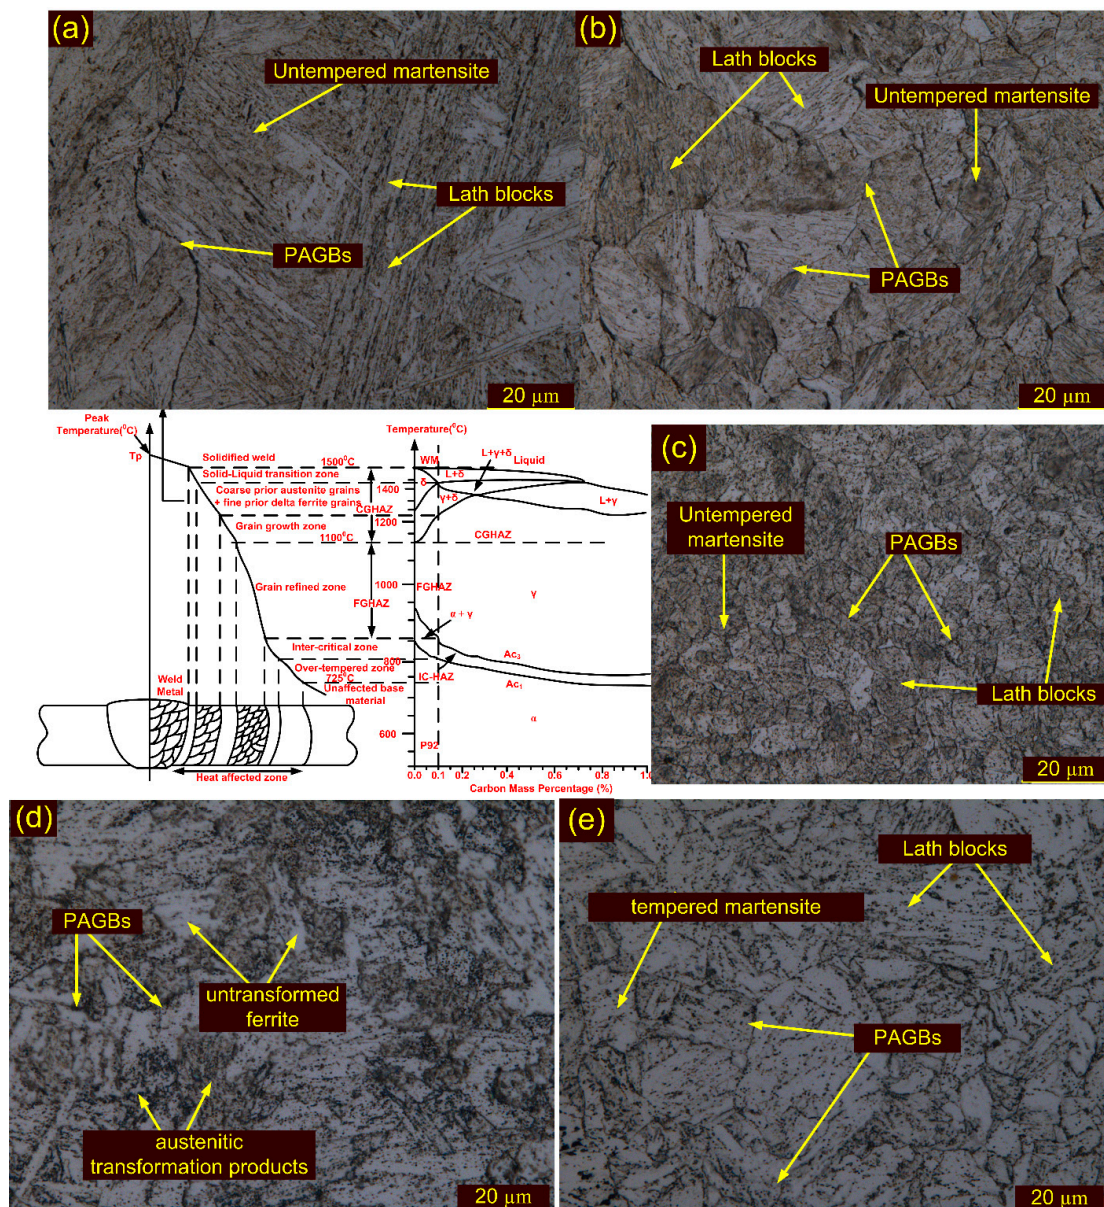
**Figure 5.** Fe–C diagram showing the formation of various zones in P92 weldments corresponding to different peak temperatures, and optical images of weldments: (a) WFZ, (b) CGHAZ, (c) FGHAZ, (d) ICHAZ, (e) SCHAZ.

The effect of the welding thermal cycle on microstructural evolution along weldments is depicted in a systematic Fe–Fe<sub>3</sub>C phase diagram (Figure 5). Figure 5 also presents the peak temperature experienced by each sub-zone and the corresponding optical micrographs. The microstructural evolution strongly influences the variation in mechanical properties along the sub-zones during the welding thermal cycle [58]. Zhang et al. [50] had reported the lower critical temperature ( $A_{c1}$ ) and upper critical temperature ( $A_{c3}$ ) for P92 steel to be 835–845 °C and 920–930 °C, respectively. The peak temperature experienced by the region varied as it moved away from the fusion boundary toward the BM. The weldment could be divided into five sub-zones on the basis of  $A_{c1}$ ,  $A_{c3}$  and peak temperature (Figure 5). The sub-zones will be referred to as the weld fusion zone (WFZ), coarse-grained HAZ (CGHAZ), fine-grained HAZ (FGHAZ), inter-critical HAZ (ICHAZ) and sub-critical HAZ (SCHAZ) [59].

The micrograph of the WFZ consists of a typical columnar lath martensitic microstructure. The lath blocks and packet boundaries are seen very clearly in Figure 5a. The SEM image corresponding to the WFZ shows the complete dissolution of the precipitates, as the temperature was much higher than the melting temperature. The lath blocks of different orientations within the lath packets are marked in Figure 6a–c. The WFZ of P92 steel is more prone to  $\delta$  ferrite formation because of the presence of Cr, W and Mo [60]. Based on the chemical composition of the WFZ (Table 1), various empirical relationships, i.e., the ferrite factor ( $K_{ff}$ ), have been suggested for evaluating  $\delta$  ferrite formation. Schneider’s formula is the method most commonly used to predict the formation of  $\delta$  ferrite [61]. The  $K_{ff}$  and  $Cr_{eq}$  are used to estimate ferrite formation and are listed in Equations (3) and (4):

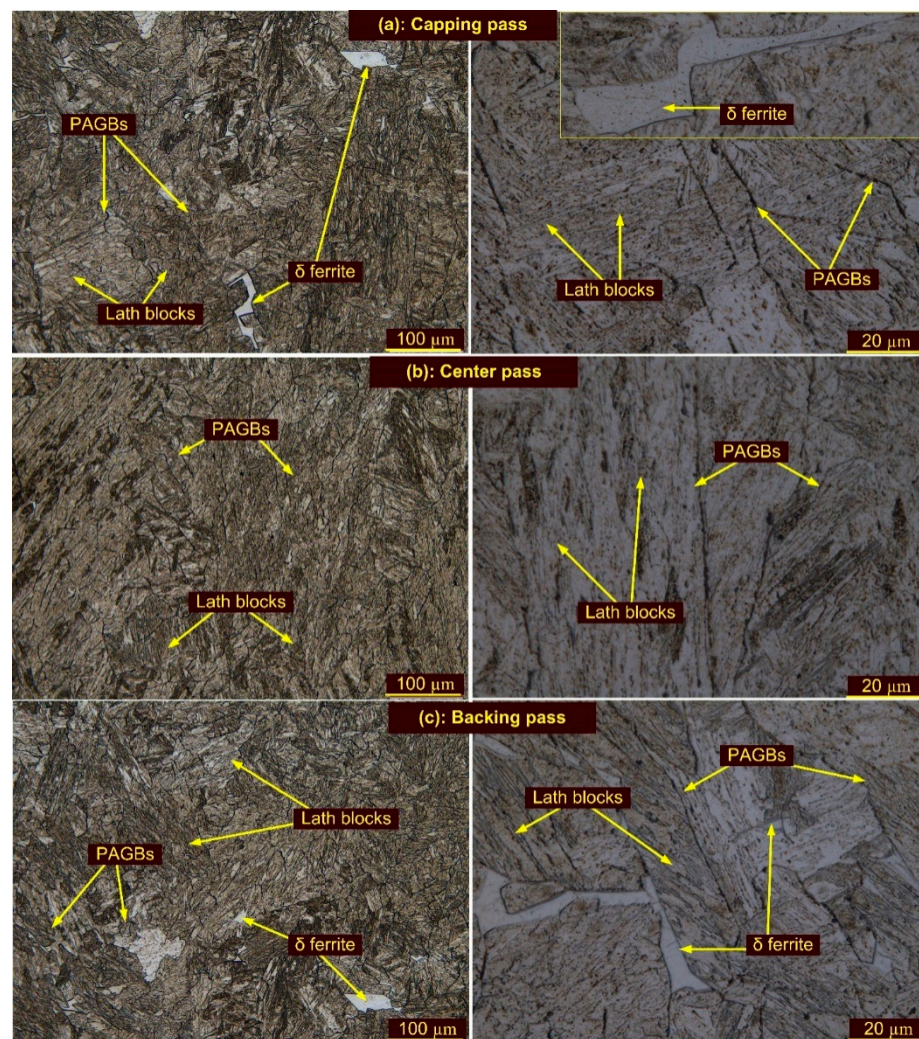
**Figure 7.** Optical image of WFZ corresponding to passes: (a) capping pass, (b) center pass, (c) backing pass.

A micrograph showing the effect of the welding passes on the WFZ is given in Figure 7. The WFZ corresponding to the capping and backing passes showed a microstructure type with elongated grains and typical lath blocks (Figure 7a–c). For both passes, WFZ showed the presence of  $\delta$  ferrite patches of different shapes and morphology. The WFZ corresponding to the backing and capping passes was directly exposed to the surroundings and achieved a higher cooling rate. Ferrite stabilizers such as W and Cr, present in the filler metal, also accelerated the formation of the ferrite patches in the WFZ. Previous studies also reported the role of ferrite stabilizer content on the formation of ferrite patches [62].

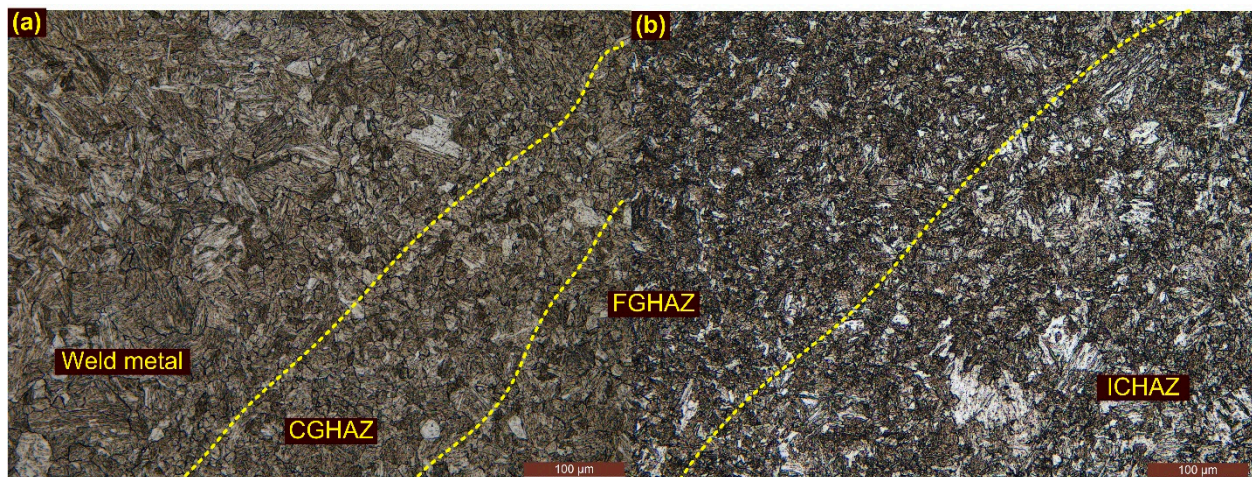
Figure 8. (a) Interface of the WFZ and CGHAZ; (b) interface of the FGHAZ and ICHAZ.

Figure 8 shows the boundary between the WFZ and the HAZs. Figure 8a represents the interface of the WFZ and the CGHAZ and ensures the proper mixing of the BM and the filler metal. Figure 8b shows the interface of the FGHAZ and the ICHAZ. A microstructural variation across the interface is very clearly observed.

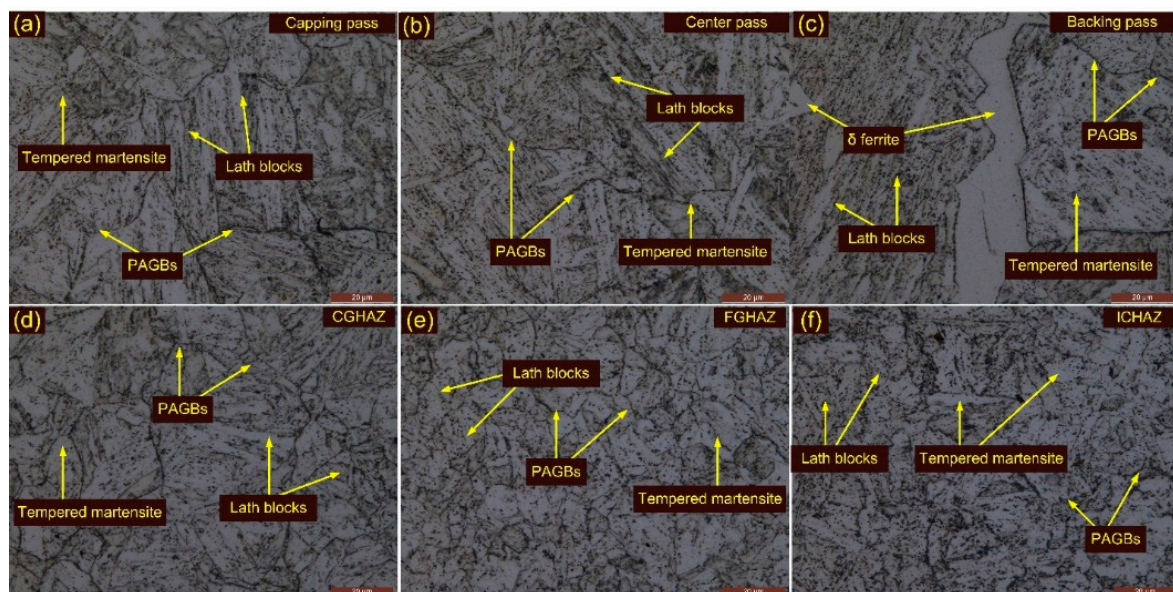
Figure 9. Weldments after T1 treatment: WFZ (a) capping pass, (b) center pass, (c) backing pass; (d) CGHAZ, (e) FGHAZ, (f) ICHAZ.

Optical images of the weldments after T1 are depicted in Figure 9a–f and their corresponding SEM images in Figure 10a–e. Optical images of the weldments after T2 are depicted in Figure 11a–f and their corresponding SEM images in Figure 12a–c. The T1 and T2 treatments resulted in a tempering of the martensite and the evolution of the precipitates in the WFZ. A tempered martensitic microstructure was seen in the WFZ for T1 (Figure 9a–c) and T2 (Figure 11a–c). Micrographs of the WFZ were captured in the capping, center and backing passes to observe the combined effect of PWHT and the welding passes. The  $\delta$  ferrite patches observed in the WFZ for the AW joint also remained after PWHT. The WFZ corresponding to the backing pass (Figure 9c) and capping pass (Figure 11a,c) show the presence of  $\delta$  ferrite patches. As mentioned by Saini et al. [30], dissolution of the  $\delta$  ferrite mainly starts after heating to a temperature greater than the  $A_{c3}$ , while in the present work, PWHT was carried out at 760–780 °C, which was lower than the  $A_{c3}$ .

The CGHAZ after T1 and T2 showed a complete change in microstructure due to the evolution of the precipitates and exhibits the tempered martensitic microstructure Figures 9d and 11d. The PAGs' size remained unaffected after T1, compared to the CGHAZ in the AW joint, and was  $24 \pm 6 \mu\text{m}$ . However, a noticeable increase in PAGs' size was measured after T2 ( $32 \pm 6 \mu\text{m}$ ). Figure 10c shows the SEM image of the CGHAZ after T1 and confirms the evolution of the precipitates along boundaries, blocks and the matrix. This resulted in a uniform distribution of the precipitates along boundaries and the matrix. The coarse  $\text{M}_{23}\text{C}_6$  precipitates evolved at the boundaries while fine MX evolved within the matrix during T1 and T2 treatments. The FGHAZ also showed a tempered martensitic microstructure; however, PAGs' size was measured to be lower than in the CGHAZ. For T1 and T2, PAGs' size in the FGHAZ was  $13 \pm 3 \mu\text{m}$  and  $14 \pm 1 \mu\text{m}$ , respectively. PAGs' size after T1 and T2 remained constant, as compared to the FGHAZ of the AW joint. Figures 9e and 11e show optical images of the FGHAZ corresponding to T1 and T2 welded joints. The SEM image after T1 (Figure 10d) shows nonuniformity in the size and distribution of the precipitates. This might be due to the simultaneous evolution of the new MX and  $\text{M}_{23}\text{C}_6$  precipitates and coarsening of the existing undissolved  $\text{M}_{23}\text{C}_6$  and MX precipitates. During welding, the MX precipitates remained undissolved in the FGHAZ and did not show any growth during T1. Hence, after T1, the major coarsening was seen for  $\text{M}_{23}\text{C}_6$ , which ultimately contributed to the heterogeneity in the size and distribution of the precipitates, while  $\text{Nb}(\text{C},\text{N})$  and  $\text{V}(\text{C},\text{N})$  remained unaffected [46]. The heterogeneous microstructure of the FGHAZ made it susceptible to Type IV cracking. Figures 9f and 11f show optical micrographs of the ICHAZ for T1 and T2, respectively. The ICHAZ did not show any major change after PWHT; however, there might be coarsening of the carbide precipitates. It shows a typical tempered martensitic microstructure with fine PAGs and randomly distributed precipitates. However, heterogeneity in the size of the precipitates might occur because of the coarsening of the carbide precipitates. A typical SEM image of the ICHAZ for T1 is shown in Figure 10e. It shows two different regions, i.e., UF and ATP, and the density of the precipitates along the boundaries of UF and ATP was different (Figure 10e). The precipitates that coarsened after treatment are also marked in Figure 10e. The PAGs' size in the ICHAZ was  $10 \pm 2 \mu\text{m}$  and  $12 \pm 3 \mu\text{m}$  in UF and ATP, respectively.

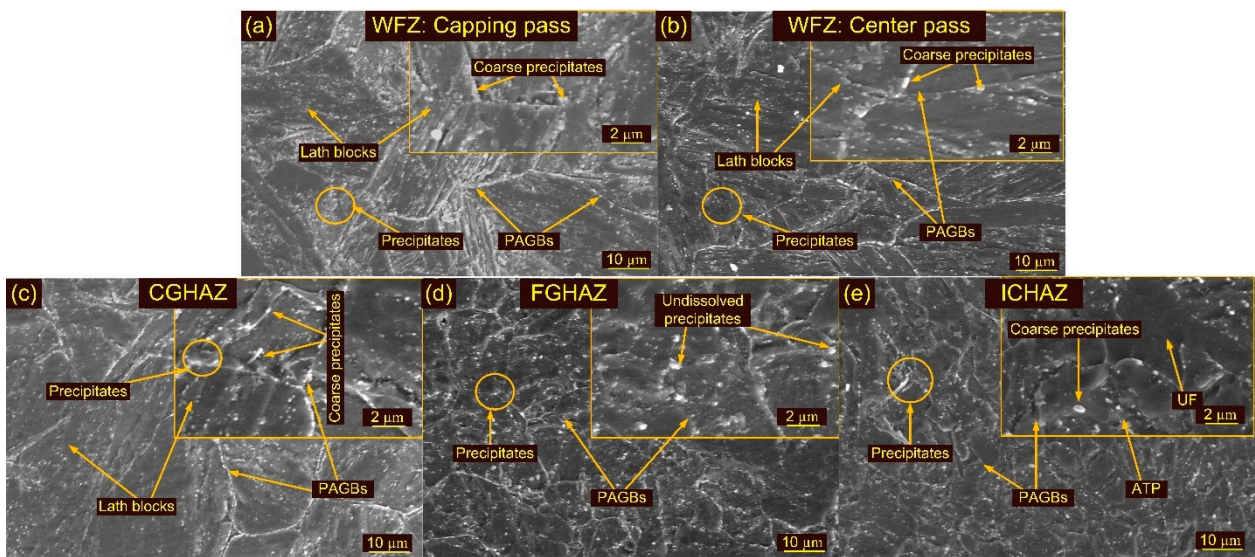
Figure 10. SEM images of weldments after T1 treatment: WFZ (a) capping pass, (b) center pass; (c) CGHAZ, (d) FGHAZ, (e) ICHAZ.

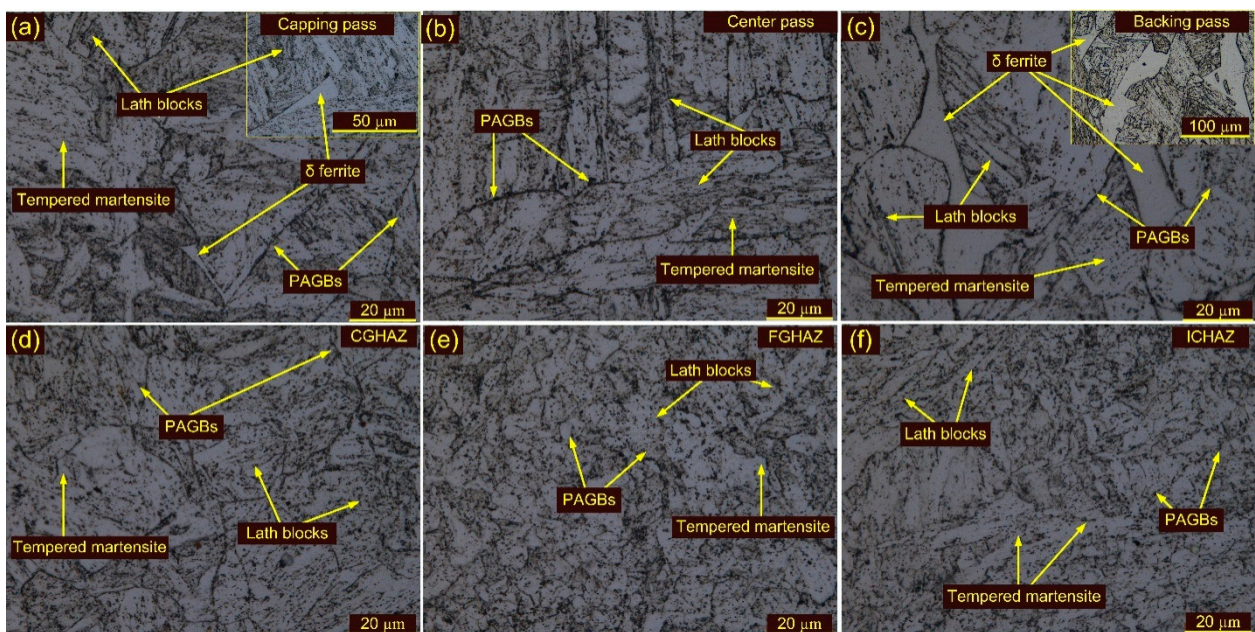
Figure 11. Weldments after T2 treatment: WFZ (a) capping pass, (b) center pass, (c) backing pass; (d) CGHAZ, (e) FGHAZ, (f) ICHAZ.

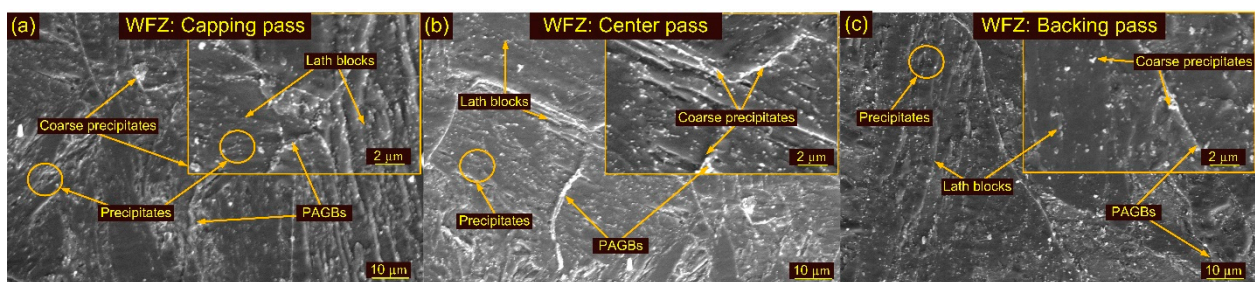
Figure 12. SEM images of weldments after T2 treatment: WFZ (a) capping pass, (b) center pass, (c) backing pass.

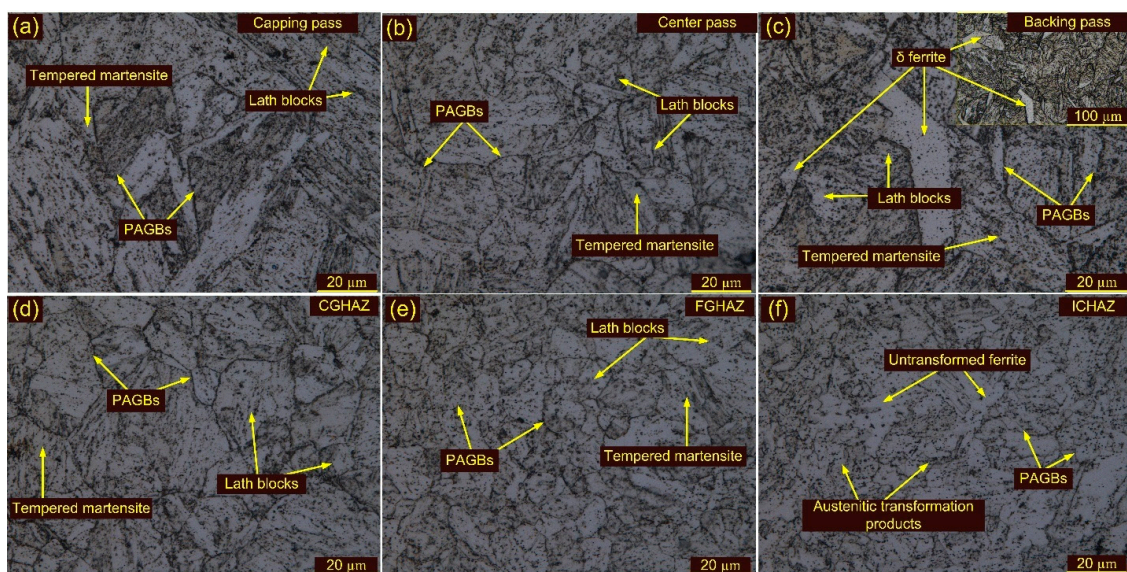
Figure 13. Weldments after HT1 treatment: WFZ (a) capping pass, (b) center pass, (c) backing pass; (d) CGHAZ, (e) FGHAZ, (f) ICHAZ.

Optical and SEM images of weldments after HT1 and HT2 treatment are presented in Figures 13–15. The optical images in Figure 13a,c show the typical lath block-type microstructure in the capping and backing passes for HT1 treatment. However, lath morphology disappeared to some extent in the center pass (Figure 13b). The  $\delta$  ferrite patches remained unaffected during HT1 and are seen in both the capping and backing pass regions (Figure 13c). The PAGs' sizes in the capping, center and backing passes were  $25 \pm 5 \mu\text{m}$ ,  $38 \pm 8 \mu\text{m}$  and  $30 \pm 6 \mu\text{m}$ , respectively. The SEM images corresponding to each pass are given in Figure 14a–c. The major precipitation is seen along the blocks and boundaries. The higher magnification image shows the decoration of the precipitates along blocks and boundaries and inside the matrix. Typical optical images of the HAZs are presented in Figure 13d–f. The HT1 resulted in a minute effect on the PAGs' size in the

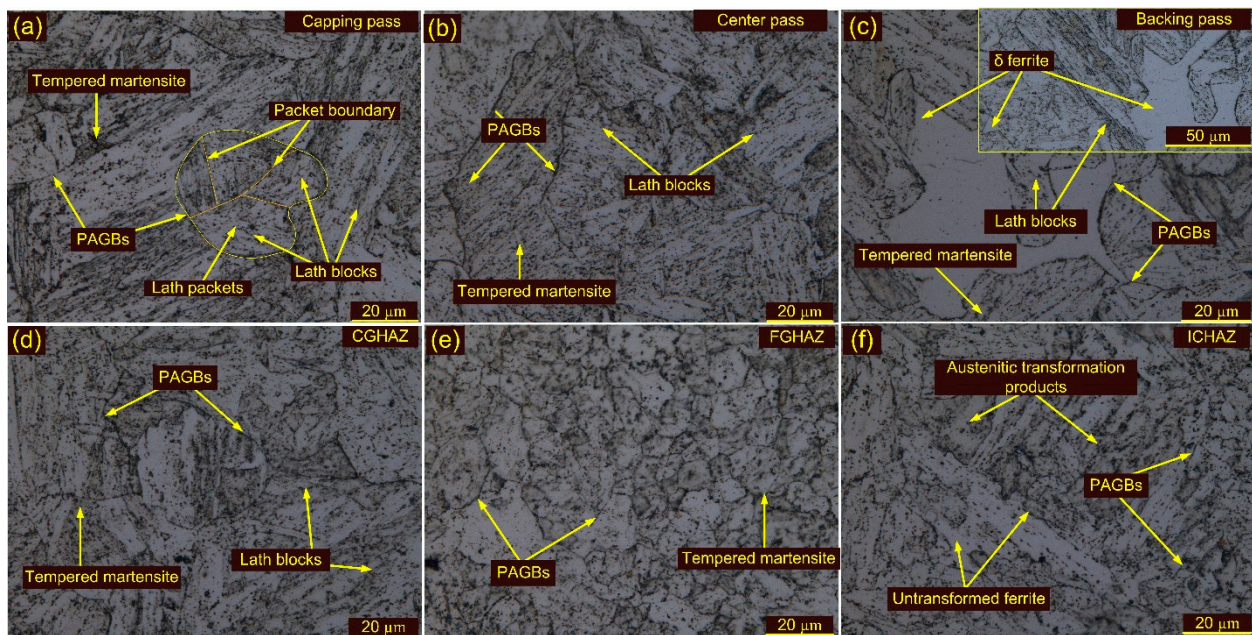
**Figure 15.** Weldments after HT2 treatment: WFZ (a) capping pass, (b) center pass, (c) backing pass; (d) CGHAZ, (e) FGHAZ, (f) ICHAZ.

Optical images of the WFZ after HT2 treatment are depicted in Figure 15a–c. The WFZ corresponding to the capping pass shows lath blocks and lath packets within the PAGBs. The lath blocks had different orientations within lath packets. Coarsening of the grains is also seen in the WFZ. The PAGs' sizes in the capping, center and backing passes were  $28 \pm 5 \mu\text{m}$ ,  $40 \pm 6 \mu\text{m}$  and  $31 \pm 4 \mu\text{m}$ , respectively. The WFZ corresponding to the backing pass showed typical lath blocks and  $\delta$  ferrite patches (Figure 15c). SEM images are presented in Figure 16a–c. A higher magnification image presents the precipitate decoration along blocks and boundaries (Figure 16). The HAZs after HT2 are presented in Figure 15d–f. Coarse PAGs consisting of blocks and boundaries are seen in the CGHAZ (Figure 15d). The PAGs' size was  $32 \pm 7 \mu\text{m}$ . Equiaxed PAGs with a size of  $13 \pm 3 \mu\text{m}$  are seen in the FGHAZ (Figure 15e). The ICHAZ after HT2 is presented in Figure 15f.

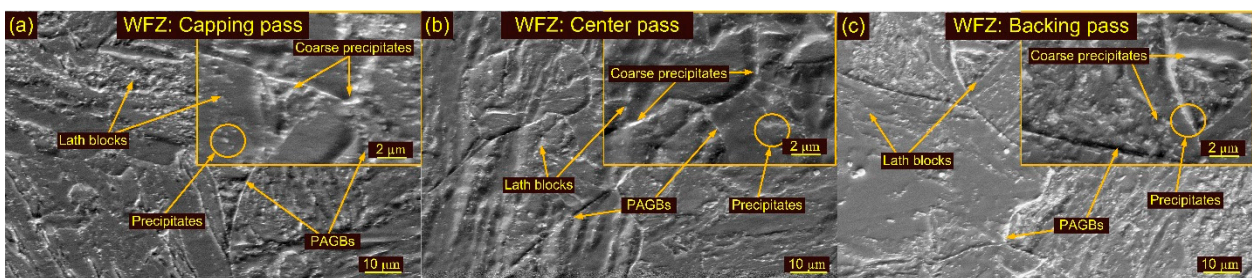
**Figure 16.** SEM images of weldments after HT2 treatment: WFZ (a) capping pass, (b) center pass, (c) backing pass.

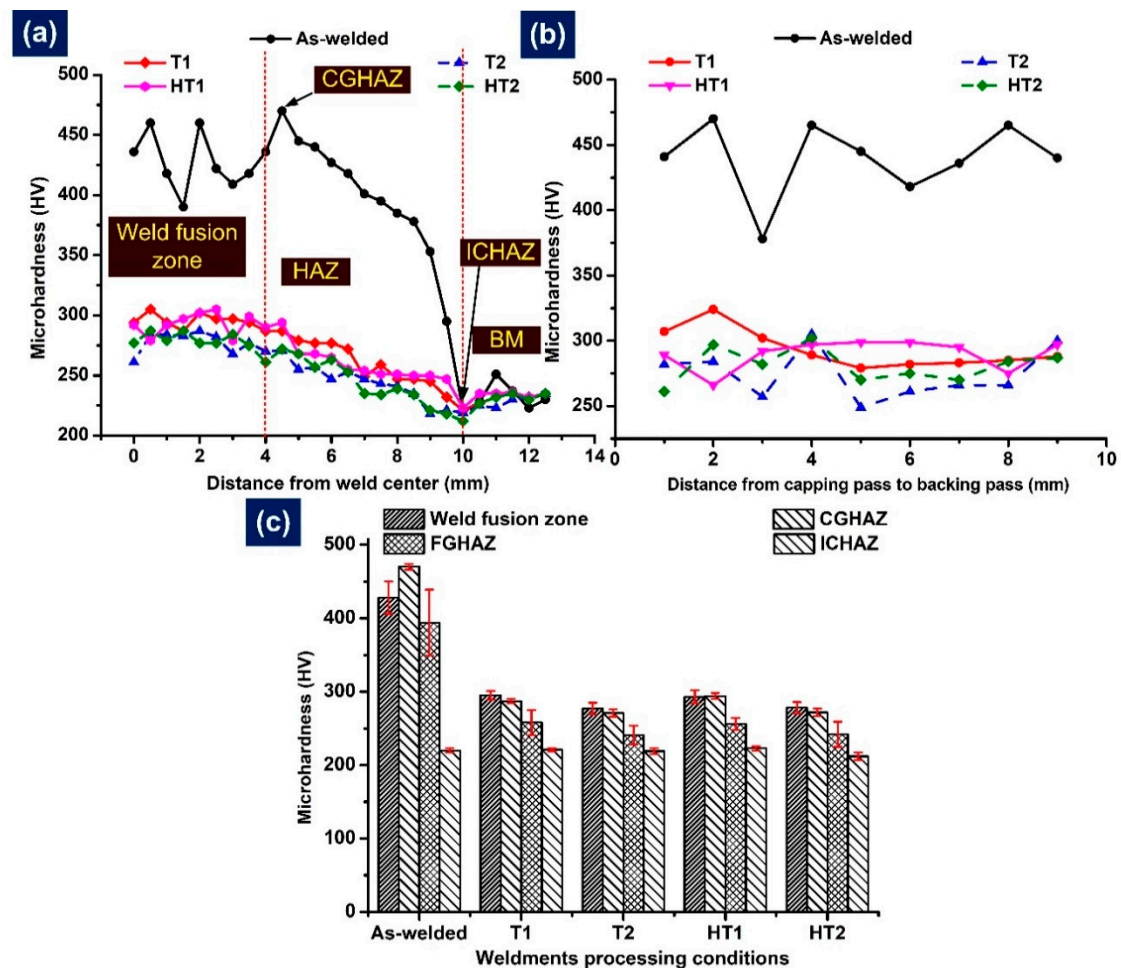
**Figure 17.** (a) Hardness profiles along the weldments, (b) hardness profiles, and (c) hardness of weldments after different heat treatment conditions.

The hardness variation plots for welded joints in AW and PWHT conditions are depicted in Figure 17a. In the AW condition, the hardness of the WFZ was 390–460 HV with an average of  $428 \pm 22 \text{ HV}$  (Figure 17c). The variation in hardness might be due to the nature of multi-pass welding and the presence of soft  $\delta$  ferrite patches [65]. The soft ferrite patches showed a hardness value much lower than that of the surrounding matrix of untempered martensite. Pandey et al. [49] also reported hardness values of  $\delta$  ferrite patches between 179 and 301 HV. The hardness of the WFZ depends on heat input,

66 HV, 52 HV, 71 HV and 60 HV for T1, T2, HT1 and HT2, respectively. The PWHT at 120 min was more effective at minimizing the hardness variation. The reduction in hardness in the CGHAZ and FGHAZ is attributed to a tempering reaction [71]. The combined effect of PWHT and welding passes on hardness values is given in Figure 17b.

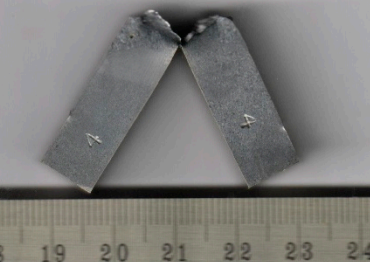
**Figure 18.** Impact test results for AW and heat-treated joints showing impact toughness values and impact specimens before and after fracturing.

For the rest of the weldment conditions, impact toughness was measured for the WFZ only and the results are presented in Figure 18. T1 improved impact toughness significantly, as it imparted ductility to the WFZ by tempering the martensite. However, impact toughness still measured lower than the minimum accepted value of 47 J. After T2, i.e., at a constant temperature with increased PWHT time from 90 min to 120 min, impact toughness was 68 J, close to the recommended value of 47 J. The increase in impact toughness was attributed to the tempering reaction. Tempering of martensite imparts softening to the martensitic matrix via a reduction in dislocation density, breakup of lath and evolution of precipitates. In both T1 and T2 treatment, a complete fracture of the test specimen occurred, which ensured that the mixed-mode fracture was dominated by a cleavage area or brittle fracture. With the increase in PWHT temperature, i.e., from 760 °C (T1) to 780 °C (HT1) for a constant PWHT duration of 90 min, impact toughness increased from 45 J to 70 J and achieved the minimum landmark of 47 J. That result might be due to adequate tempering of the martensite. The impact test results for HT2 showed the highest impact toughness value of 124 J (Figure 18). The test specimen for HT2 also showed yielding before fracture, as given in Figure 18. A great impact of PWHT parameters on the impact toughness of Cr–Mo steel welded joints was also reported by Pandey and Mahapatra [69]. From the impact test results, it can be recommended to either perform PWHT at 760 °C for 120 min (T2) or at 780 °C for 90 min (HT1). T1 resulted in poor impact toughness while HT2 needed a higher cost than HT1.

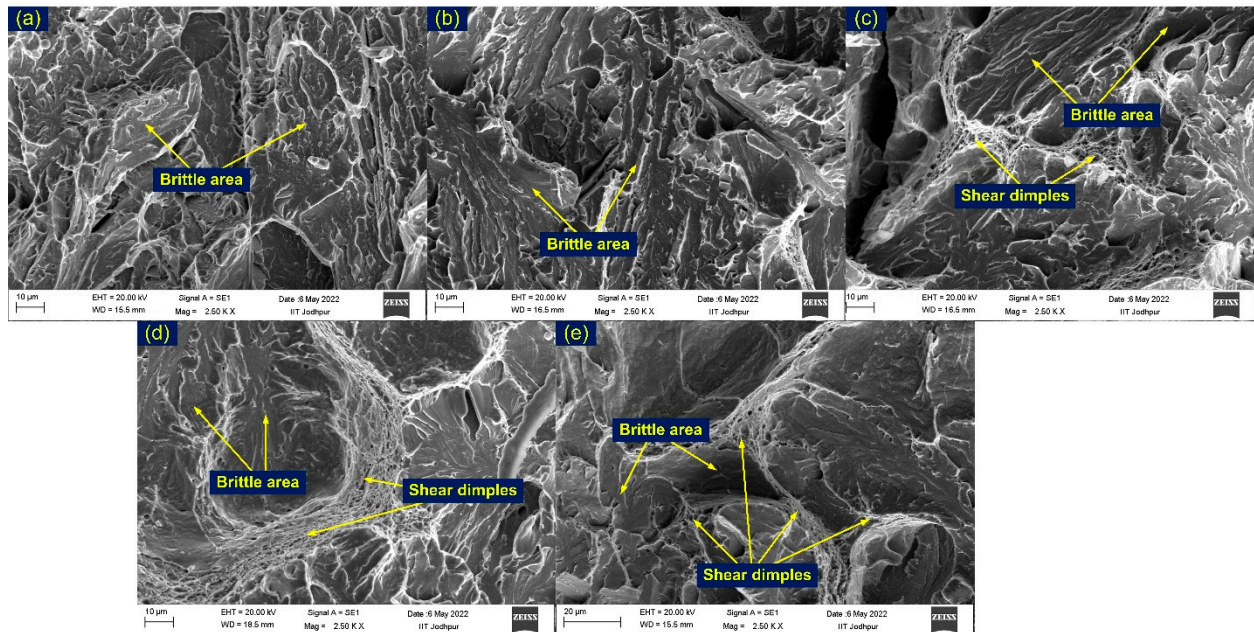
**Figure 19.** SEM image of fractured impact tested specimens: (a) AW, (b) T1, (c) T2, (d) HT1, (e) HT2.

SEM micrographs of the impact-tested fractured specimens are presented in Figure 19. The appearance of the fracture surface for AW and T1 specimens supports the impact test

results, as in both cases the fracture was dominated by a brittle area (Figure 19a,b). The fracture surface shows the typical characteristics of a cleavage area and river patterns. In T2, both dimples and a cleavage area appeared at the fracture surface; however, the fracture mode was dominated by the brittle area (Figure 19c). In HT1 (Figure 19d) and HT2 (Figure 19e), both cleavage and shear dimples are seen; however, the major portion was represented by the brittle area.

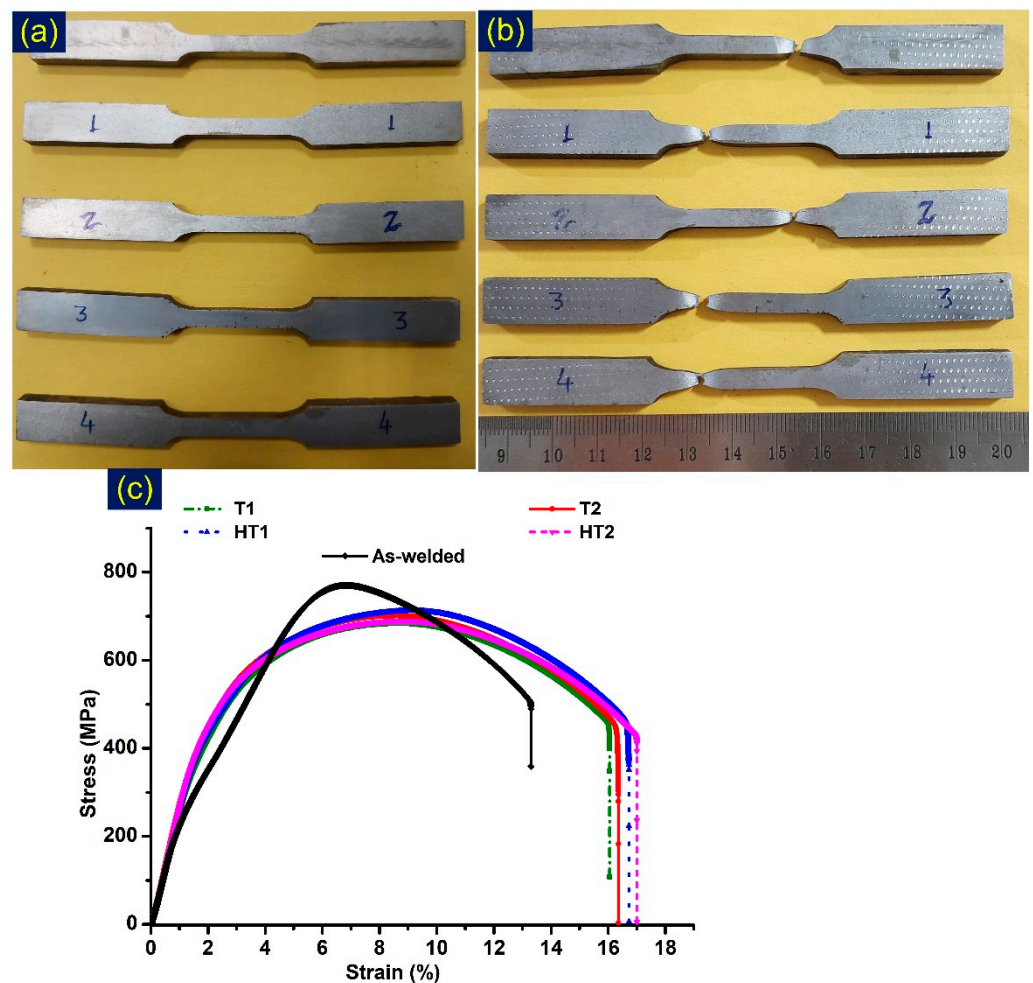
**Figure 20.** (a) Tensile specimens before testing and (b) after testing; (c) stress–strain curve for tested specimens.

Tensile test results are depicted in Table 4. Tensile specimens before and after fracture are given in Figure 20a,b, while Figure 20c shows the stress–strain curve. The specimen for the AW test showed the fracture in the P92 BM zone with tensile strength (TS) of 751 MPa. The failure of the tensile specimen from the P92 BM instead of the WFZ ensured that the joint was safe for USC boiler application. The TS value measured near the P92 BM was 758 MPa. However, for the AW joint, % elongation (13%) measured lower than that of the P92 BM (33%). The lower value might be due to the presence of the WFZ and HAZ in the gauge area of the specimen. The TS values were 683 MPa, 701 MPa, 711 MPa and 690 MPa for T1, T2, HT1 and HT2, respectively. The fracture in each condition was measured in over-tempered BM. TS for the heat-treated specimens measured lower than for the BM and AW joint. This might be due to the over-tempering of the martensite in the P92 BM.
