# Influence of water salinity on corrosion risk—the case of the southern Baltic Sea coast

**Abstract** Water corrosivity in Gdansk Bay, Poland, the southern part of the Baltic Sea, was investigated. The analysed region is heavily industrialized, and the coastline is very diverse. Twenty-seven test points along the coastline were selected. Water parameters such as salinity, total dissolved solids content, resistivity, conductivity, oxygenation, pH and corrosion rate were determined. The results of the investigation are presented. Water samples were collected, and structural steel specimens were exposed in the water for 2 months. The corrosion rate for each test point was determined and plotted on a map. The spatial distribution of water parameters was calculated using the ‘inverse distance to a power’ method and presented on the maps. Salinity did not exceed 0.7 ‰, and average corrosion rate equalled 0.0585 mm/year.

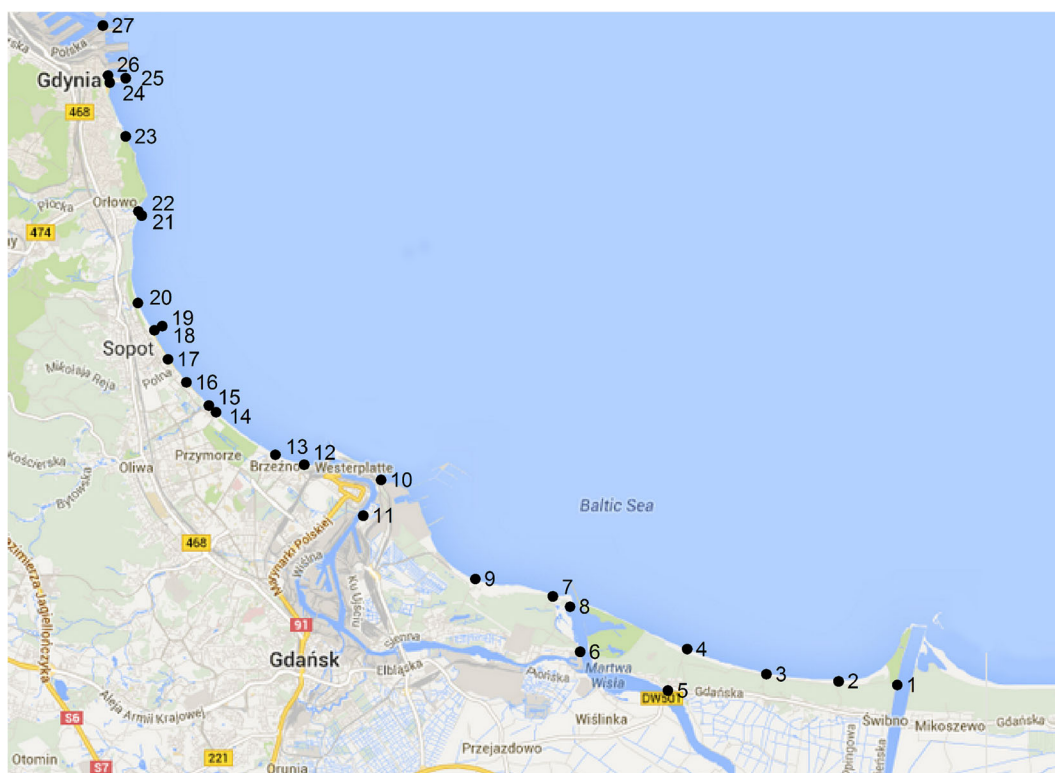
**Fig. 1** Test points along the Gdansk Bay coastline

Twenty-seven measurement points were chosen. They were located along the Gdansk Bay coastline, from the Vistula River mouth near the Isle of Sobieszewo (Gdansk) to the Port of Gdynia. The locations where the measurements and the water samples were taken are presented in Fig. 1. The description, localization and water parameters for each and every point are presented in Table 2.

At every test point (Fig. 1), the following seawater parameters were measured:

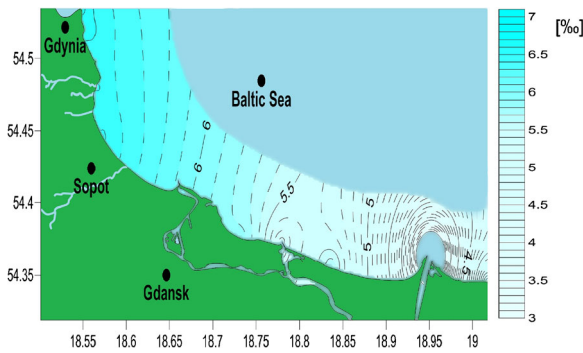
**Fig. 2** Map of salinity distribution along the Gdansk Bay coastline

The distribution of water salinity in the investigated region is presented in Fig. 2. On the OX and OY axes, the longitude and the latitude are presented in the NAD83 system, respectively. The further away from the Vistula River mouth one moves, the higher the salinity is. The Vistula River is a sweet water source for the Isle of Sobieszewo area. Local salinity is also influenced by smaller watercourses and rivers, for instance in Jelitkowo (Table 2, sample no. 15). In the areas located further away from watercourses, the salinity is approximately the same, for instance in Gdynia (Table 2,

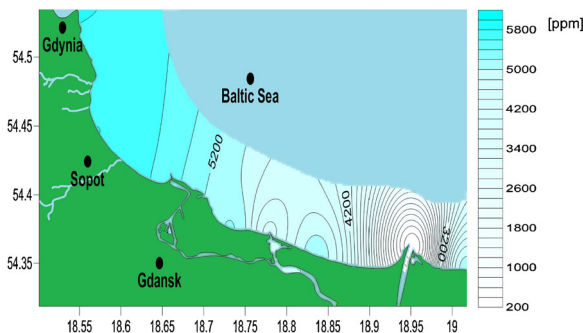
**Fig. 3** Map of TDS distribution along the Gdansk Bay coastline

The distribution of TDS along the Gdansk Bay coastline is presented in Fig. 3, and resistivity is presented in Fig. 4. The TDS content is well correlated with resistivity (Pearson correlation coefficient = -0.85). The reason for such a strong correlation is the use of the same probe for both measurements.

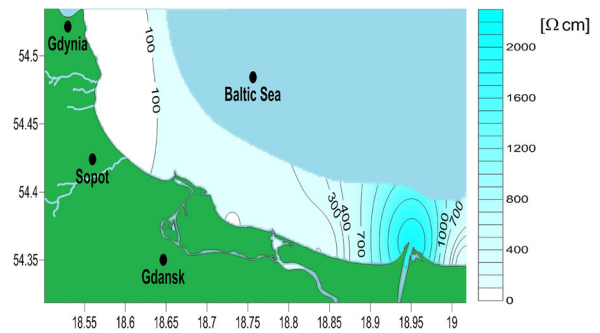
**Fig. 4** Map of resistivity distribution along the Gdansk Bay coastline

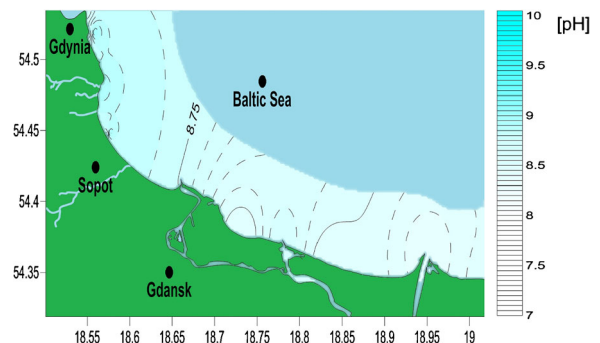
**Fig. 5** Map of seawater pH distribution along the Gdansk Bay coastline

The pH of seawater in Gdansk Bay is presented in Fig. 5. Only at two test points was water pH out of the 8–9 range. In the Dead Vistula River (Table 2, sample no. 11), the water was slightly more acidic and the pH was equal to 7.88. In Gdynia Orlowo (test point 21), the pH was slightly higher and was equal to 9.78. The measurement was taken inside the bay, where the water is rather unstirred and there is a small polluted river nearby, which might enhance biological activity leading to an increase in the pH of the water.

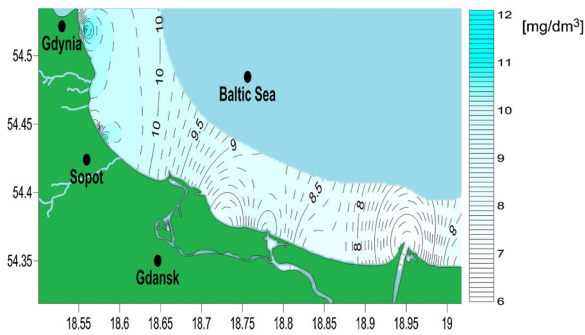
Fig. 6 Map of seawater oxygenation distribution along the Gdansk Bay coastline

The oxygenation of seawater in the investigated area is presented in Fig. 6. The lowest oxygenation value was

equal to  $6.74 \text{ mg/dm}^3$  and was observed at the Vistula River mouth. The Vistula River is notoriously reported to be polluted at its river mouth. Bacterial pollution from municipal sewage, chemical plant sewage and fertilizer run-off might be the causes of the very low water oxygenation (Environment and United Nations Environment Programme Global 2007).

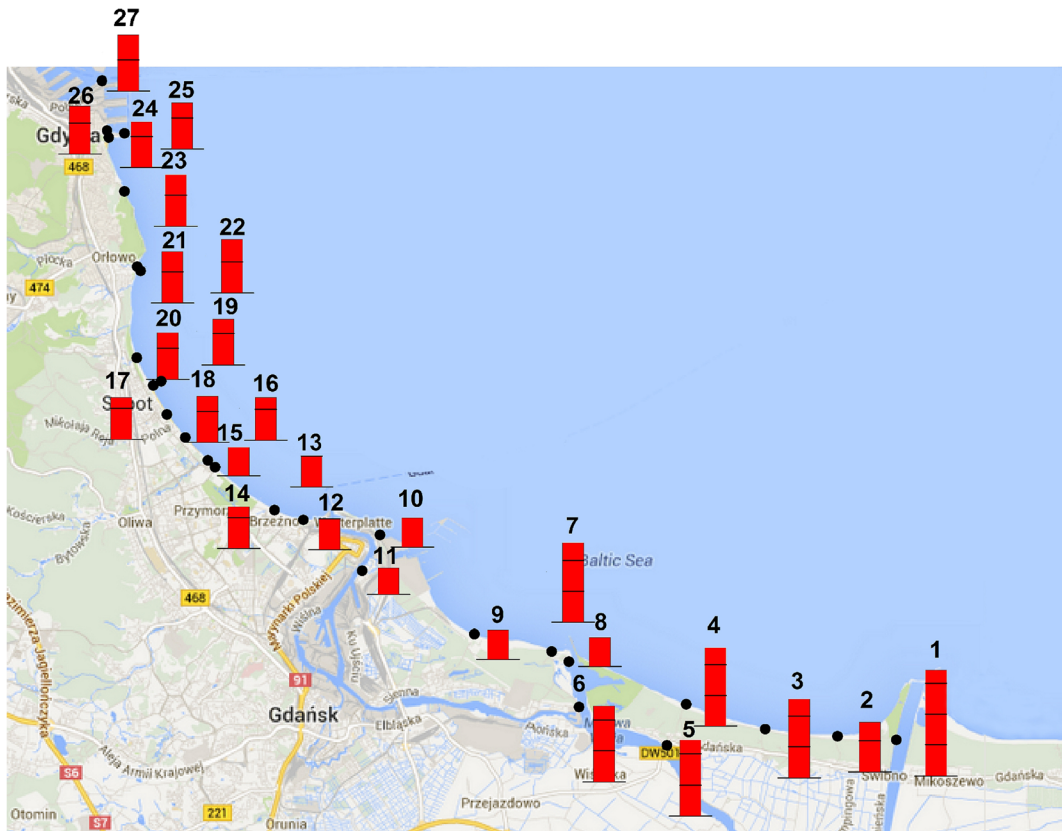
Fig. 7 Map of relative corrosion rates along the Gdansk Bay coastline

The determined corrosion rates for all test points ranged from 0.035 to 0.1061 mm/year, and their values are presented in Fig. 7. The obtained corrosion rates are lower than typical corrosion rates for oxygenated 3.5 % seawater, which were equal to approximately 0.5 mm/year and in extreme cases 1.0 mm/year (Gardiner and Melchers 2003). Thus, the low salinity of seawater has a positive effect from the standpoint of corrosion risk of offshore structures. It has to be noted that locally where the water flows, string and oxygenation are high and the corrosion rate might rise significantly.

The highest corrosion rate among investigated samples was recorded for the Vistula River dug-through (Table 2, sample no. 1) and was equal to 1.061 mm/year. Yet, water resistivity, obviously due to the proximity of the river mouth, was the highest, and the salin-

ity was the lowest. If only those parameters were concerned, one would expect the opposite effect—lower corrosion rates as compared to the other test points. Thus, the other factors must have had an effect on corrosion aggressiveness in that area. One can assume that it was a water pollution factor, which was not investigated in this study. The further away from the Vistula River mouth

one goes, the lower the corrosion rates are, probably due to the mixing of seawater with sweet water from the river. The corrosion rate determined for water sampled from the Dead Vistula River (Table 2, sample no. 11) was the least corrosive. Apart from the Vistula River dug-through, it also had the lowest resistivity.
