Mechanical and physical assessment of epoxy, mineral, solvent-based, and water-soluble coating materials

Ginneth Patricia Millán Ramírez

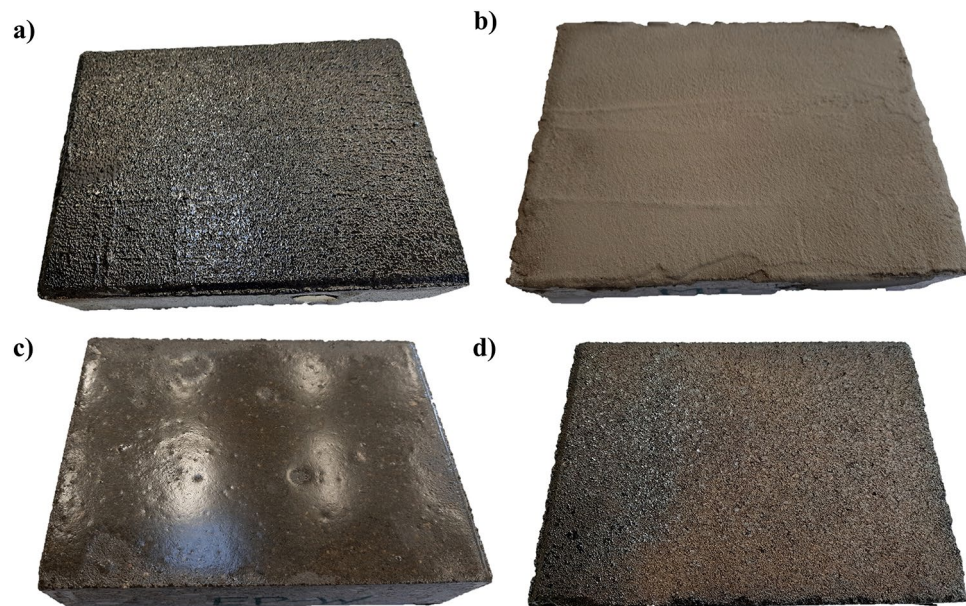
Figure 3. Coating materials applied in concrete slabs with wet substrate (a) BW (b) MI (c) EP (d) BR.

BW, MI, EP, and BR coating materials were applied according to the manufacturer's specifications. A total of 36 concrete specimens were used during the research. Figure 3 shows the coating materials applied to concrete slabs.

- **Application of coatings to the surface of the concrete slabs** The application varied according to the type of coating material.
 - **Epoxy coatings** After mixing the coating compounds, one layer of the mix was applied with a regular brush on the surface of each concrete sample.

- **Water-soluble and solvent-based coatings** According to the manufacturer's recommendations, three layers of the material were applied using a regular brush. The second and third layers were applied after the previous layer dried to touch, about 30 min for solvent-based coating and about 1 h for water-soluble coating.

- **Mineral coating** After mixing the material with water, two layers were applied with a spatula, distributing the material uniformly on the concrete slab's surface. The second layer was applied after the first layer had dried to touch after about 1.5 h.

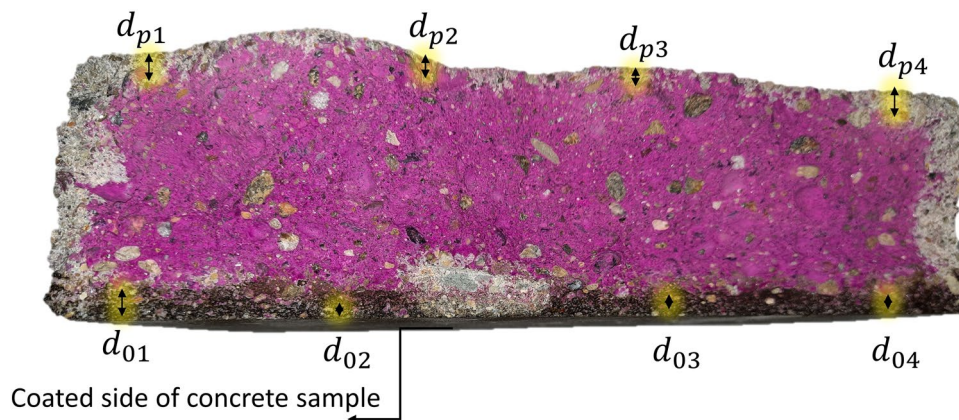
Figure 5. Carbonation measurement on both sides of concrete samples.

According to Page et al.²⁵, the performance of coating materials against corrosion can be measured by the carbonation suppression ratio (R_{cs}) which compares the coated and the uncoated sides of concrete samples. Figure 5 shows the average depth d_0 and d_p .

Carbonation depth. After applying the coating material, concrete samples were stored in an indoor controlled environment at $20 \pm 2^\circ\text{C}$ and $75\% \pm 5\%$ relative humidity for 90 days. Next, phenolphthalein solution was sprayed onto the fresh broken concrete surface according to the CPC-18 RILEM²³. This solution is characterized by being a colorless liquid commonly used as an acid-base indicator that changes to purple when the pH is higher than 9. As a result, the non-carbonated concrete surface, where the specimen is still alkaline, turns into a purple color, and the carbonated concrete surface remains colorless due to the reduction in the alkalinity of concrete.

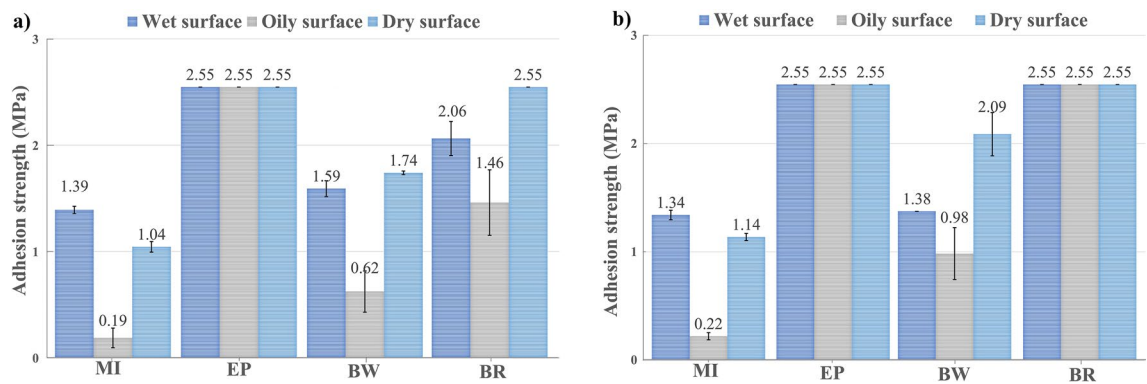
Figure 7. Average adhesion test in concrete slabs (a) Samples air-dried for 28 days (b) Samples air-dried for 14 days + oven-dried for 14 days.

Pull-off adhesion strength of coating materials. Figure 7 shows adhesion strength values for MI, EP, BW, and BR coatings applied on concrete slabs and dried in two conditions and on three surfaces. [Point 2.1.1.].

The results indicate that epoxy materials presented the highest adhesion strength values in all scenarios by exceeding the maximum possible measure of the dynamometer (5 kN). These values follow the values given by the manufacturer. It is noteworthy that all EP samples presented substrate failure under the load, evidencing a

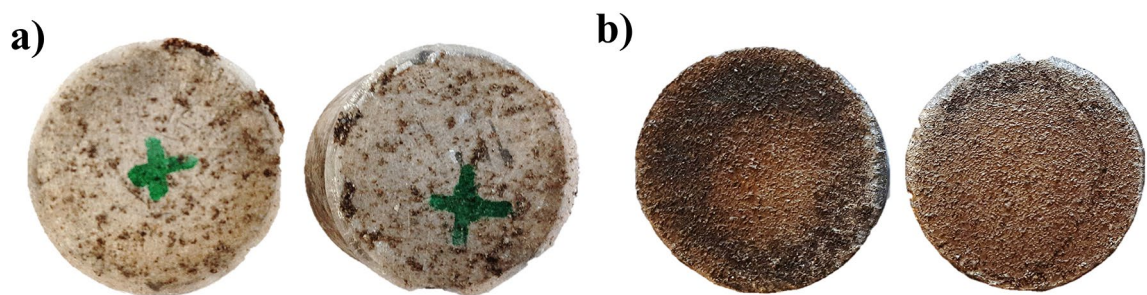
Figure 9. Dolly after pull-off adhesion test in the dry substrate: (a) BR samples exposed to air and oven drying (b) BR samples exposed to air drying.

For concrete slabs with BR Coating, the maximum pull-off adhesion strength values were observed in the samples dried for 14 days in the air plus 14 days in the oven by achieving the maximum pull force value (5 kN). However, according to the types of failures presented in the ASTM D 4541 standard and ISO 4264^{24,27}, a glue failure was evidenced in all samples; this can be attributed to the drying process in the oven. The coating reduced its mechanical properties and did not chemically interact with the epoxy resin, leaving a weak joint. For samples exposed to air drying for 28 days, a reduction in the strength adhesion was evidenced; these specimens showed a decrease of 42% in samples saturated with oil and 19% in samples saturated with water. Even though there is a reduction in the strength values, the specimens presented a cohesive failure within the coating layer, which is considered the ideal type of failure in the pull-off test. Figure 9 shows examples of the types of failures mentioned for BR coatings.

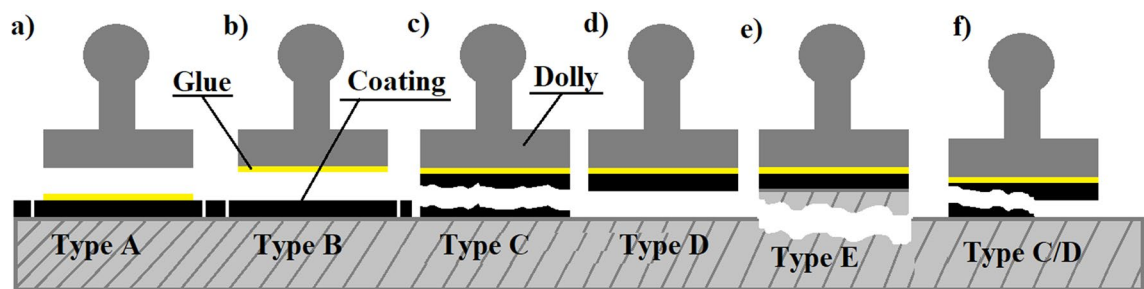
Figure 11. Types of fracture according to its nature: (a) Glue failure (b) Adhesive failure (between layers) (c) Cohesive failure (within a layer) (d) coating failure (e) Substrate failure (f) 50% cohesive failure and 50% coating failure.

ISO 4264²⁷ was used to assess the fracture type. Figure 11 describes the nature of the possible fractures. According to Fig. 11, Table 5 summarizes the types of fracture obtained in all pull-off adhesion strength tests.

The mineral coating was the only material where the presence of oil influenced the failure type. Samples exposed to air-drying presented 50% adhesive and 50% (Fig. 11b) cohesive failure, and samples exposed to oven drying showed 100% adhesive failure (Fig. 11a). For wet and dry surfaces, cohesive failure was evidenced in both types of drying, showing values aligned to those of the manufacturer. Figure 10 illustrates concrete specimens saturated with oil surface and protected with a mineral coating.

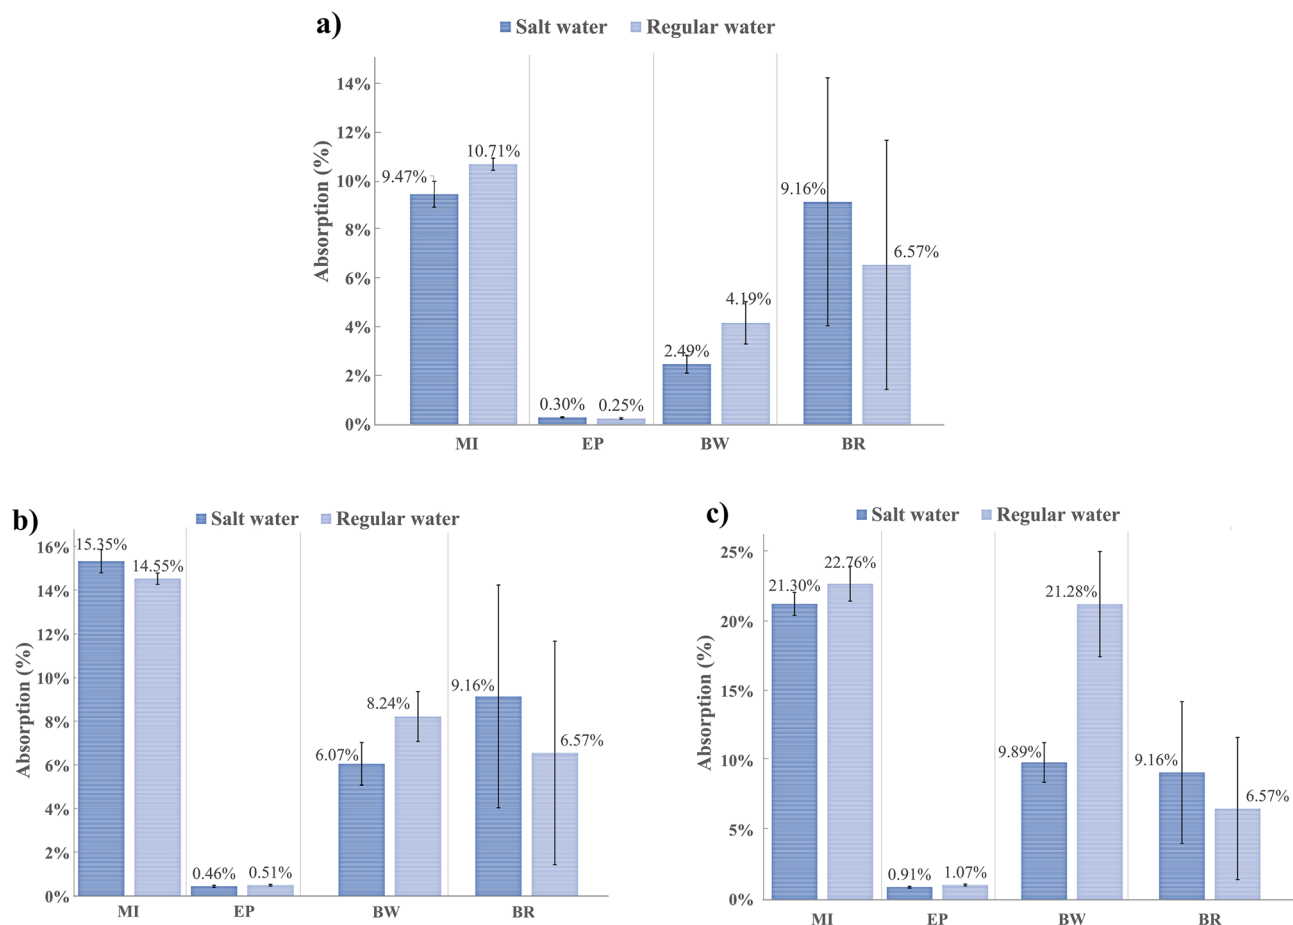
Figure 12. Average coating water absorption: (a) After 24 h (b) After 7 days (c) After 28 days.

Absorption test. Figure 12 shows the results of the water absorption test of the four coating materials at different stages, 24 h, 7 days, and 28 days. Table 7 describes the final weight gained by the different coating materials samples.

According to the results, MI, EP, and BR coatings presented similar absorption coefficients between each of them during the three stages when exposed to regular and saltwater. However, BW coating was widely affected by regular water, showing a total increment in the absorption coefficient after 28 days of exposition of around 21% in regular water, 10% more than in saltwater. According to Anderson et al.²⁹, the low water absorption is caused by hydrocarbon constituents, showing a slight tendency to absorb water over the years. Additionally, physical changes were noticeable after seven days of contact. In the case of regular water, changes in the sample color were evident due to the chemical changes produced by the presence of oxygen that interacts with the basic components of the material, changing from black to brown color. For saltwater, some samples showed cracks in their surface, accelerating the corrosion of specimens. Figure 13 shows the changes in the color of the coating samples.

Data presented in Fig. 12 was used to calculate the water absorption rate, and Table 8 shows the results.

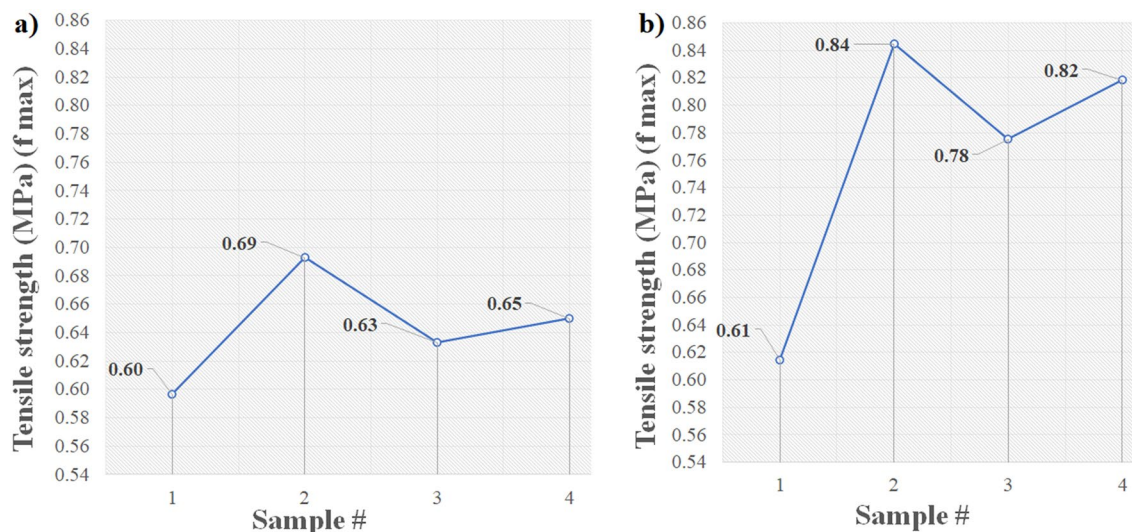
Figure 14. Tensile strength (a) after 14 days (b) after 28 days.

Tensile test of the mineral coating. Figure 14 shows the tensile strength results at 14 and 28 days of mineral coating. It shows an increment of around 25% in their strength value over time.

Tensile test of the mineral coating. Tensile strength in mineral coatings was assessed by using samples of size (250 mm \times 50 mm) and conditioned at $20 \pm 2^\circ\text{C}$ and $75\% \pm 5\%$ relative humidity. Tensile tests were performed at 14 and 28 days of air-drying using a testing machine with a maximum test load of 5 kN. The free distance between the holders was about 205 ± 1 mm, and the transverse speed was set to 10 mm/min. A total of eight specimens were tested. Elastic modulus, tensile strength, and strain at fracture in tension were calculated at the maximum load.

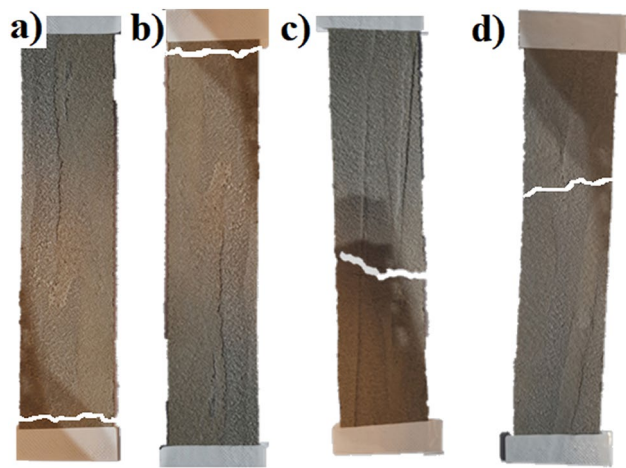
Figure 15. Detail failure mode and type: (a) Lateral at grip/tab Bottom (b) Lateral at grip/tab Top (c) Angled Gage Middle (d) Lateral Gage Middle.

After the test, samples were carefully photographed, and the failure type was determined according to the ASTM D 3039 standard. Figure 15 shows some examples of the typical failure modes obtained in this research.

Table 9 summarizes the failure modes, location, young modulus values, and the elongation of each sample.
